Mizen Head Footbridge or 'Building a Bridge, to a Build Bridge'

MIZEN Head Footbridge in County Cork is a reinforced concrete through-arch structure spanning 50 m. The original structure was demolished and rebuilt 2009-2011, 100 years after its completion. This article describes the construction challenges of safely reconstructing a bridge in a difficult site location.

By Kieran D. Ruane

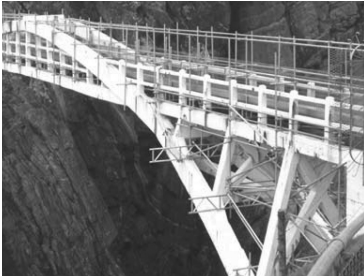
Figure 1. Temporary access scaffold supported directly from the arch ribs erected in June 2005.

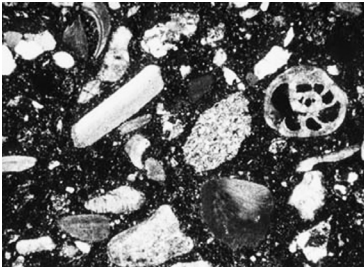
Petrographic examination was carried out on two core samples taken from the structure. The coarse aggregate used in the deck construction was dominated by crushed greywacke and sandstone particles having a nominal maximum size of 14 mm. The aggregate in the coarse fraction was probably locally derived.

Figure 2. Petrographic analysis of the original bridge concrete showing presence of sea shells.

No evidence of damage due to alkali-aggregate action was found in the petrographic examination, although traces of gel were present in voids in the paste. Examination of a thin section taken from a portion of the core sample showed fine cracks running through aggregate particles into the cement paste. These were found to contain alkali silicate gel and indicated that an expansive reaction had taken place between the greywacke aggregate and alkalis in the paste, causing very localized damage to the concrete in the area where the core had been taken. This is considered to be the only reported example of alkali-aggregate reaction in Ireland to date.

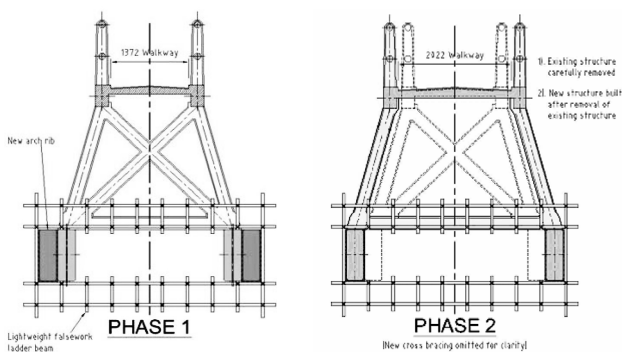
Figure 5. Sectional elevations through the bridge indicating the solution to use the existing ribs as falsework for the construction of new ribs. The new ribs would then be used to support demolition works on the old bridge.

Option 2: A scheme which initially involved the construction of new arch ribs (parallel to and outside the existing ribs) using the existing ribs (strengthened if required) as falsework, followed by the sequential demolition of the existing bridge, followed by the construction of trestles edge beams, hangers, and the deck slab. This scheme produced a replica of the existing bridge though the deck would be 700 mm wider. The mass concrete foundations at the arch springing points and deck ends would be retained.

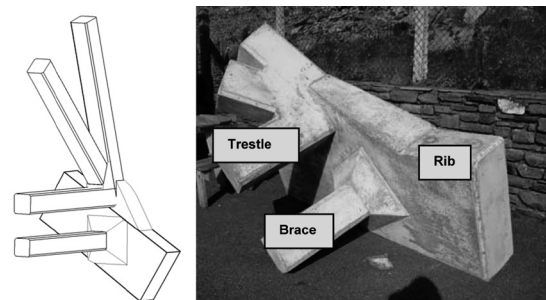
Figure 6. Trial panel comprising braced arch rib section at trestle support.

Construction of the trial panel was an early activity in the construction program. It allowed the engineers, carpenters and reinforcement fixers to develop their detailed construction plans before undertaking the permanent works. The geometry of the bridge was difficult to form. The ribs vary in depth and they are flared out in the back-spans. Where members such as braces and trestles intersect the ribs, the member ends are locally widened with tapering faces. Each of these details was faithfully reproduced from the original bridge and detailed in to the new works. The carpenters likened the formwork required to construct the new bridge to cabinet-making such was the complexity involved.

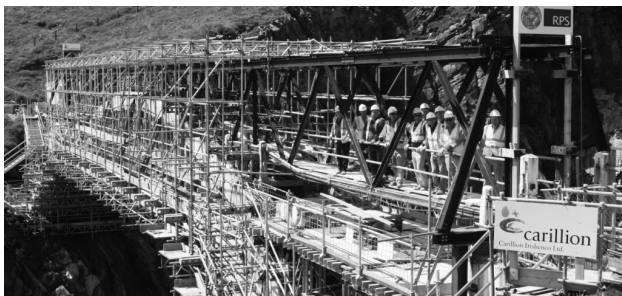
Figure 7. Erection of the temporary truss. All of the members were delivered and erected by hand.

- Use of the existing arch ribs to support the construction of the new ribs, an access scaffold in the back-spans and a temporary deck system.
- Use of a 52-metre-long steel truss to span across, and above, the existing bridge deck to act as a fail-safe for the works, to provide support to the main access scaffold and to provide support to an overhead winch and gantry capable of lifting and transporting a safe working load of 1,500 kg.
- Use of a large scale scaffold to allow full access to all parts of the central portion of the bridge.
- Use of the new arch ribs to support the demolition of the old arch ribs and the construction of other permanent works structural elements.
