## Restoring the “God Box”: Mies van der Rohe's Carr Chapel at IIT

BY GUNNY HARBOE

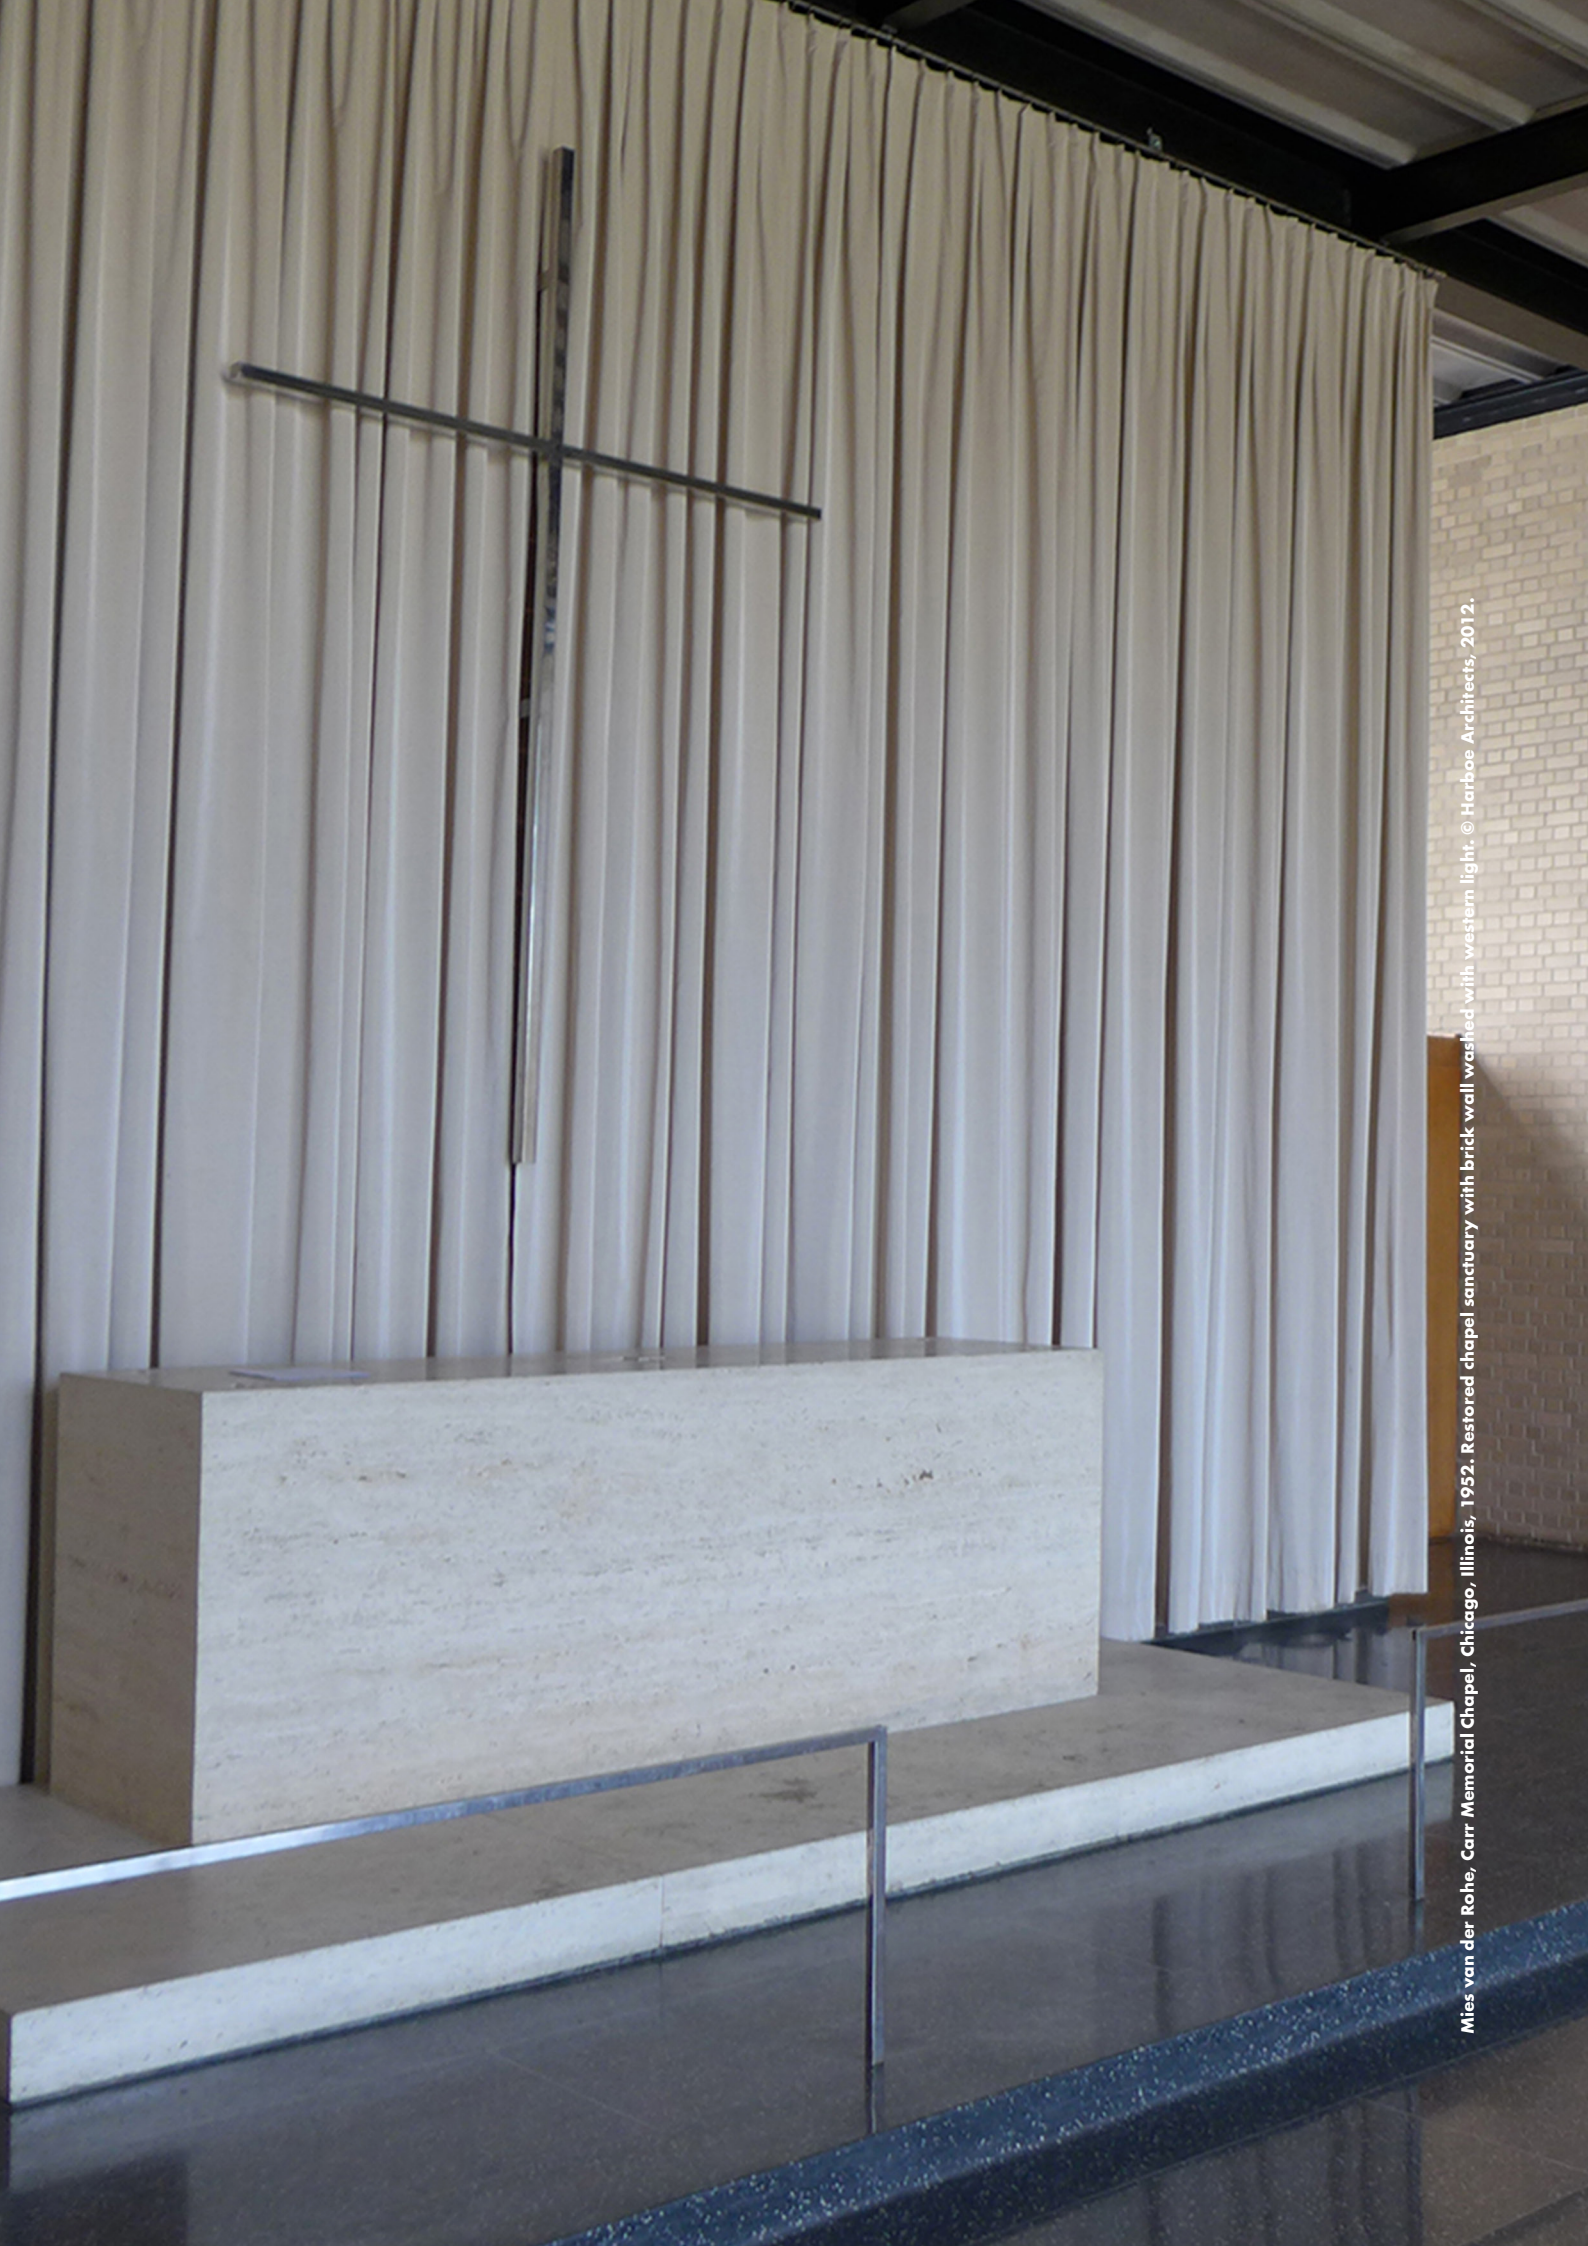
Mies van der Rohe, Carr Memorial Chapel, Chicago, Illinois, 1952. Restored chapel sanctuary with brick wall washed with western light. © Harboe Architects, 2012.

As mentioned previously, sometime in the 1960s there had been a large box like enclosure created in the loft over the sacristy area to accommodate the pipes for the organ. This was not part of Mies van der Rohe’s original design and, in fact, detracted greatly from the lighting effect of the western light washing the yellow brick walls. With advances in technology related to musical instruments and amplification, the pipe organ was no longer needed and had been out of use for some time. As part of phase 2 of the restoration, the pipe organ enclosure was removed allowing the light to once again cascade along walls (essay cover).

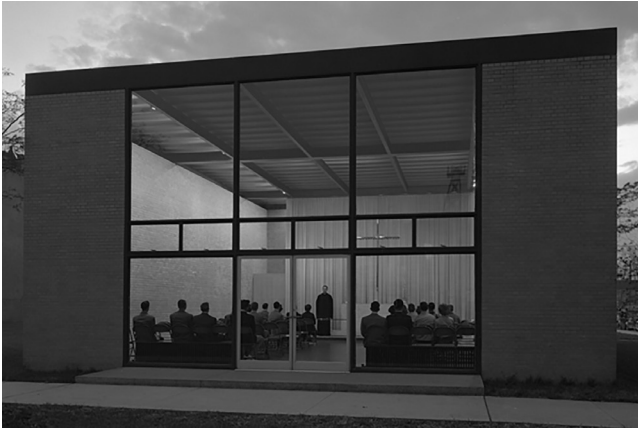
01 Mies van der Rohe, Carr Memorial Chapel, Chicago, Illinois, 1952. Historic view of east façade. © Hedrich Blessing, 1952.

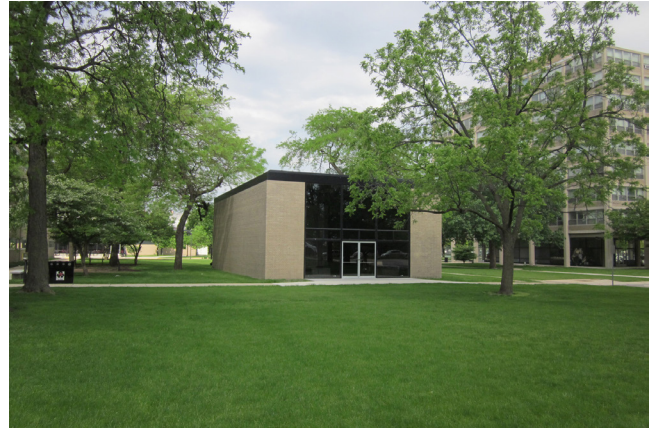
02 Mies van der Rohe, Carr Memorial Chapel, Chicago, Illinois, 1952. Looking west at the restored chapel. © Harboe Architects, 2011.

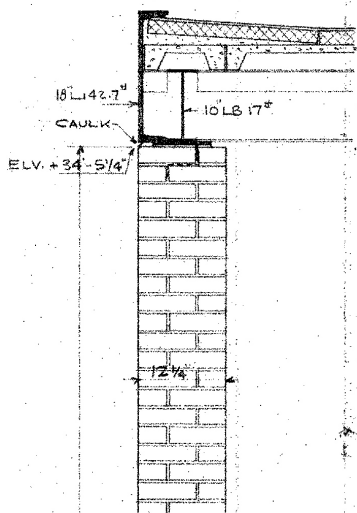
Additional water infiltration occurred at the perimeter of the roof where there was virtually no flashing detail at the roof's edge. The roofing material simply terminated at the top flange of a large steel "C" channel that was welded together to create a continuous steel ring at the top of the masonry walls. Not only did water infiltrate along the inside edge of the top flange, but it also penetrated at the caulk joint between the steel channel and the top of the masonry

wall (figure 03). This resulted in water infiltrating into the solid masonry wall from the top down and the blooming of efflorescence on the inside walls, particularly in the corners. Although this detail was simple in concept and aesthetically elegant, thus holding true to Mies van der Rohe's design philosophy of "less is more", in this case, "less" was not enough.

**03** Mies van der Rohe, Carr Memorial Chapel, Chicago, Illinois, 1952. Historic detail drawing of roof edge.  
© Illinois Institute of Technology Archives, 1951.

At some point previously, there had been an attempt to address the lack of flashing by the addition of a simple aluminum sheet flashing that lapped over the roof edge and came down over the face of the steel channel about five inches (13 cm). This was a cheap and inelegant solution that also resulted in some surface deterioration of the steel channel likely due to galvanic reaction of the aluminum with the steel. To restore the original design intent of a simple clean line of the "C" channel and to try and provide some additional slope to the roof, a steel angle was added to the top of the flange of the channel. While this did add an extra line to the top of the roof, it is set back as far as possible and is only visible when some distance back from the building. The original clean line of the top of the "C" channel has thus been restored, and several additional inches of insulation were added that not only provides a higher R value to the roof, but gives more slope away from the roof edge and reduces the risk of standing water on the roof (figure 04). A new PVC roofing membrane was then installed which has been performing well.

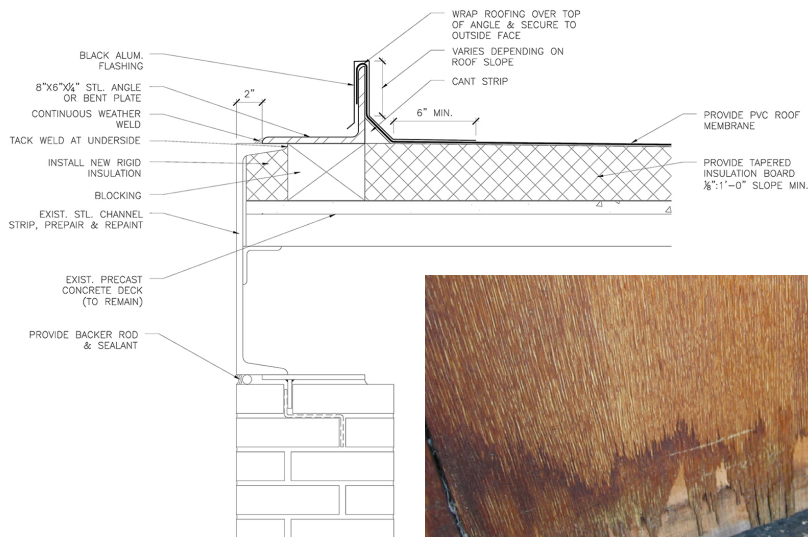
**04** Mies van der Rohe, Carr Memorial Chapel, Chicago, Illinois, 1952. Detail drawing of redesigned roof edge.  
© Harboe Architects, 2008.

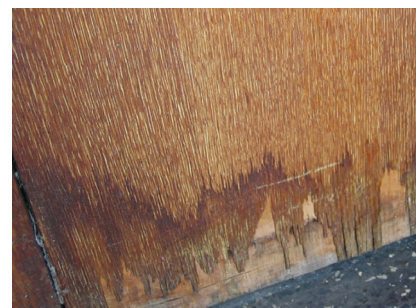
paneling that flanked either side of the altar and the doors in the choir room and sacristy areas had been abused by repeated poor cleaning methods that had ruined the bottom of the panels. Additionally all the woodwork located just inside at the west curtain wall had suffered greatly from UV degradation.

**05** Mies van der Rohe, Carr Memorial Chapel, Chicago, Illinois, 1952. Damage at the bottom of wood veneer panel due to improper cleaning methods and UV degradation.  
© Harboe Architects, 2011.

The approach to conserving all the woodwork was to retain as much original historic material as possible. All the wood paneling along the flanking walls to either side of the altar was carefully removed and taken off site to a furniture conservation studio. The remaining solid oak framing members that were left in situ were cleaned and refinished in place. The oak veneer plywood had suffered significant damage along the bottom edges due to poor cleaning techniques. In many cases there were losses of veneer (figure 05). For these areas carefully selected new veneer was spliced in with patch called a “Dutchmen”<sup>5</sup>. In the case of the doors at the rear vestibule, the UV degradation was so severe that they were deemed to be beyond restoring at an affordable cost and they had to be replaced. All the solid oak sticking that made up the door frames were also removed, restored in the shop and reinstalled, as were the two cantilevered oak benches.
