The *Neue Nationalgalerie*: the Refurbishment of a Modern Monument

BY MARTIJN JASPERS

After 46 years of continuous use, Mies van der Rohe's *Neue Nationalgalerie* in Berlin closed its doors to start works on its refurbishment. Being a masterpiece of the second half of the 20th century, conventional standards in terms of dealing with high-level heritage must be adhered to. The quality of this refurbishment can be found in the project's holistic approach. Not only by taking into account the visual integrity but also by paying attention to its physical substance, time-bound and classical elements, the added value of the project is created.

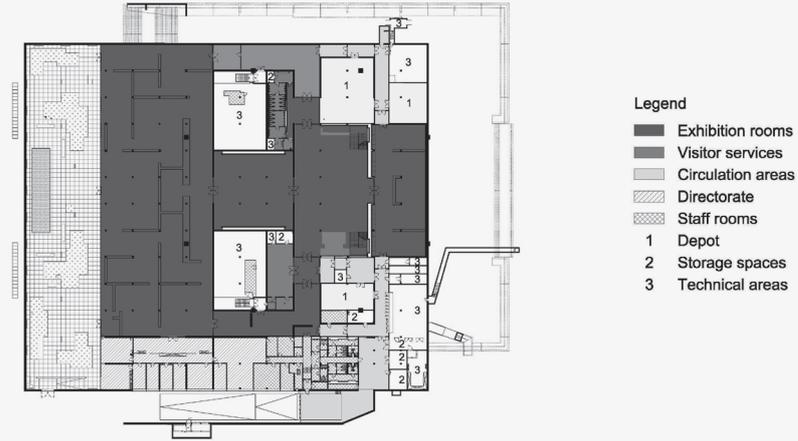
In the recording of the status quo of the building, a full sense of the misused areas and the areas where multiple uses occurred was obtained (figures 01-02). The under-dimensioned visitor services such as the cloakroom, ticket counter and museum shop; the lack of space for the preparation of exhibitions, the shortcomings in the transport routes for the art and the too restricted back-of-house areas, such as the workshop and storage areas.

01 Mies van der Rohe, *Neue Nationalgalerie*, Berlin, Germany, 1968. Basement floor with the status quo of the building, status 2014.
© David Chipperfield Architects for the *Bundesamt für Bauwesen und Raumordnung*.

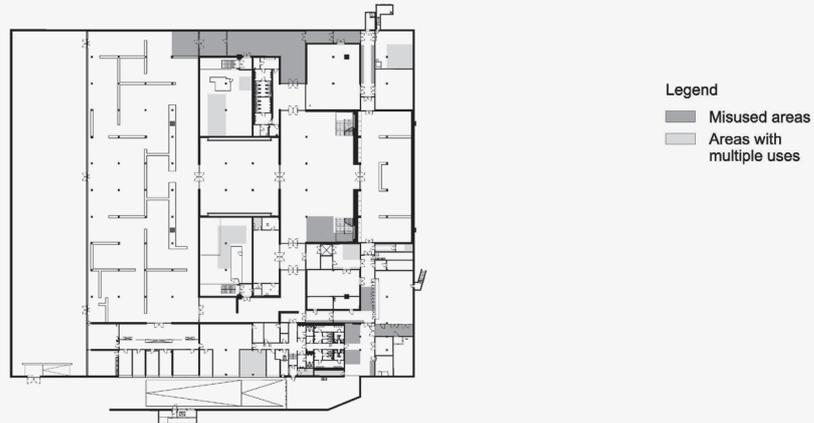
02 Mies van der Rohe, *Neue Nationalgalerie*, Berlin, Germany, 1968. Basement floor with the identified misused areas and the areas with multiple uses, status 2014.
© David Chipperfield Architects for the *Bundesamt für Bauwesen und Raumordnung*.

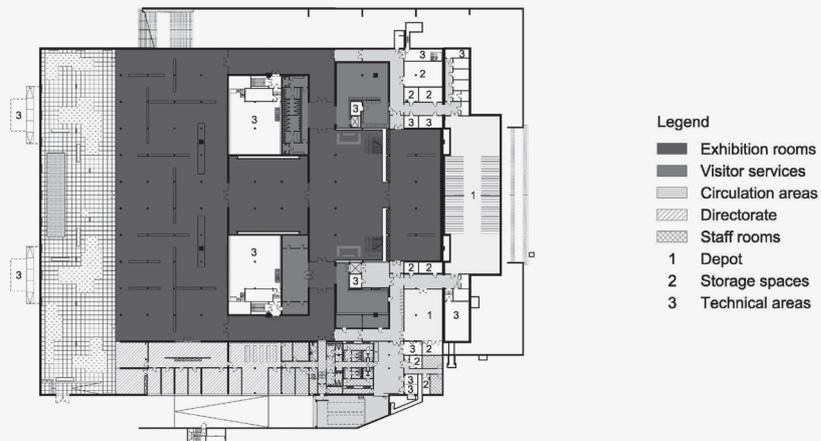
03 Mies van der Rohe, *Neue Nationalgalerie*, Berlin, Germany, 1968. Refurbishment by David Chipperfield Architects, 2017. Basement floor after the restructuring of the use, planning status 2014. © David Chipperfield Architects for the *Bundesamt für Bauwesen und Raumordnung*.

The restructuring of the use starts with the re-establishment of Mies van der Rohe's original layout for the public areas of the basement floor. By removing the interim cloakroom from the northern museum corridor and the book/museum shop from the foyer, Mies van der Rohe's ideal plan is reinstated. New positions for both functions were found in the existing sculpture and painting storage areas. This conversion of the storage areas and the need for additional technical back-of-house spaces led to the insertion of a new underground construction underneath the front podium of the building (figure 03).

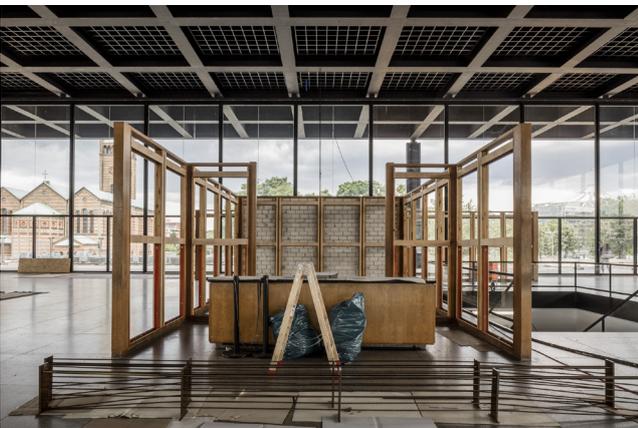
07 Mies van der Rohe, *Neue Nationalgalerie*, Berlin, Germany, 1968. Refurbishment by David Chipperfield Architects, 2017. The original cloakrooms in the upper hall are fully dismantled. The repair of the wooden paneling will be executed in a workshop environment. © Ute Zscharnt for David Chipperfield Architects, 2016.

This depth of intervention makes it inevitable that almost the full interior of the *Neue Nationalgalerie* is dismantled, resulting in the possibility to repair the hidden building parts and renew the hidden technical infrastructure. The inability to deal with certain repairs and modifications on site results in the dismantling and storage of over 30,000 elements and construction parts. These have been provided with identification labels, recorded in a database and marked on repositioning plans (figure 07).

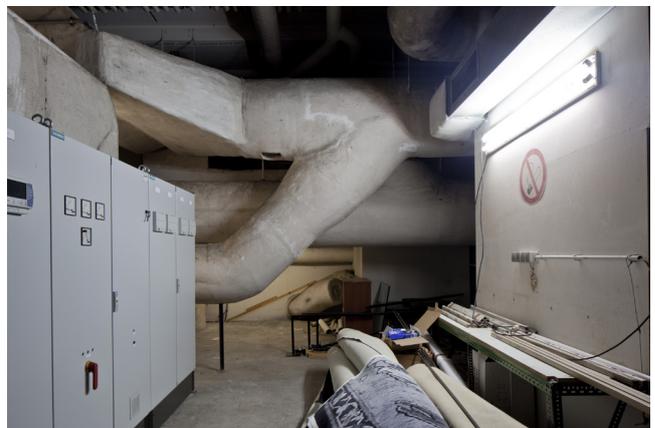
08 Mies van der Rohe, *Neue Nationalgalerie*, Berlin, Germany, 1968. Refurbishment by David Chipperfield Architects, 2017. A new central ventilation and air-conditioning plant will be installed in the former heating plant room. © Ute Zscharnt for David Chipperfield Architects, 2013.

In the original *Thesenpapier zur Denkmalpflege*³, the goal was set to keep as much as possible of the original substance, referring to the monument as a whole. Drawing up this thesis paper at the start of the planning, it did become clear during the planning process that it is only possible to fulfill this precondition with certain limitations. Despite the respect towards the original substance, the demands set for the continuation of the use of the building as a museum result in loss of material. The measures that need to be taken are more specifically: the spatial change of the back-of-house area, structural fire protection measures, the repair of concrete, the protection against corrosion, the full replacement of the insulation and waterproofing as well as the full renewal of the transient building services of which only the visible components such as the light fittings, ventilation grilles et cetera can be kept (figure 08).

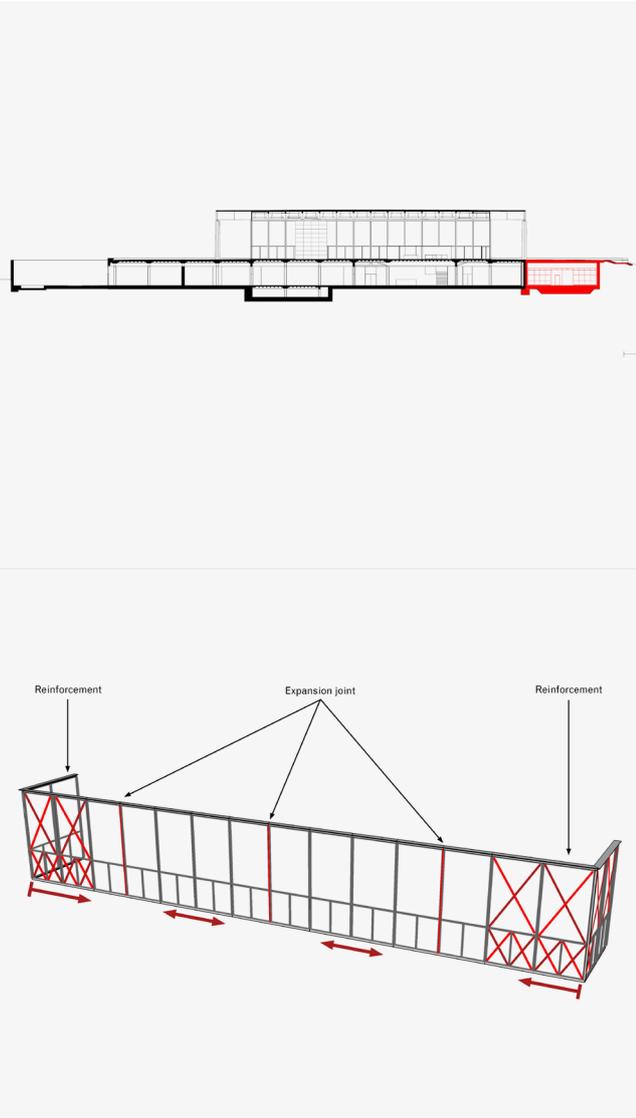
11 Mies van der Rohe, *Neue Nationalgalerie*, Berlin, Germany, 1968. Refurbishment by David Chipperfield Architects, 2017. The package of measures for the curtain wall façade with the introduction of three vertical expansion posts and shear-resistant design of the corner areas. © David Chipperfield Architects for the *Bundesamt für Bauwesen und Raumordnung*.

The package of measures for the façade consists of several components: 3 new vertical expansion posts are introduced on each side of the façade, a structural bonding of the glass sheets created by the shear-resistant design of the corner areas and a segmentation of the brace construction to ensure a restraint-free vertical expansion of the façade (figure 11).

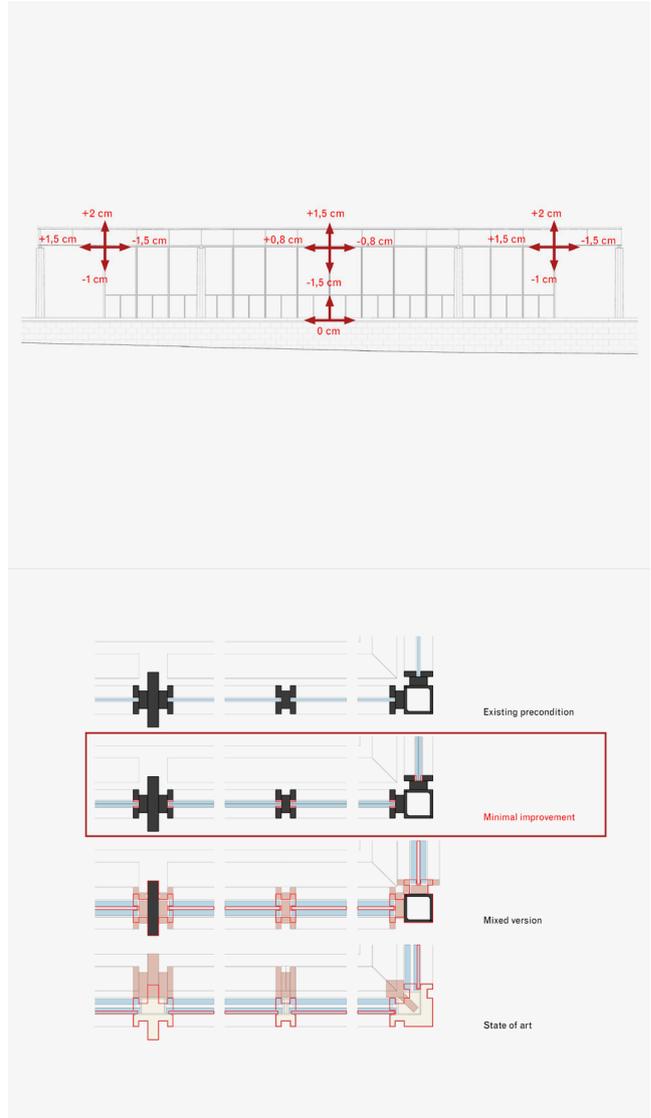
A first analysis of the causes revealed a complex web of contributing factors, comprising the static undersized upper sheets, the corrosion in the area of the glazing beads and considerable deformation caused by thermal expansions and wind loads. The movement of the façade construction is obstructed in the area of its upper fixture through the specific execution of its brace construction. The horizontal movement was discussed to a large extent during the planning process, but ultimately ignored in the final detailing of the façade.

Several months of measurements with the aid of a 3D scanner and a local weather station provided an objective image of the actual considerable deformations related to outside temperature and wind. The results of this measurement were transferred into a deformation diagram, illustrating the fixed point, the directions of movement and the longitudinal extensions (figure 10).

10 Mies van der Rohe, *Neue Nationalgalerie*, Berlin, Germany, 1968. Diagram for the deformation of the façade caused by thermal expansion and wind loads, indicating the fixed point, the directions of the movement and the longitudinal extensions. © David Chipperfield Architects for the *Bundesamt für Bauwesen und Raumordnung*.
