THE FUTURO HOUSE IN LIMNI, CORFU

A Living Space

ABSTRACT: The restoration of the Futuro house in Corfu is complicated by being both an art object and a living space. The glass-fiber reinforced polymer (GFRP) materials showed damage that could be related to ageing and exposure to the local, unfavorable environmental conditions (light, humidity and temperature). In order to establish the technical condition of the building, non-destructive techniques were used. Additionally, indoor air quality was tested. The research has shown that the most relevant causes of damage to GFRP materials are moisture, exposure to sunlight and thermal changes. The intervention strategies applied so far are not conclusive. Maintenance is always needed. Further investigations are deemed necessary to understand the properties and state of conservation of the materials at a micro scale.

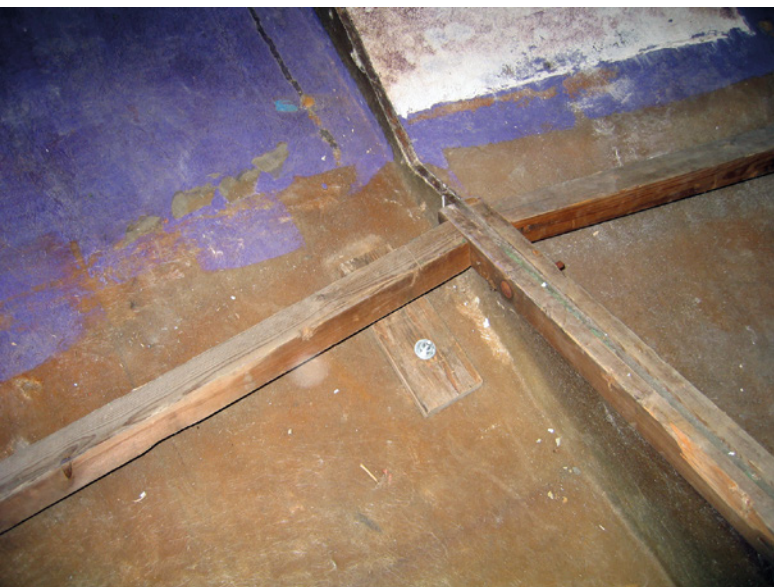
01 Wooden reinforcement of the lower elements of the building, covered with the characteristic purple and grayish topcoat. © E. Stamatopoulou, 2008

The lower panels are internally reinforced with wood and steel to strengthen the construction [FIGURE 01]. Additionally, the building has twenty oval windows of doubled Perspex (PMMA) sheets.⁷

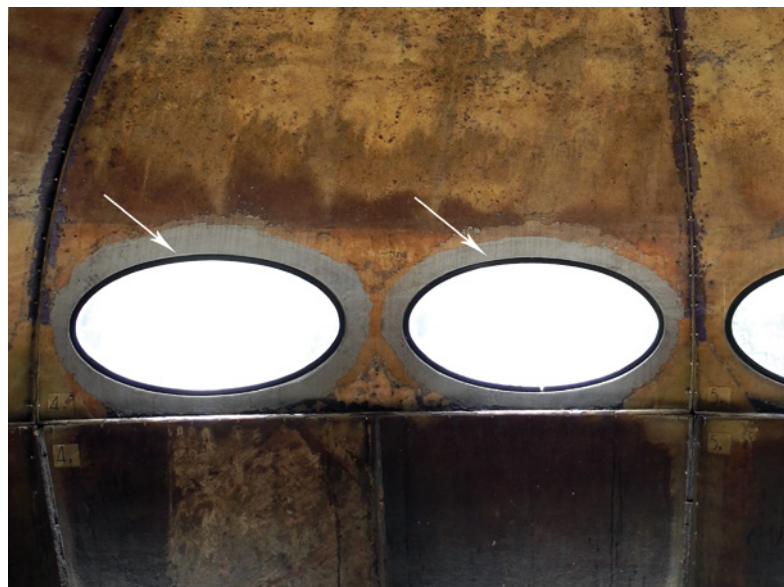
02 View of the interior depicting element 4T. The arrows point the newly reshaped openings. © E. Stamatopoulou, 2008

cracked and broken parts of the edges and surface of the panels. Furthermore, restoration was focused on the repair and stabilization of mechanical damage at the midline of the house. Finally, some of the grooves holding the window seals had deteriorated, which allowed water to leak into the house. Therefore, it was also decided to re-form the openings and to secure the seals with mastic [FIGURE 02].

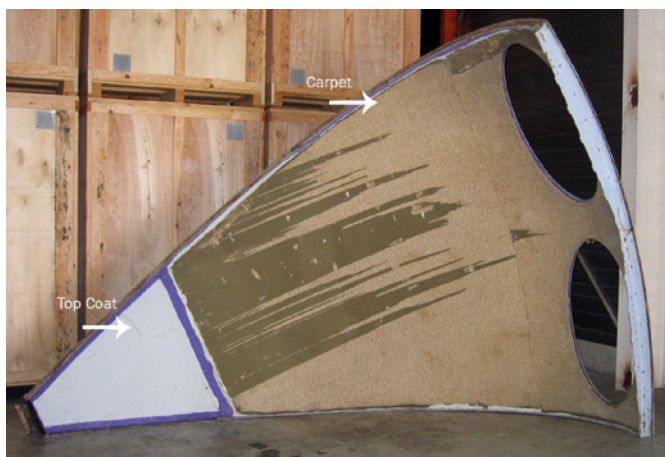
Internally, the upper panels of the house were partially covered with a grayish top coat, and the lower segments were upholstered with carpet [FIGURE 03].

03 Interior of the Futuro house, 2007. Arrows show the layer of top coat with a grayish color on top of purple primer and the presence of a synthetic carpet at the lower part of the segment. © E. Stamatopoulou, 2008

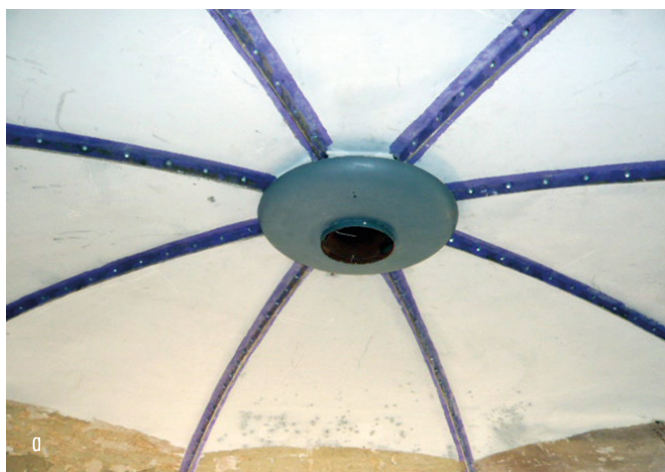
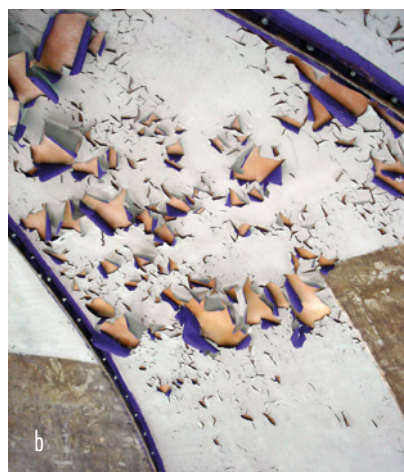
05 a-b Condition of the top coat in the interior of the Futuro house in 2007 (a) and in 2010 (b). © E. Stamatopoulou, 2010.

A year later in 2010, severe damage (extensive flaking) to the internal primer and top coat was noted [FIGURE 05]. Also, the carpet was moist and emitting a foul smell.

This could have been related to the increased impermeability of the outer surface after restoration which hindered the dispersal of internal moisture. As a result, condensation under the primer and top coat may have caused it to swell and flake, which was then exacerbated by seasonal temperature variations. Later in 2010, both the cracked and flaking internal primer and top coat were entirely removed.

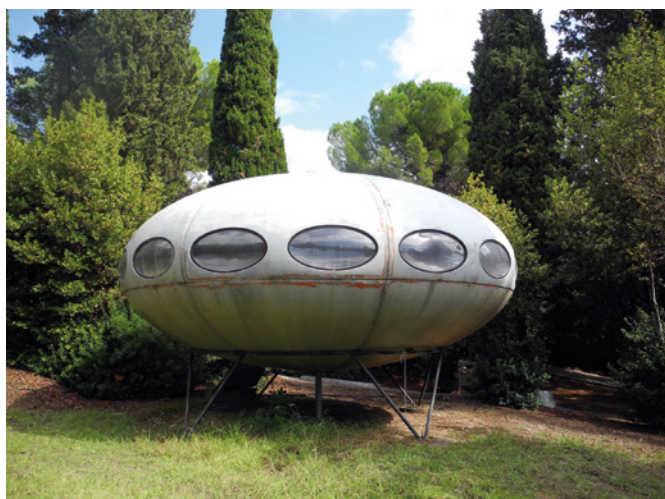
06 The Futuro house installed in Limni, Corfu, in its current condition. © E. Stamatopoulou, 2019

Today the condition of the Futuro House is poor and plans for restoration need to be reviewed. A recent inspection, made in summer 2019, revealed extensive areas of new flaking, cracks, blisters and material loss on the exterior top coat [FIGURE 06, FIGURE 07].

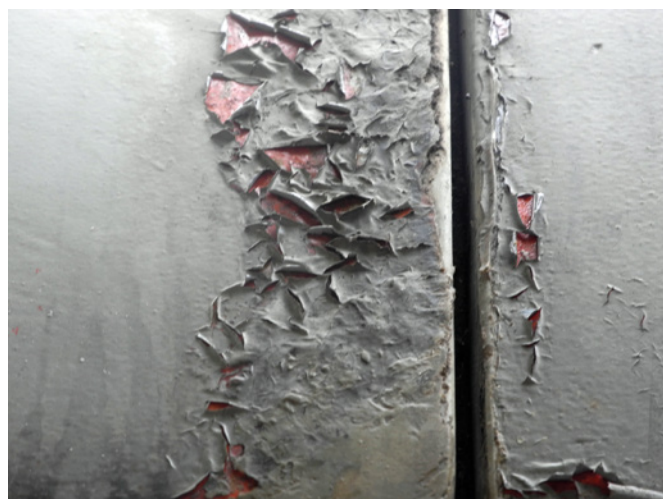
07 Detail of the deterioration of the exterior top coat in 2019 that had been applied during the restoration of the Futuro house in 2009. © E. Stamatopoulou, 2019

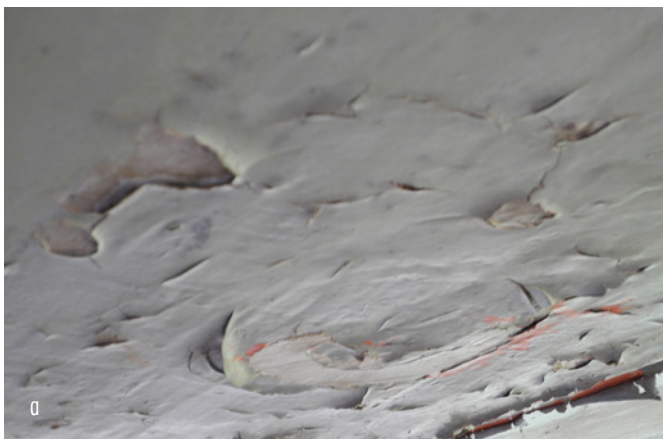
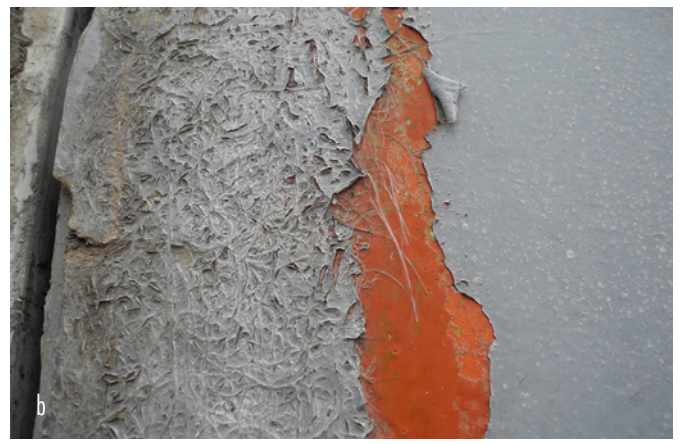
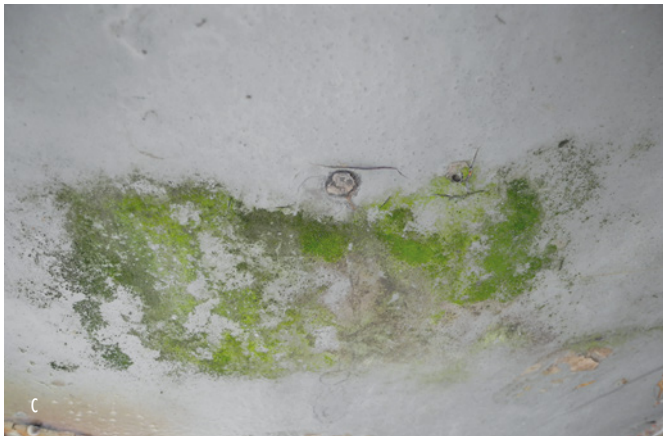
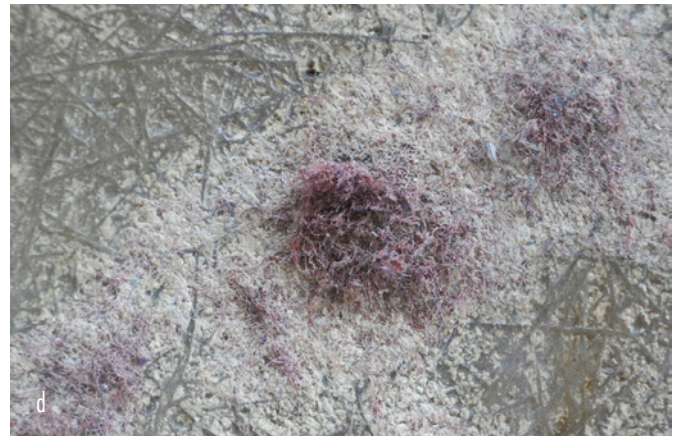
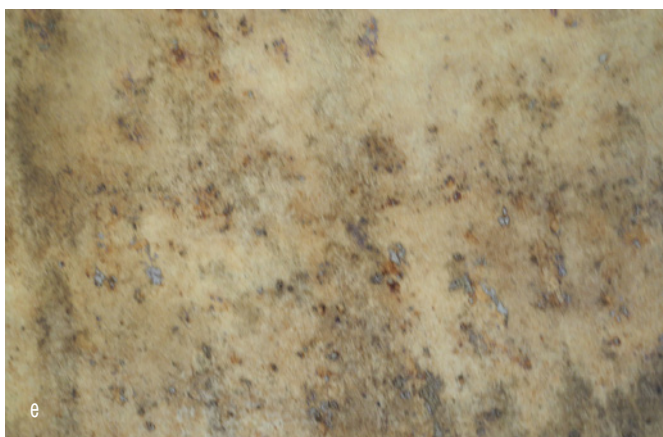
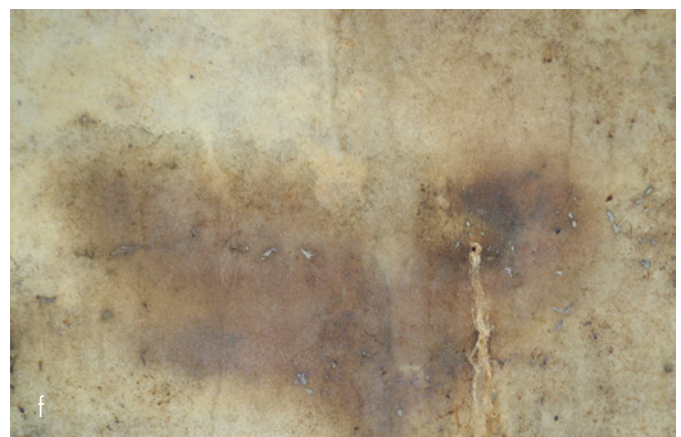
08 a-f Macro – photographs of the inner and outer surface of the Futuro house showing, (a) exfoliation of the outer coating, (b) areas with previous restoration, (c) growth of mold on the outer bottom region, (d) growth of reddish mold in the inner surface, (e) inner areas with surface irregularities, (f) inner area with extended change of color from yellowish to brown. © E. Stamatopoulou, 2019

The photographic documentation illustrated a range of defects such as exfoliation and cracks, as well as areas of previous restoration. [FIGURE 08].

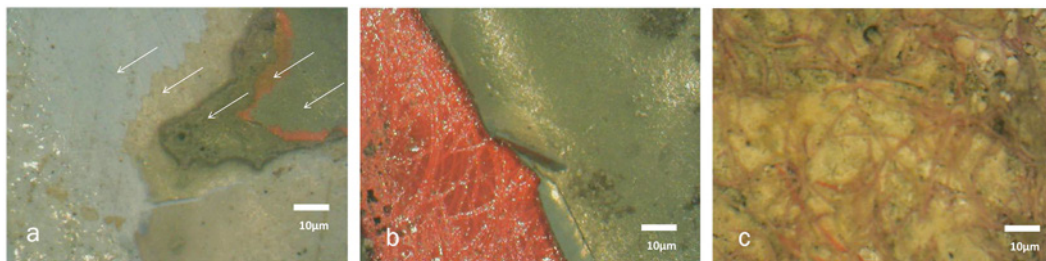
09 a-c Documentation of the outer and inner surface of the Futuro house using a portable digital microscope with x50 magnification. (a) The arrows mark the various layers on the outer surface, (b) region with exfoliation of the grey gel coat leaving visible the original inner core of red resin, (c) inner surface of the GFRP material depicting the random disposition of the glass fibers. © E. Stamatopoulou, 2019

the surface characteristics of the panel core as well as various layers of coatings on the outer surface [FIGURE 09].

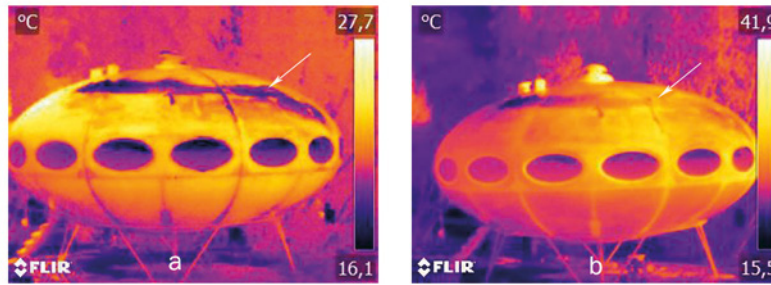
10 a-b The arrows point the area where measured temperature at 10 a.m. is 18 °C (a) when at 6 p.m. is 30 °C (b).
© M. Karoglou, 2019

ThermaCAM QuickReport 1.1. software. The examination of the structure revealed an uneven distribution of temperature during the day [FIGURE 10].

These temperature fluctuations may severely affect the stability of the composite material by causing local cracks, humidity condensation and exfoliation and delamination of the various layers.¹⁴ In the case of GFRP, the coefficient of thermal conductivity of the polymer is greater than that of the fibers. This means that the behavior of the constituent parts of the composite material differ, resulting in residual tensions.¹⁵

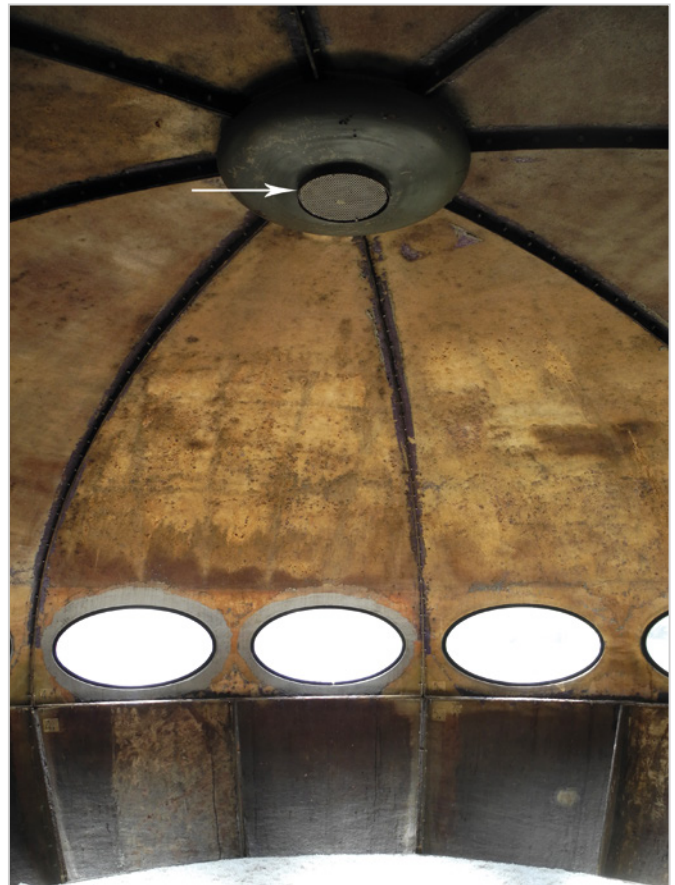
11 Interior of the Futuro house. The arrow indicates the position of the air-conditioning.
© E. Stamatopoulou, 2015

The concentration of formaldehyde detected in the Futuro house was lower than the acceptable exposure levels and non-risky for the habitants. Nevertheless, it was advised to use a system to regularly renew the indoor air. For this reason, a ventilation and air-conditioning system to provide fresh air was installed on the ceiling of the house and the temperature for the interior was set at 18°C annually [FIGURE 11].
