DETERIORATION, HARM AND CONSERVATION OF BUILDING PLASTICS HERITAGE

Robert Loader

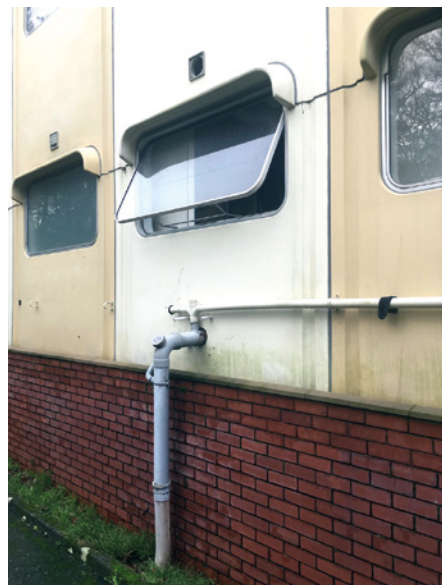
03 Drain-pipes and vents cut through a GRP panel at the Olivetti Building, December 2018. © R. Loader

The worst damage to the GRP is man-made, comprising various service and drainage connections that have been drilled through the panels [FIGURE 03]. These will compromise the fire protection to the panel and water penetration will result in delamination of the fibreglass. For minor mechanical damage to GRP there are well-tried techniques to rebuild solid fibreglass components, as previously recorded by Beerkens for the repair of the entrance steps to the Futuro House at the Boijmans Museum.⁷ However, damage caused by pipe holes, especially through foamed sandwich panels, presents a more awkward problem. Face-fixed GRP disks would be a straightforward solution to seal the exterior and interior and, although visible, once painted, would then be relatively unobtrusive.

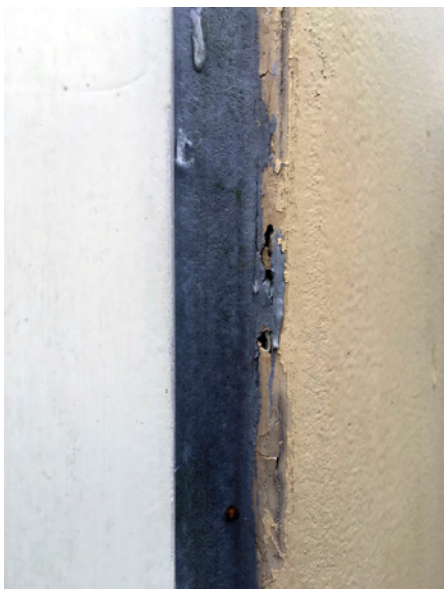
04 Corner voids due to an absence of glass fibre matting behind the outer gel-coat layer at the Olivetti Building, December 2018. © R. Loader

Along the external corners of many panels on the Olivetti building are small voids [FIGURE 04], similar to those found on the Futuro house held at the Boijmans Museum. This is a common problem with tightly radiused panel corners and is due to poor fabrication workmanship. If fibreglass is not sufficiently pressed into the corners during manufacture, a cavity is left between the fibreglass-polyester matrix and outer gel-coat which will eventually collapse. In the case of the Futuro house these voids were fairly easily treated by injecting gel-coat resin and filler into the void.⁸ But if left untreated these voids provide an easy route for moisture to penetrate to the interior of the panel.

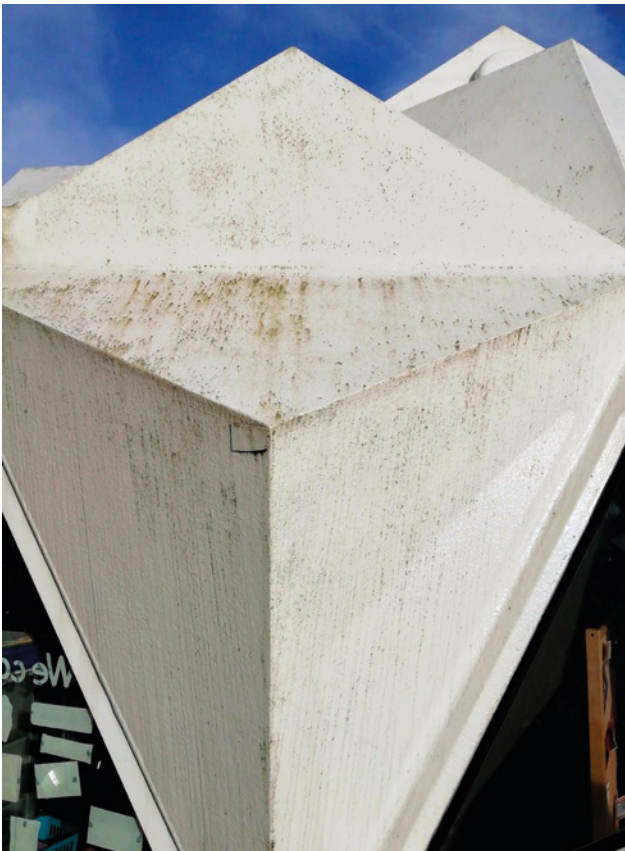
The original, finely corrugated character of the outside of the panels (formed by an acrylic insert in the production mould) is no longer visible due to recent waterproofing work in which a thick, fibre-reinforced liquid resin, Acrypol+, has been applied over the panels. Previously, the fine, incised lines controlled and directed water run-off, while the new rough coating is quite effective at trapping the water, dirt and algae that accumulate every

08 The classroom panels in February 2019 before cleaning. A build-up of dirt and algae is trapped in the fibres of the new reinforced polymeric coating. © S. Pritchard

winter [FIGURE 08]. Once applied this coating is practically impossible to remove.

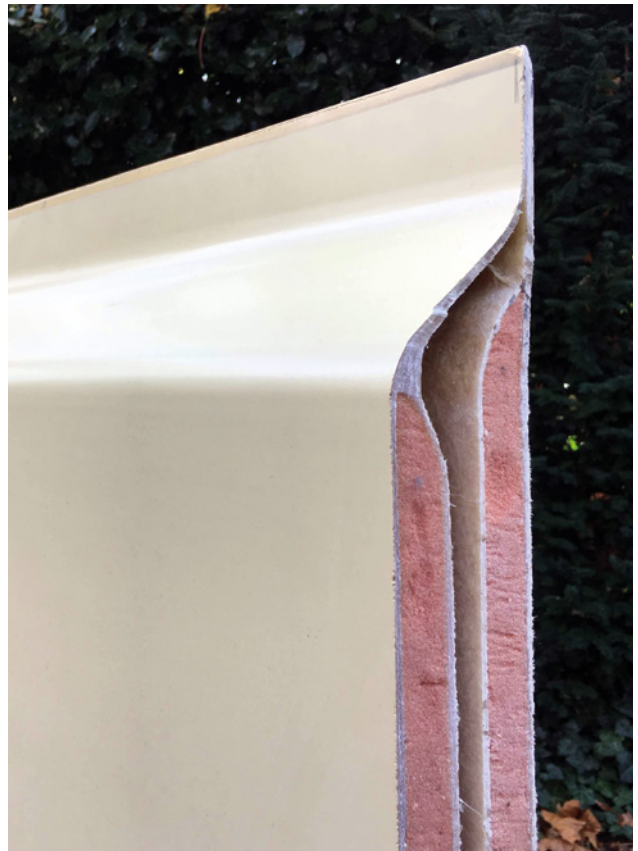
09 Cut-away section through a typical Herman Miller panel showing the double sandwich panels and air cavity. The panel face is painted, but the original gel-coat colour is visible around the perimeter edge. © R. Loader

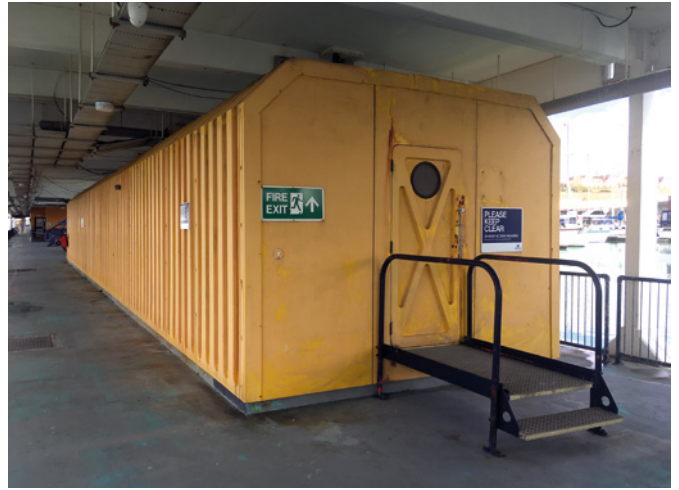
10 Building for Yachtsmen's Showers and Lavatories at Brighton Marina. © R. Loader, October 2019

jetty structure the GRP is largely protected from direct sunlight and rain, so is in quite good condition for its age. Nevertheless, the building owners have already demolished two similar unlisted structures, and the two surviving structures remain at risk. The author has proposed to the local authority that these buildings should be locally listed, which remains under consideration by the local authority at the time of writing.

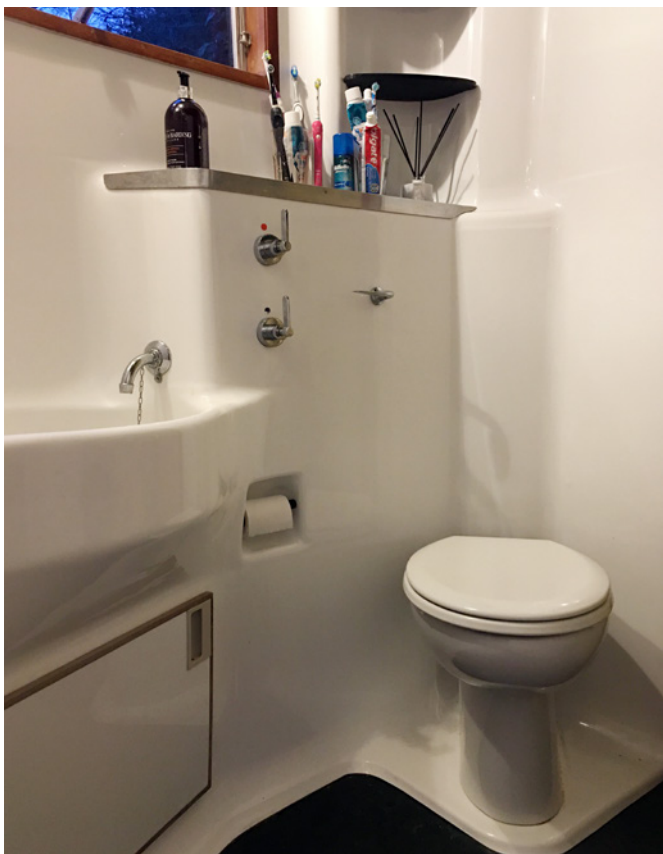
13 Intact ICI prototype acrylic bathroom, Hartford, England. © R. Loader, November 2021

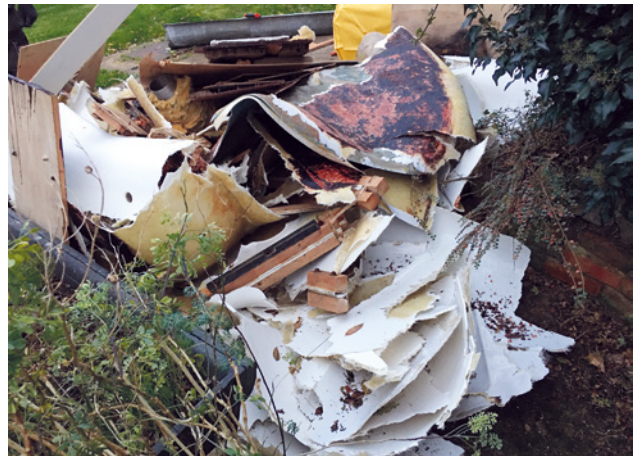
14 Remains of a prototype ICI acrylic bathroom pod recently removed from a house, Hartford, England. © R. Loader, November 2021
