Restoration of Crown Hall

This essay documents the research of restoration and modifications to Mies van der Rohe's masterwork, Crown Hall, the heart of the Chicago campus of the Illinois Institute of Technology. Restoration was necessitated by 5 decades of use during which the building had fallen into major disrepair. During the restoration, practical and philosophical issues arose from the building's landmark designation by regional and national authorities. The essay describes the forensic research that preceded design, investigation and selection of alternate materials modifications to the building envelope. This includes a detailed description of modifications balancing original materials and systems with current codes.

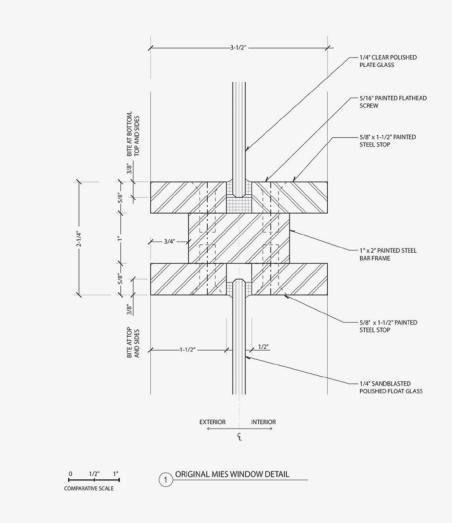
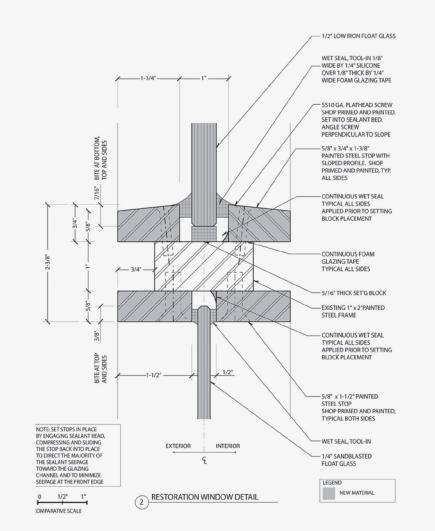
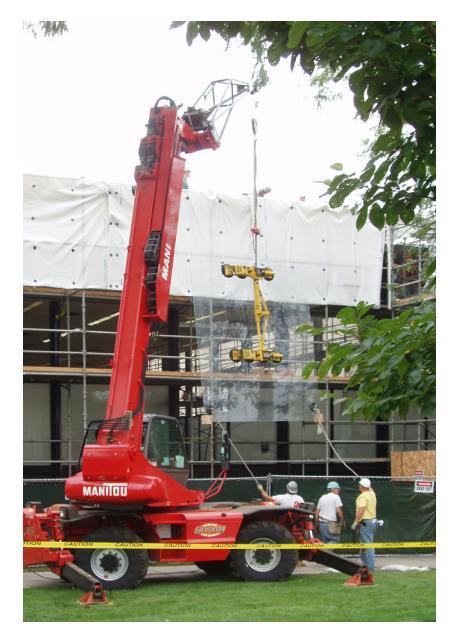
Mies van der Rohe, Crown Hall, Chicago, USA, 1950–1956. Restoration works.
© Krueck + Sexton Architects, 2005.

The restoration of the exterior steel consisted of removing and replacing steel that had corroded beyond repair, sandblasting the remaining steel frame and a three-coat paint system. The building's entry doors were removed and sent to the original manufacturer, Ellison Bronze Inc., for refurbishment then reinstalled with modern hardware and integrated security devices. Italian travertine for the entry porches was selected to match the texture, color and grain of the original stone.

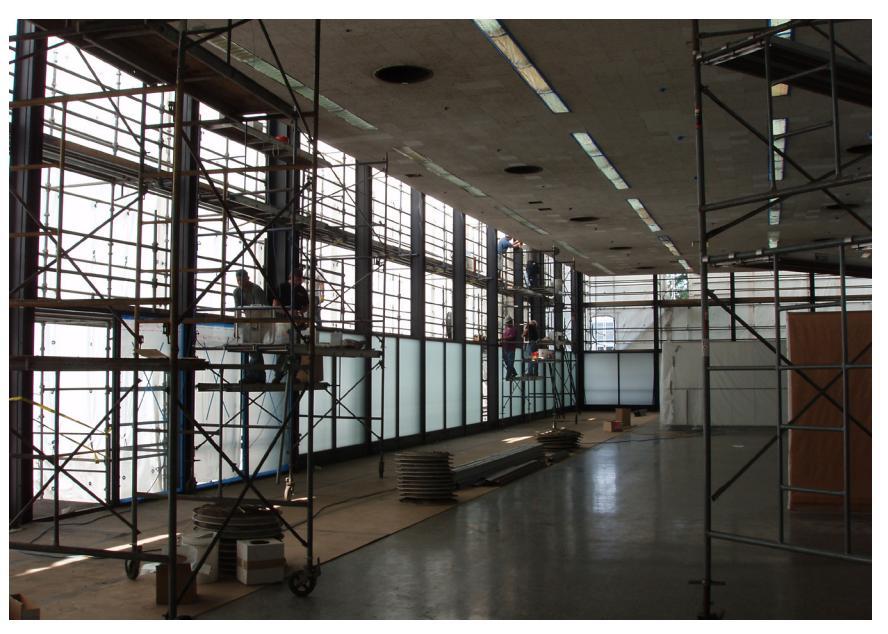
Mies van der Rohe, Crown Hall, Chicago, USA, 1950–1956. Restoration works.
© Krueck + Sexton Architects, 2005.

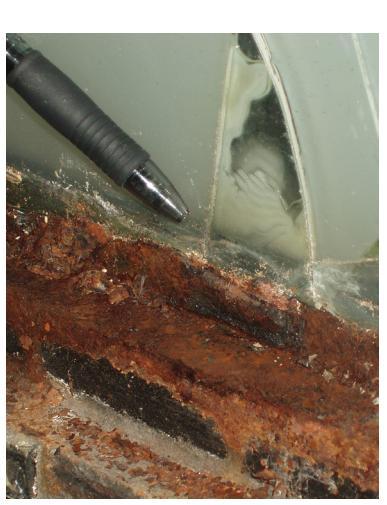
Mies van der Rohe, Crown Hall, Chicago, USA, 1950-1956. Detail view of sill with glazing stop removed.
© Krueck + Sexton, 2005.

The question remained as to the cause of the great amount of base glass cracking. Certainly, there was visible oxidation but could the cause of the glass failure be due to water infiltrating the glazing channel and freezing? Removal of the existing steel window stops revealed that in many places the original red iron oxide primer was visible through the top coat. In other locations, the steel stops were found to have only a light coating of primer on concealed surfaces.

The original drawings called for use of a mastic tape product at various locations, which in all likelihood was intended to provide separation and a layer of protection between components of the steel frame. However, this material was not found between the steel stops and frames. This steelto-steel condition permitted water to infiltrate the glazing It was only after removing a dozen steel stops that severe oxide jacking was conclusively identified as the singular cause of the glass breakage. The most significant corrosion was found at the bottom horizontal bar of the window frame (figure 07) and approximately 12-18 inches (300-450 mm) along the vertical jamb members. This caused moderate amounts of pitting of the top surface of the steel frame that was readily apparent after sandblasting. Corrosion build-up and oxide jacking at the glazing setting blocks exerted an upward pressure on the glass. This corrosion build-up, combined with the increased thickness of the glass installed during the 1975 renovation, caused a significant number of the lower level translucent panels to break.

The original $5/8 \ge 1^{1/2}$ inches (16 mm ≥ 38 mm) profile of the steel stops was maintained using all new materials at the lower level lights. This afforded a high degree of shop fabrication and finishing quality control while eliminating the need for costly specialized efforts to repair material or areas of material that had deteriorated through the years.

At the upper stops, current codes required increased thickness of the stop at the glazing channel from the original 5/8 inches (16 mm) bar to 3/4 inches (19 mm) to allow sufficient support of the large upper glass lights. The important design question was whether this could be accomplished within the spirit and letter of preservation. A detailed study determined that a sloped profile at the upper stop would maintain the appearance and proportion of the original 5/8 inches (16 mm) front face of the stops while addressing the increased support requirement at the glass (figure \circ 3). This profile also improved window wall performance by establishing positive drainage away from the glazing channel.

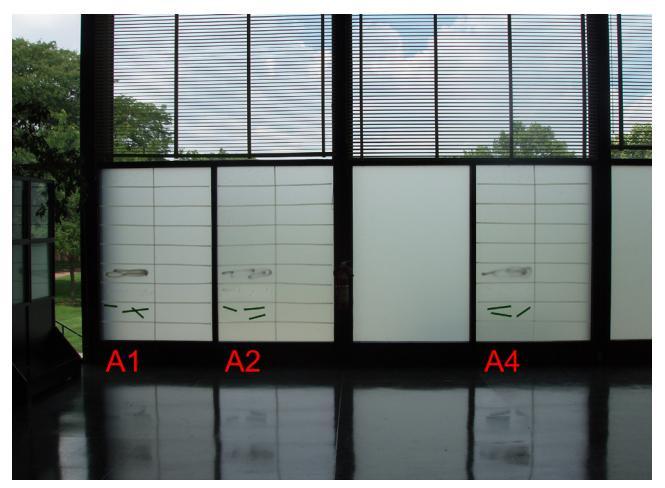
O8 Mies van der Rohe, Crown Hall, Chicago, USA, 1950-1956. Mock-up sample of various materials on glass to test seal. © Krueck + Sexton, 2004.

For the lower translucent glass, ¹/₄ inches (6 mm) clear tempered glass that was sandblasted, as originally designed by Mies van der Rohe was selected, however, it was coated with a three-part epoxy clear sealer. The sealed sandblasted glass was selected after full-size mock-ups were compared for color, surface texture, translucency and interior reflectance to an adjacent untreated sandblasted panel. No one on the design team, the University committee or city and state preservation officers could detect a difference. When the University requested another mock-up to test the sealer, a sealed panel was divided into sections (figure 08) and a variety of materials from markers, spray paint, spray glue and masking tape were applied and aged for 3 months. With design team direction, University maintenance was able to remove all the markings without affecting the visual character of the sandblasted glass. The quality of the sandblasted glass was retained and completely maintainable.

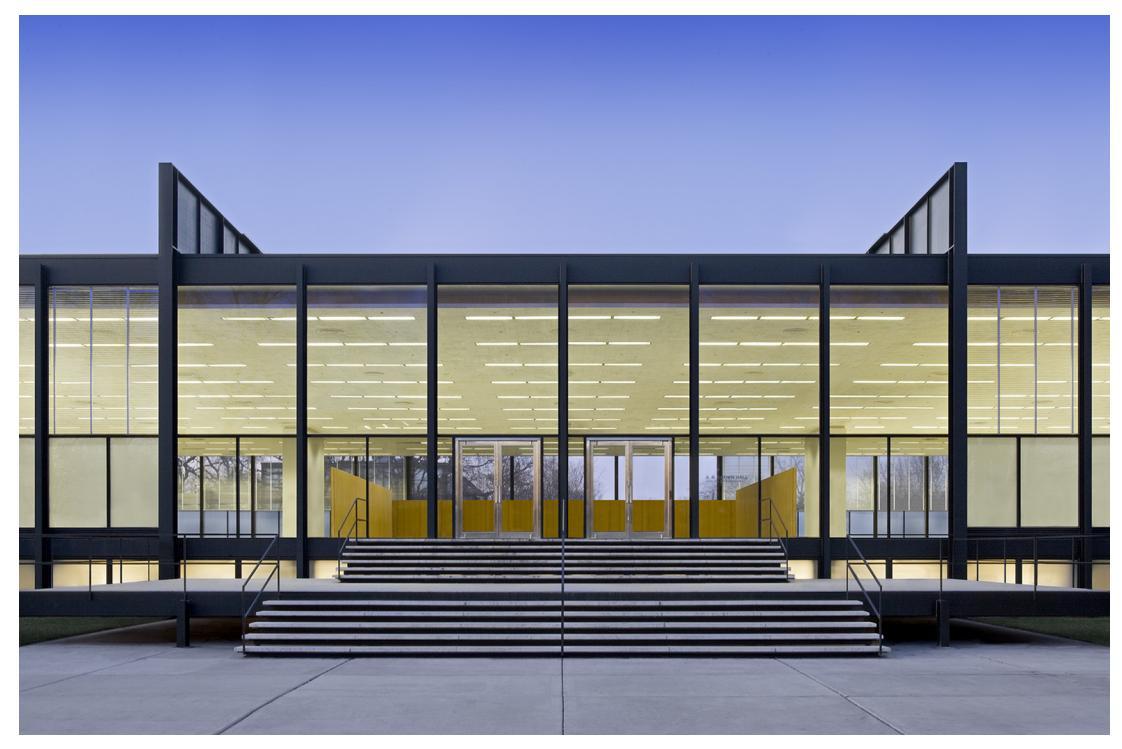
09 Mies van der Rohe, Crown Hall, Chicago, USA, 1950-1956. Restoration by Krueck + Sexton Architects. © William Zbaren, 2005.

The result of the new coating system was an impressive display of the building's clarity and simplicity (figure 09). By removing layers of deteriorated coatings and applying a high-performance coating, the pristine lines of the building's structure were restored to their original elegance.
