he Polana High School in Maputo, designed by José João Tinoco and José Forjaz around 1970, is a plain functional building both as regards to the spatial organization of its composing pavilions and as to its construction that is mostly made of exposed reinforced concrete structures and elements. After decades of heavy duty use and an almost absolute lack of maintenance, it recently went through some urgent repair operations. In this sense, it exemplifies what could be today effective conditions regarding economic possibilities and cultural problems to recover Modern heritage in Africa.

By Vincenzo Riso

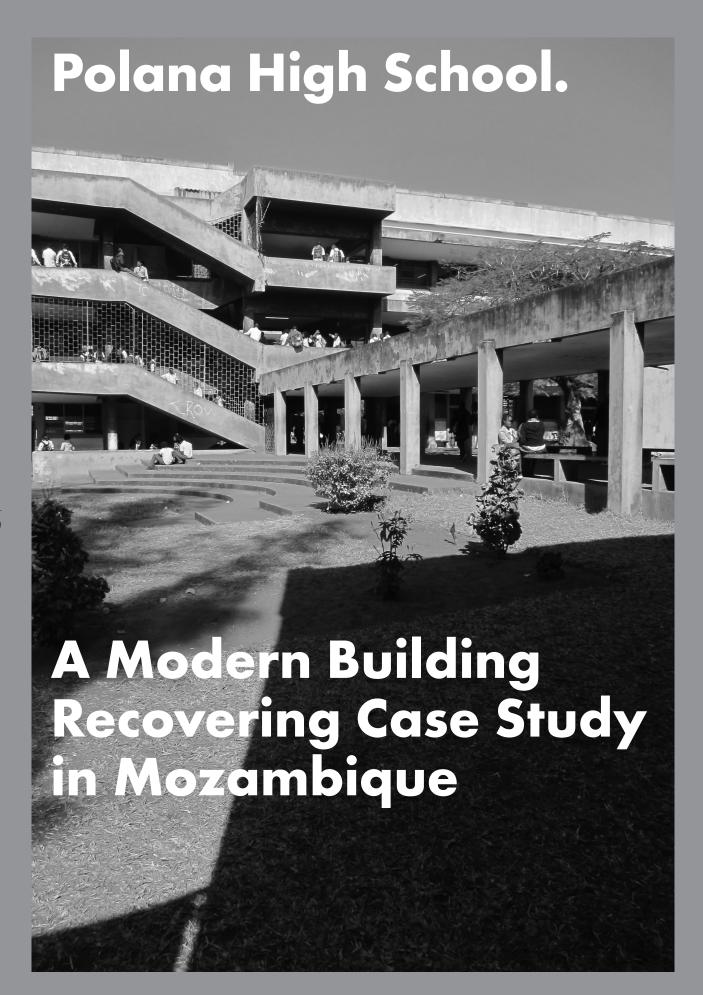
< José João Tinoco and José Forjaz, Polana High School, Maputo, 1970–73. The intersection between the central corridor and one of the classroom pavilions. Photo by Vincenzo Riso, June 23 2010.

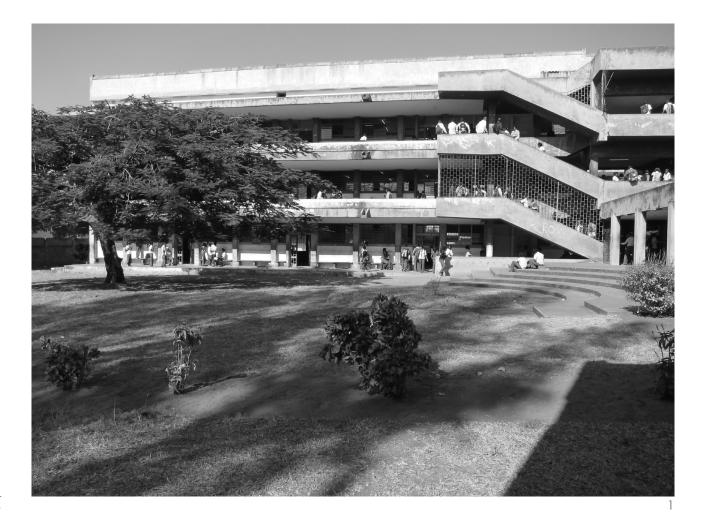
Figure 1. The north side elevation of one of the classroom pavilions.

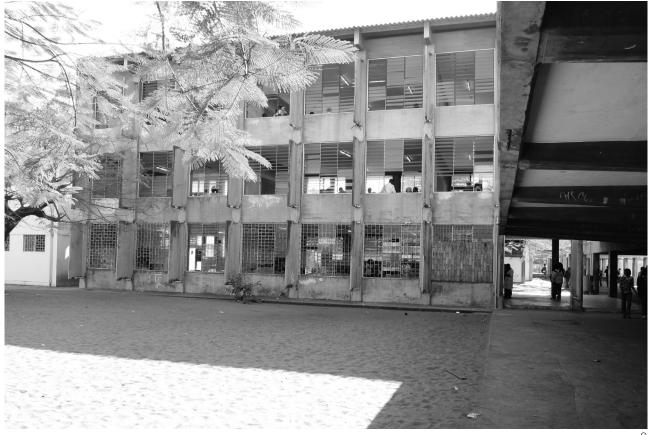
Figure 2. The south side elevation of one of the classroom pavilions.

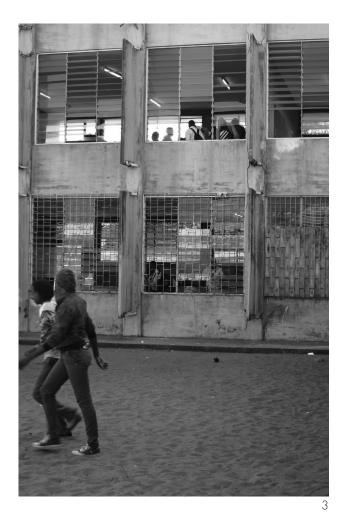
Figure 3. Detail of the south side elevation with vertical sunbreakers to protect the underneath fully operable glazing surface.

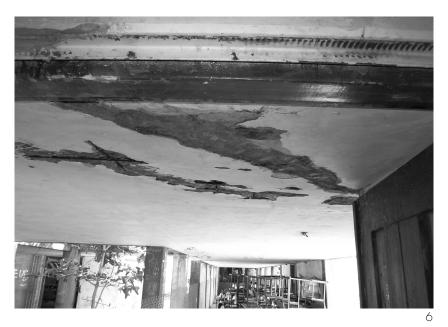
The simple and efficient organization as well as its material roughness served the school well for several decades, but in recent years the concrete structure has began to show some serious decomposition problems, some of which are a result of the corrosion caused by the prevailing coastal winds, others being caused by internal percolations of effluent waters. Severe corrosion problems concerned also the metallic operable sashes of the glazing surfaces and more dangerously even the steel fitting supports of the heavy vertical sun-breaker concrete panels.

Figure 4. Detail of steel corrosion on the fitting supports of the vertical sunbreakers

To give the reader an idea of the nature of these interventions we can relate that they consist, for instance, in filling the concrete splits with proper epoxy resin; exchanging the steel fitting supports of the vertical sunbreakers for similar but bigger ones; and finally safely replacing the asbestos cement undulated plates covering the roof with IBR (metallic and polyethylene) sheets colored in red (though also available in grey).

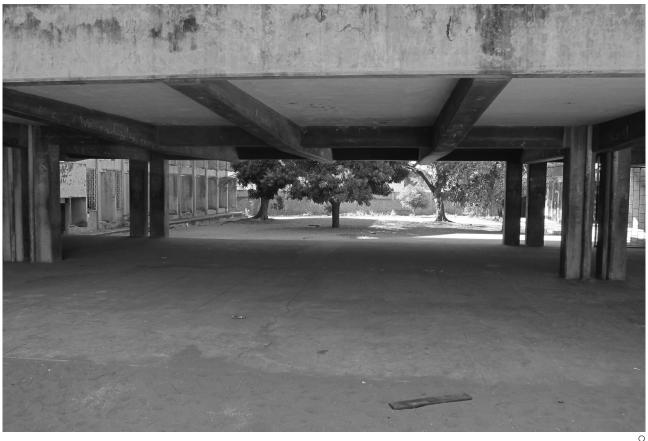
Figure 7. Detail of frequent concrete break up areas
