How to Deal with Halen Estate

BY BERNHARD FURRER

Halen Estate

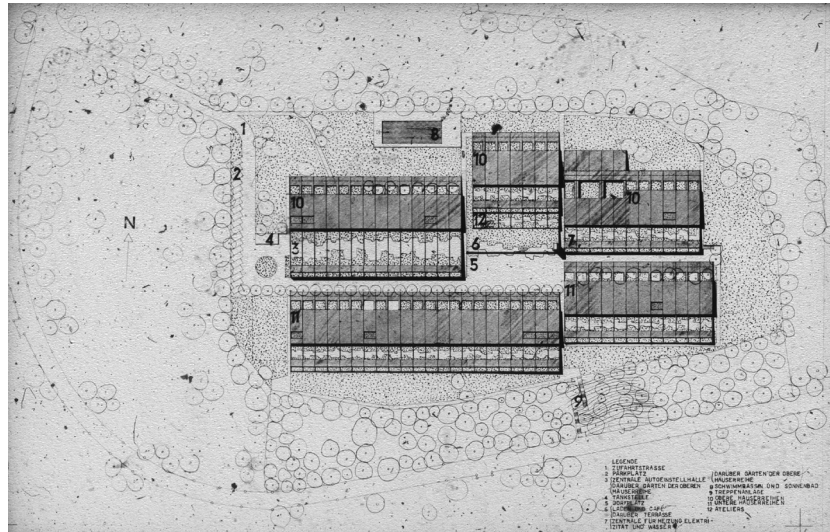
01 General plan. © Archive *Atelier 5*, 1950s.

- 1 - Access road
- 2 - Parking area
- 3 - Central parking garage (above the gardens of the upper row)
- 4 - Petrol station
- 5 - Central square
- 6 - Shop and club-room
- 7 - Power station for heating, electricity and water (above gardens of the upper row)
- 8 - Swimming pool and sun bath
- 9 - Stair connection
- 10 - Upper rows
- 11 - Lower rows
- 12 - *Ateliers*.

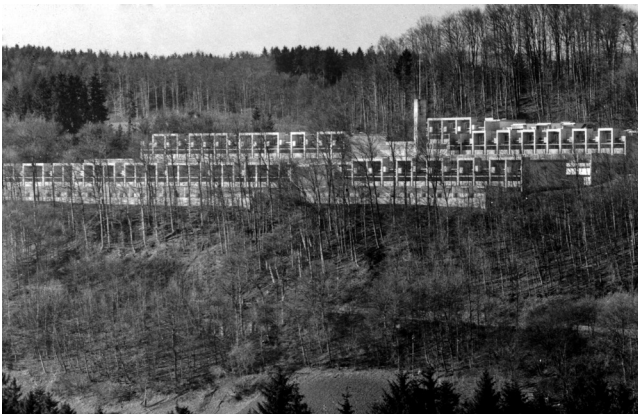
02 Halen Estate shortly after its construction. The uniformity of the houses is broken by the number of different housing types and the irregular insertion of houses with solarium. The tall chimney indicates the central square. © Archive *Atelier 5*. Photo by Albert Winkler, 1960s.

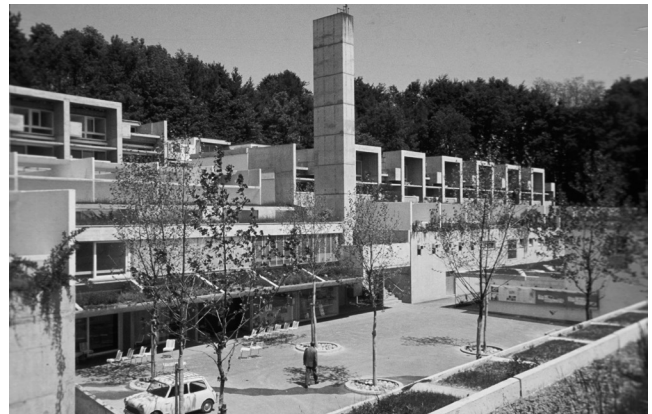
03 Central square immediately after completion. The horizontal streets and pathways and the perpendicular stairs lead up to it; they all lead to the square tangentially, not axially. The shop, the club-room and the laundries are directly connected to the square. On their way to the public transport stations or to the parking garage most of the inhabitants cross the square. © Archive *Atelier 5*. Photo by Albert Winkler, 1960s.

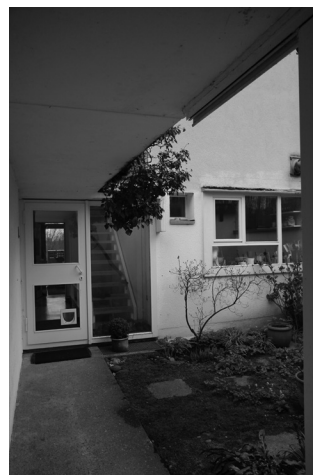
05 Courtyard of the broad type of houses. It is private, but orientated to the pathway, the public space. Beyond the outside door (many inhabitants normally leave it open) the view opens onto the courtyard and to the northern façade. A covered path leads to the entrance. Note the differentiated manners of mounting the windows (from outside, flush mounted, from inside). © Bernhard Furrer, 2012.

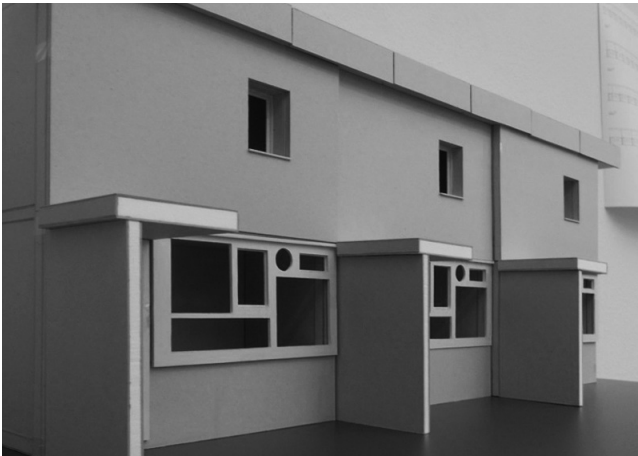
06 Model showing the effects of outside insulation of rear facades. Insulation would have required new concrete elements of the roof fascia mounted towards the outside. The differentiation of the mounting of windows would have been essentially harmed. © Suter + Partner architects, 2012.

From the outside, the success of the efforts towards adequate projects will mainly be discernible on the façades towards the north. As in many similar cases, improving the insulation of the façades is most delicate. A first intention with an external insulation of 12, 8 or 6 centimetres, covered by plaster, was abandoned, as it would have greatly altered the expression of the façades in relation to the intelligently differentiated position of the openings and windows. As every owner of a row would have been free to decide whether to insulate or not, the aspect of the façade would have become irregular for decades. Currently, proposals with 2,00 cm of extra thickness and/or a system of wall tempering (drying the wall increases its insulation capacity and assures comfort with lower ambient temperature) are being discussed.

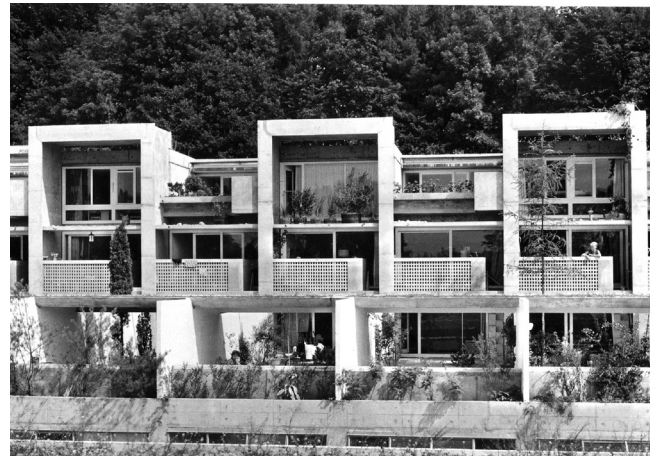
07 Upper western row. The photo taken shortly after completion shows the fresh shiny impression the Estate makes, due to a clear design and to the bright colors (plastered walls, site concrete, concrete elements, windows). The change between houses with and without solarium creates a big variety. © Archive *Atelier 5*. Photo by Albert Winkler, 1960s.

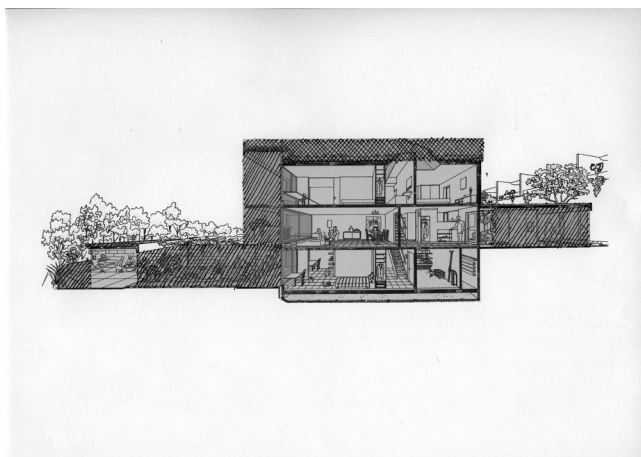
09 Schematic isometric drawing illustrating the general rules of the guidelines. In grey the zones open to individual interventions, the hatched roofs that have to be renewed collectively for each row, double hatched the parts that are important for the general conception and aspect, where only restricted changes are possible. © Bernhard Furrer and *Atelier 5*, 2013.

The approach has been exemplary. An expert report by the *Swiss Federal Commission for Monument Preservation* specified the reasons for the outstanding value of Halen Estate and the consequences for its restoration. In a first general approach it defined the elements worth maintaining. Based upon the entirety of the newly-digitalized original plans, the still existing office of the former architects defined every detail of the construction, materials and techniques. With these two basic documents to rely on, with an excellent knowledge of the actual condition of the Estate (regrettably, for financial reasons, a proper inventory of the current shape and all the changes could not be done), and in close contact with a delegation of the owners as well as the preservation officer in charge, the architects formulated detailed guidelines for the restoration, a booklet of some 100 pages. It describes every element with its features and defines the possibilities of and restrictions on change. It provides the possibility of individual changes within the interiors, respecting some few principles and exempting the separating walls and the stairs from change. A small enlargement of the kitchen with a sort of bay onto the courtyard is defined. On the other hand, extensions of the originally-built volume are not allowed (courtyard, open terraces, *brise-soleil*, garden). The treatment of single elements such as the windows is clearly defined.

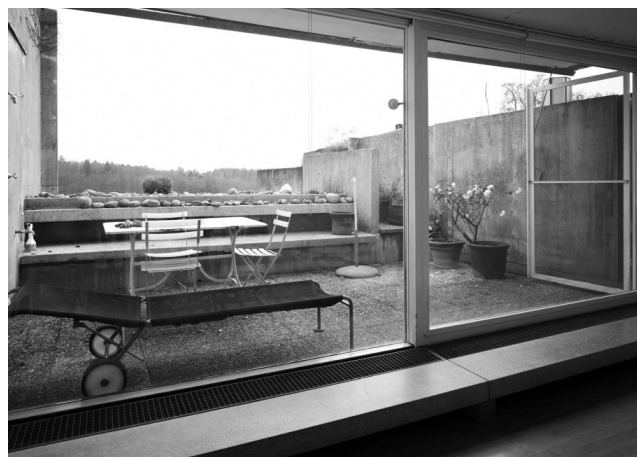
10 Solarium of the broader type of houses. The room behind the solarium opens wide to the outside with a concrete step that hides the convection heater and sliding windows with very slim frames. Towards the south a trough with plants forms a limit to the solarium, a sort of recess permits an overview of the Estate and the landscape. In accordance with the guidelines, covering of the solarium is not allowed anymore. © Archive *Atelier 5*. Photo by Nikolaus Schletterer, 1960s.
