## The Restoration of the Paintings of Le Corbusier in the Villa E-1027, Roquebrune-Cap-Martin, Alpes Maritimes

BY MARIE-ODILE HUBERT

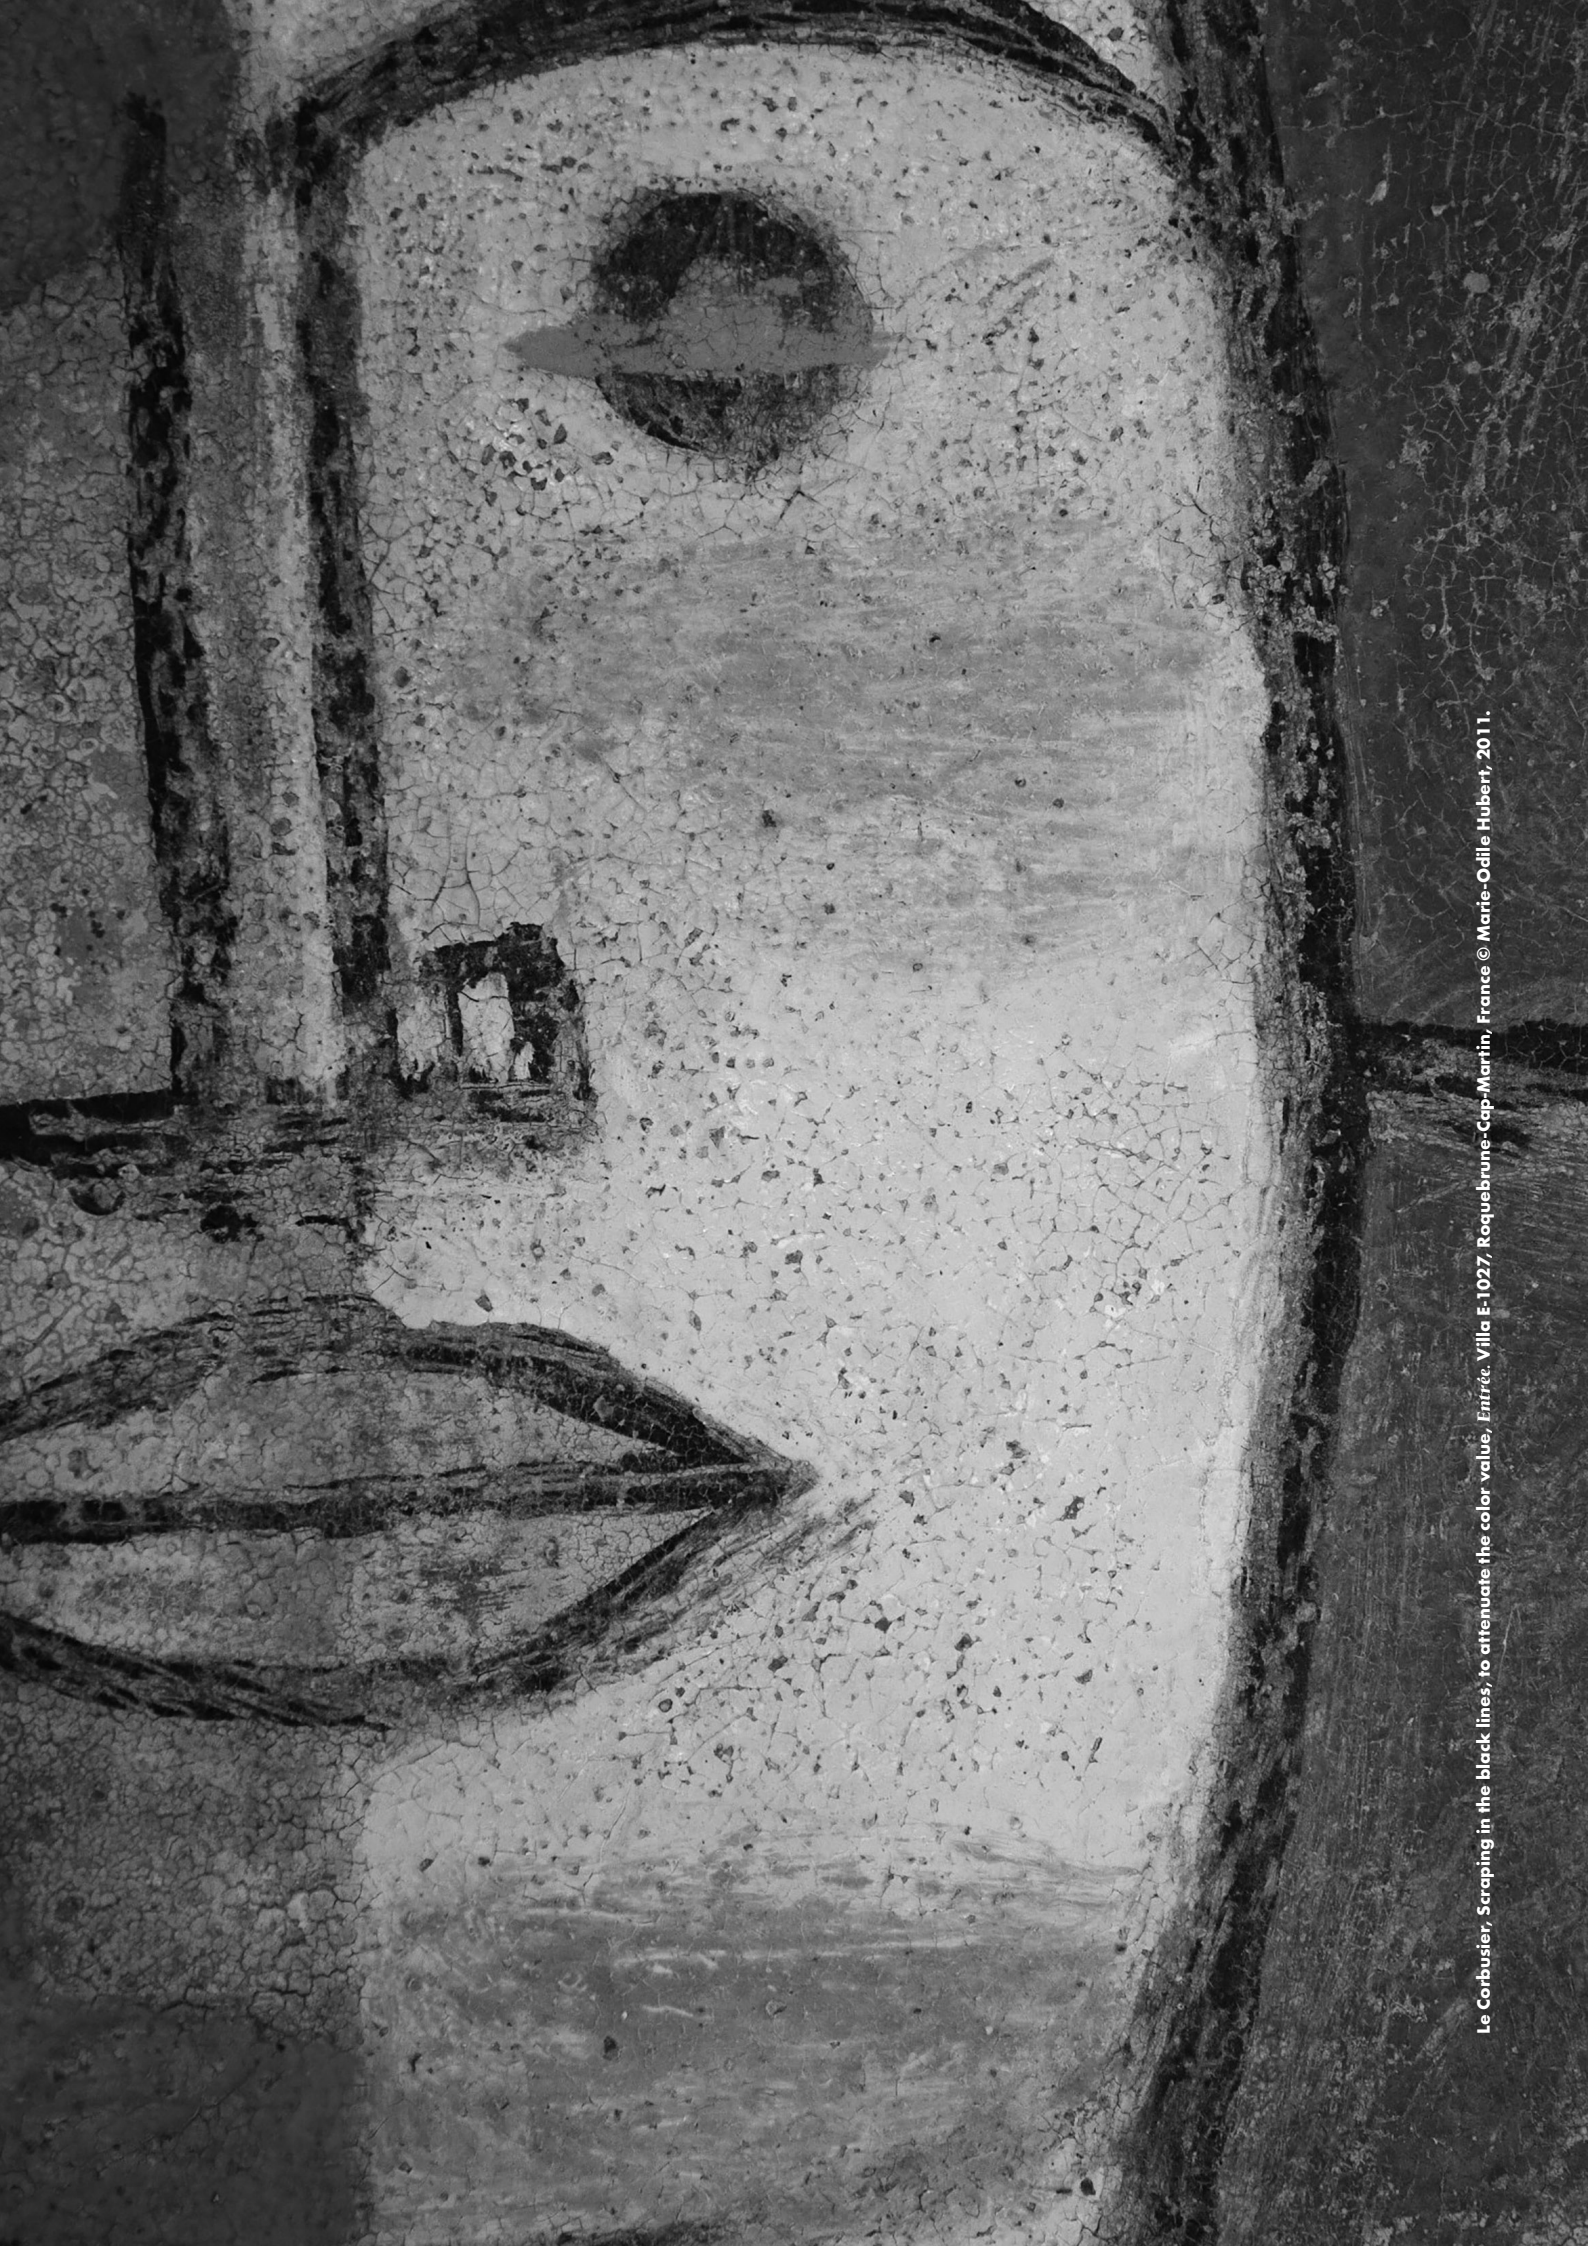
Le Corbusier, Scraping in the black lines, to attenuate the color value, *Entrée, Villa E-1027, Roquebrune-Cap-Martin, France* © Marie-Odile Hubert, 2011.

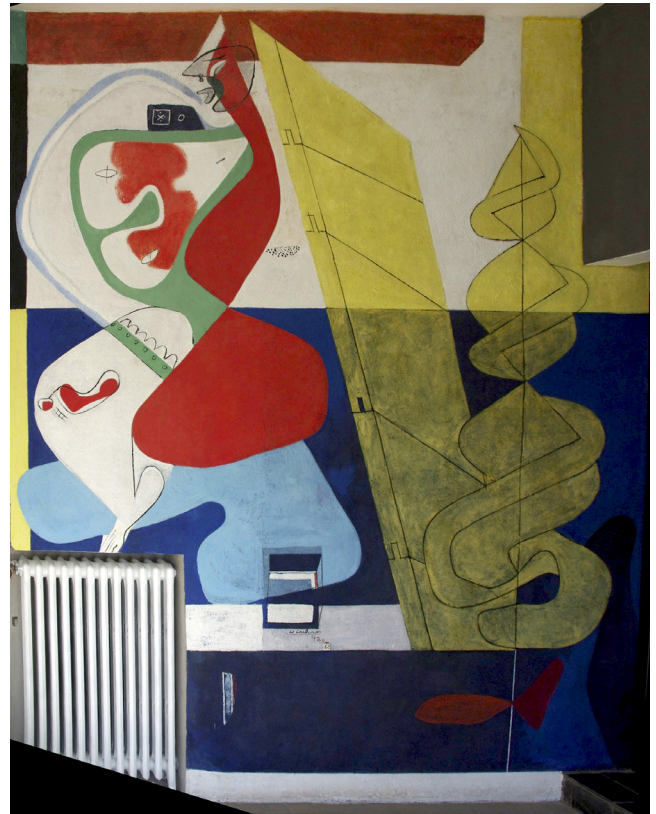
**03** Le Corbusier, Villa E-1027, Roquebrune-Cap-Martin, France. General view after treatment, *Coin Salle à Manger*. © Marie-Odile Hubert, 2011.

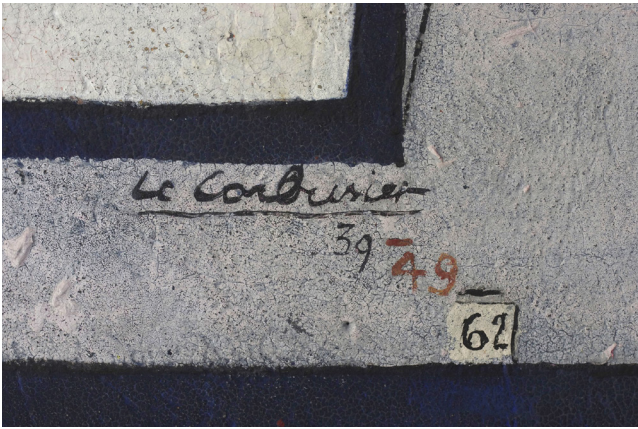
At the villa, Le Corbusier painted the murals in different phases, during several visits. These different phases are made apparent, for example, on the large painting *Coin Salle à Manger* (dining nook), where he noted the dates: 39, 49, and 62, using different types of paint each year.

04 Le Corbusier, Detail of the dates, *Coin Salle à Manger*, Villa E-1027, Roquebrune-Cap-Martin, France. © Marie-Odile Hubert, 2011.

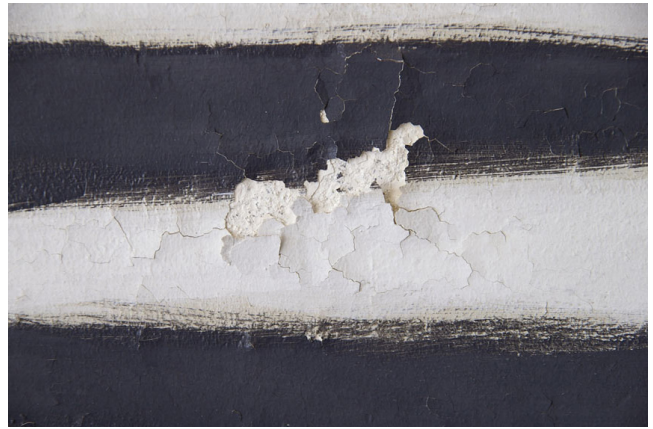
05 Le Corbusier, Liftings in the paint layer, *La Toilette Complète*, Villa E-1027, Roquebrune-Cap-Martin, France. © Marie-Odile Hubert, 2006.

The consolidation of zones where the whitewash was peeling and the painted layer was separating  
Blisters in the painted layer were mostly caused by the underlying wall coating. This whitewash had to be consolidated so that the flakes of paint could adhere to the wall.

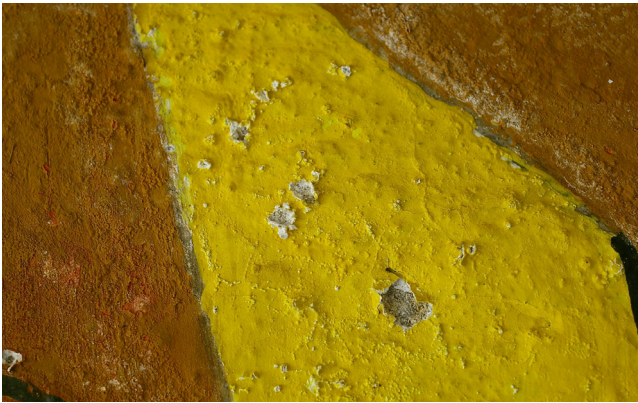
The examination of concrete, hollow bricks and cement used in construction, and the decay of these materials suggested the presence of soluble salts in the white wash underneath the paintings. These salts (sulphates, nitrates or chlorides), with the process of crystallisation and changing shapes in relation to the degree of humidity, are one of the causes of damage to the paintings, leading to blisters and lacunae.

06 Le Corbusier, Salt efflorescences, *Coin Salle à Manger*, Villa E-1027, Roquebrune-Cap-Martin, France. © Marie-Odile Hubert, 2006.

The extraction method that was chosen involved compresses (*Arbocel*® cellulose pulp) applied to the areas in question.

The compresses were thus used in the patchy areas. The amount of salts extracted (chlorides, nitrates and sulphates) was evaluated using test strips at regular intervals, and through the measurement of ion concentration and the conductivity of compress samples, tests carried out by the CICRP.

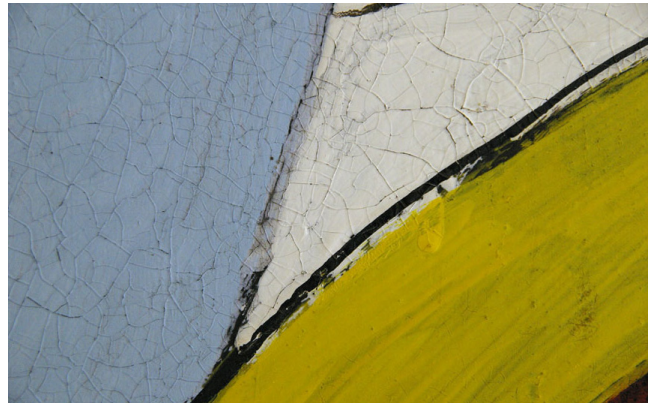
07 Le Corbusier, Removal of over-painting, before and after. Villa E-1027, Roquebrune-Cap-Martin, France. © Marie-Odile Hubert, 2011.

This operation consisted of eliminating the surface painted by Jean Broniarski in 1978.

Then we developed different solvent gels that met these criteria, in order to optimise the efficiency of the solvent on the surface while limiting its spread to the deeper layers; the effect was faster on the thickest over-painted layers. The gels were rinsed off carefully, to eliminate all residues on the layer of the original paintings.

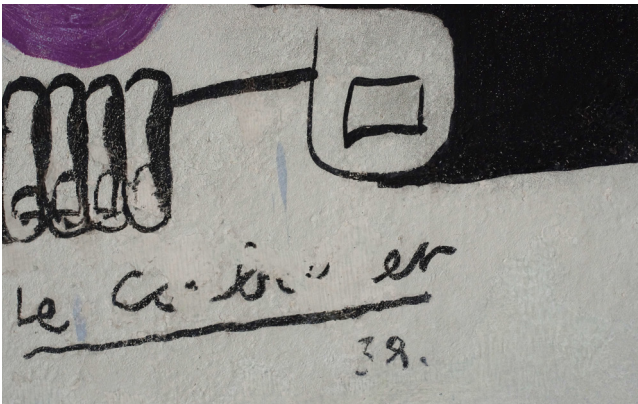
08 Le Corbusier, Signature, *La Toilette Complète*, not reintegrated. Villa E-1027, Roquebrune-Cap-Martin, France © Marie-Odile Hub

However, when signatures were missing, and no sufficiently precise photographs were available, they were not reintegrated. The surrounding lacunae were treated in the color of the background layers.

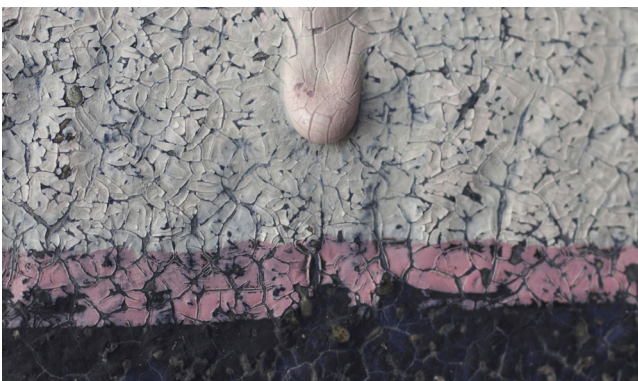
09 Le Corbusier, Detail of a drip mark and crazing, *Coin Salle à Manger*, Villa E-1027, Roquebrune-Cap-Martin, France. © Marie-Odile Hubert, 2011.

Characteristic craquelures are once again visible in areas painted with Ripolin.

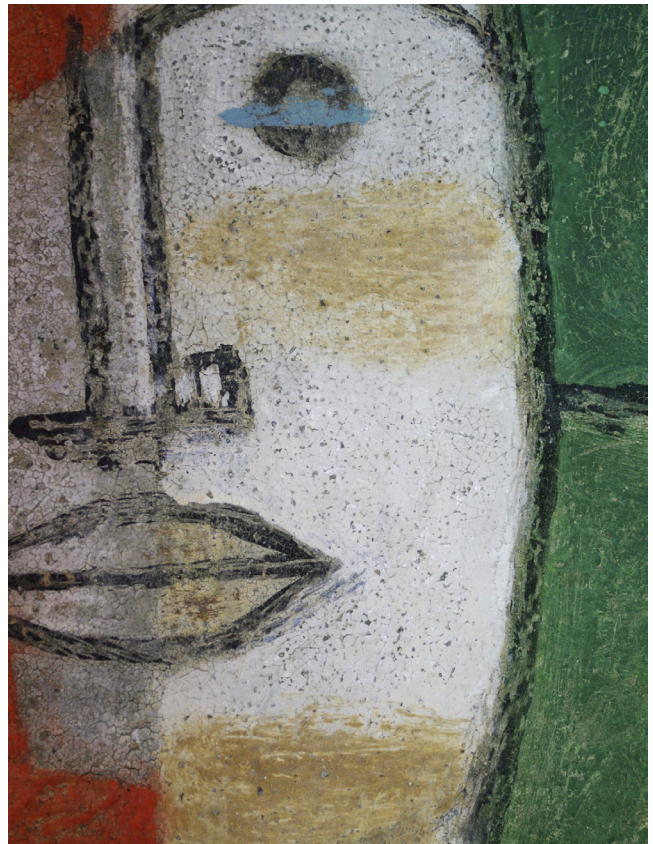
10 Le Corbusier, Scraping in the black lines, to attenuate the color value, *Entrée*, Villa E-1027, Roquebrune-Cap-Martin, France. © Marie-Odile Hubert, 2011.

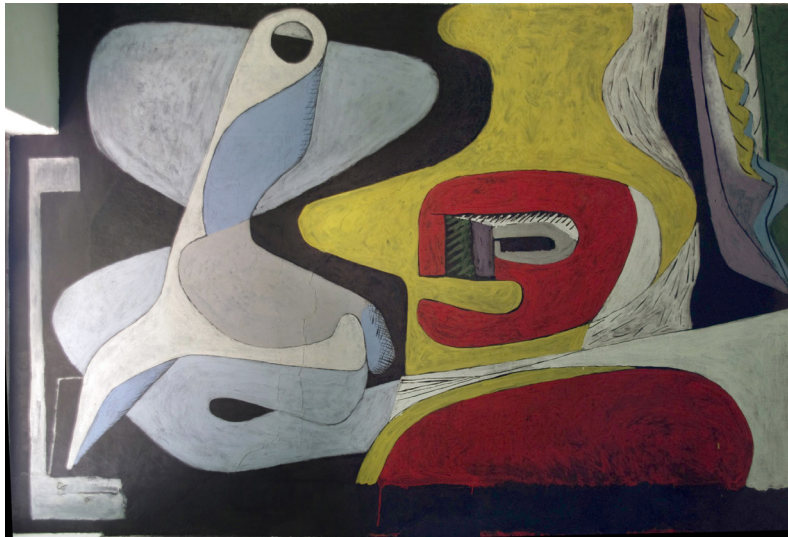
10 Le Corbusier, General view after treatment, *Chambre d'Amis*. Villa E-1027, Roquebrune-Cap-Martin, France. © Marie-Odile Hubert, 2011.

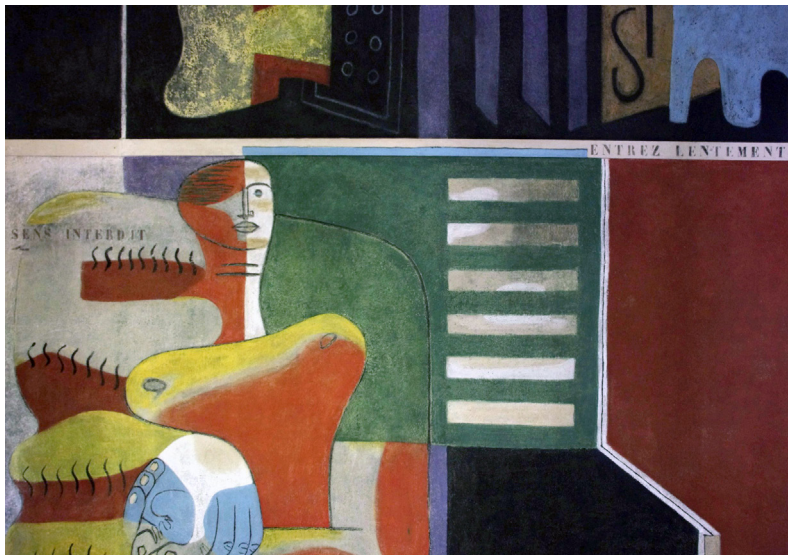
12 Le Corbusier, General view after treatment, *Entrée*. Villa E-1027, Roquebrune-Cap-Martin, France. © Marie-Odile Hubert, 2011.

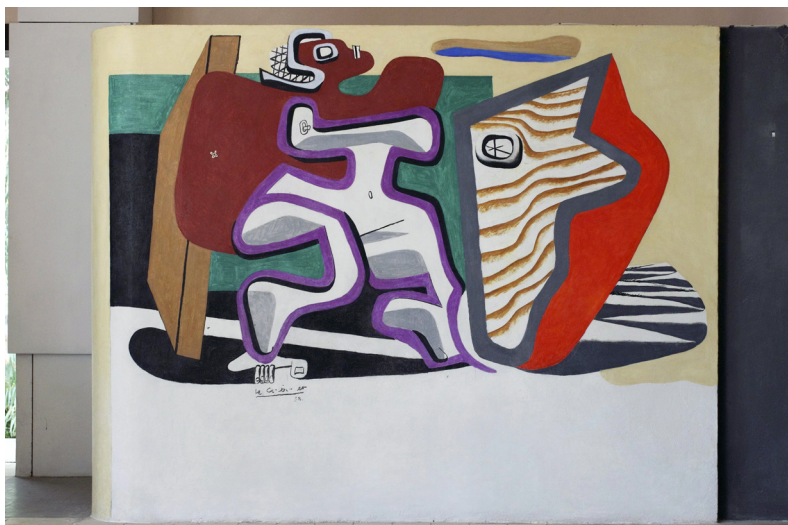
13 Le Corbusier, General view after treatment, *La Toilette Complète*. Villa E-1027, Roquebrune-Cap-Martin, France. © Marie-Odile Hubert, 2011.
