The Couvent de La Tourette from 1960 to the Present Day. Future Discernibility of Past Interventions

BY ROBERTA GRIGNOLO

The *La Tourette* Convent, built by Le Corbusier in Eveux (1953–1960) was subjected to interventions very soon after its inauguration. The article presents a critical analysis of these interventions: those overseen by Fernand Gardien (until 1964) right after completion; those undertaken before the complex was listed and for which limited documentation is available (1964–1979); the restoration campaign led by the *Architecte en Chef des Monuments Historiques* (ACMH) Mortamet, who followed an approach based on the completion of Le Corbusier's work; lastly the most recent campaign, overseen by the ACMH Repellin, who succeeded in devising intelligent alternative compliance measures thanks to the fire safety officials. The complex was returned to its original appearance, following an approach that has yet to come to terms with the aging of modern architectural works, but is nevertheless still widely used today in the conservation of 20th century architecture.

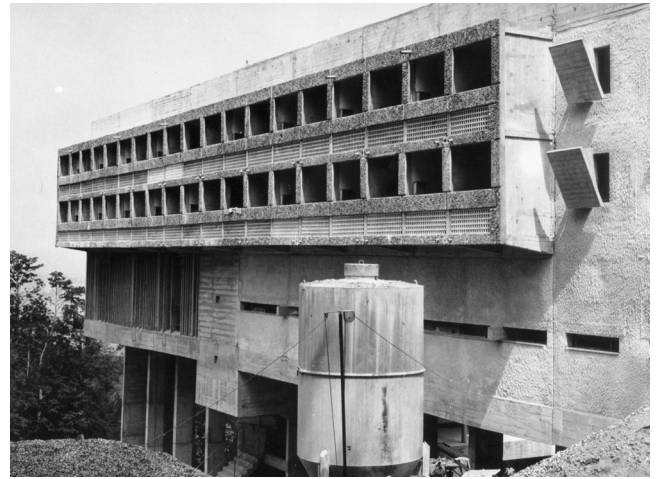
02 Le Corbusier, *Couvent de La Tourette*, Eveux, France, 1953–1960. The cracks on the *acrotères* (parapets) are already visible before the completion of the worksite. © FLC/SPA, ACT, late 1950s.

& Constructions, had not foreseen the need for expansion joints in the *acrotères* (i.e. the high parapets surrounding the roof-terrace)¹⁵. Consequently, as early as 1960, as proved by period archive sources and photographs, noticeable vertical or oblique cracks — also called “natural joints” — appeared along the *acrotères* (Figure 02)¹⁶. In September 1963, to eliminate roof leaks, the cracks were filled with *Polyjoint* special coating and the most exposed surfaces were subsequently treated with waterproof, *Polyfilm* plaster in a cement grey colour¹⁷. This product was used on the parapets, but probably also on the inclined organ surface, on the pyramid-like oratory roof and on the sloping wall of the crypt¹⁸. The use of such opaque waterproofing materials, which are clearly visible in the subsequent photographs (Figure 03), worried the monks who informed Gardien that the repair work covered and eliminated the grain and natural colour of the fair-faced concrete¹⁹. Gardien’s response left no doubts: Le Corbusier had examined and accepted the selected material, which was thus to be applied.²⁰ However, the repair work did not stop the leaks, since in March 1964 the contractor informed Gardien that the Polystrat Company would check the waterproofing work once again²¹.

Concurrently, the cracks that had formed in the parapets were treated again. The *Polyjoint* and *Polyfilm* products were removed using a methylene chloride pickling process. New vertical joints were formed at regular intervals using a circular saw. All the joints — natural and artificial ones — were then sealed with plastic polyurethane foam and a coat of epoxy resin-based synthetic mastic was applied; lastly, a two-component elastomer sealer was used to create a smooth surface. All fair-faced concrete surfaces were then treated, especially where the concrete cover had spalled. The technique consisted in chemical cleaning, passivation of the steel bars, concrete patching, and lastly, application of a silicon-based waterproofing material. During the first stage (1982–1984) the parapets and terraces above the

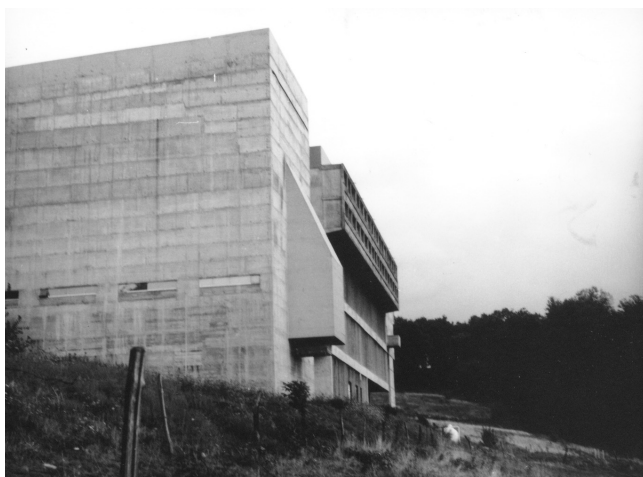
03 Le Corbusier, *Couvent de La Tourette*, Eveux, France, 1953–1960. Aerial view from the North shortly after completion. © FLC/SPA.

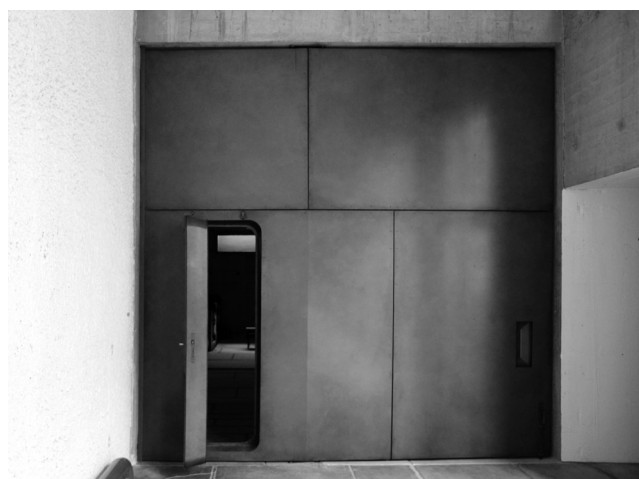
05 Le Corbusier, *Couvent de La Tourette*, Eveux, France, 1953-1960. South church pivot door built by Mortamet in 1989 following the unbuilt 1959 design of Le Corbusier. © FLC/SPA, ACT, Roberta Grignolo.

At the initiative of the *Association des Amis d'Eveux*, Mortamet also eliminated two existing church doors, which had not been built to Le Corbusier's designs, and replaced them with two pivot doors produced following the Master's original and never executed drawings. In 1989 the main South door was installed (Figure 05), followed by the North side door in 1993. This approach, based on completing the architect's work, clearly positions these interventions in an, as yet, embryonic stage of 20th century architecture conservation. Mortamet was indeed one of the first ACMHS in France to restore modern buildings. He belonged to a generation of professionals who had trained in a culture which had been "nourished" by the figure of Le Corbusier, and considered the master's works as design models — eventually needing to be finished off with a mimetic approach when they were incomplete — rather than as monuments to be preserved in the conditions in which they have reached us²³.

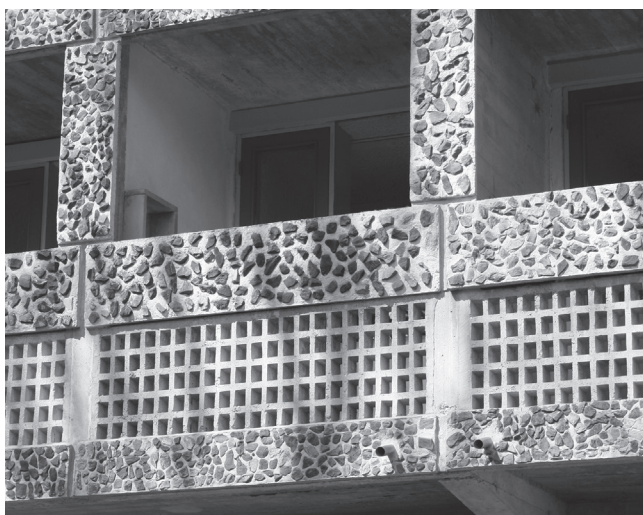
07 Le Corbusier, *Couvent de La Tourette*, Eveux, France, 1953-1960. View of the loggias with the wiring ducts running in the *goulotte* above the window fixtures. © FLC/SPA, Roberta Grignolo.

that contains the wiring — located along the upper corner of the loggias, running in full view above the window fixtures. The vertical path of the pipework was instead dealt with by inserting the *goulotte* inside the exterior *volet d'aération* (ventilation louver) of each room (the exterior *volet* — louver — provides ventilation to the cell and is located on the same plane as the window fixtures). Hidden inside the *volet*, the duct is thus visible only on close inspection.

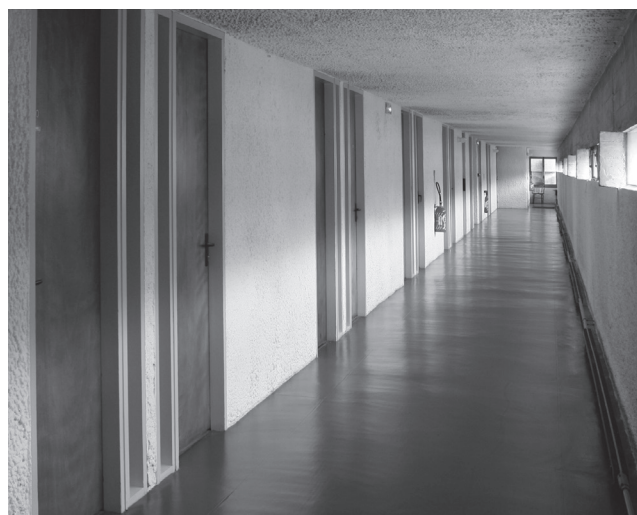
08 Le Corbusier, *Couvent de La Tourette*, Eveux, France, 1953-1960. The fire detection system doesn't change the original appearance of the cell corridors. © FLC/SPA, Roberta Grignolo.

The addition of an aspirating smoke detection system and new electric cabling — the whole electrical system was replaced by a new one — followed the original design criteria. On the communal activity levels, all the wiring ducts run in full view on a horizontal grid along the upper part of the corridors. At the cell level the situation is more complex: originally the electric cabling in this area was chased through metal ducts, which were now unusable. New ducts (for smoke detection and electricity) were therefore chased into the walls by cutting into the concrete blocks. The visible parts of the smoke detectors are now limited to 1cm diameter pipes that protrude from the cell and corridor walls and are barely visible because of the rough finish of the plaster, which was reproduced to preserve the original indoor appearance.
