The Trenton Bath House Restoration: Challenges in Sustainability

BY MICHAEL MILLS AND ANNE WEBER

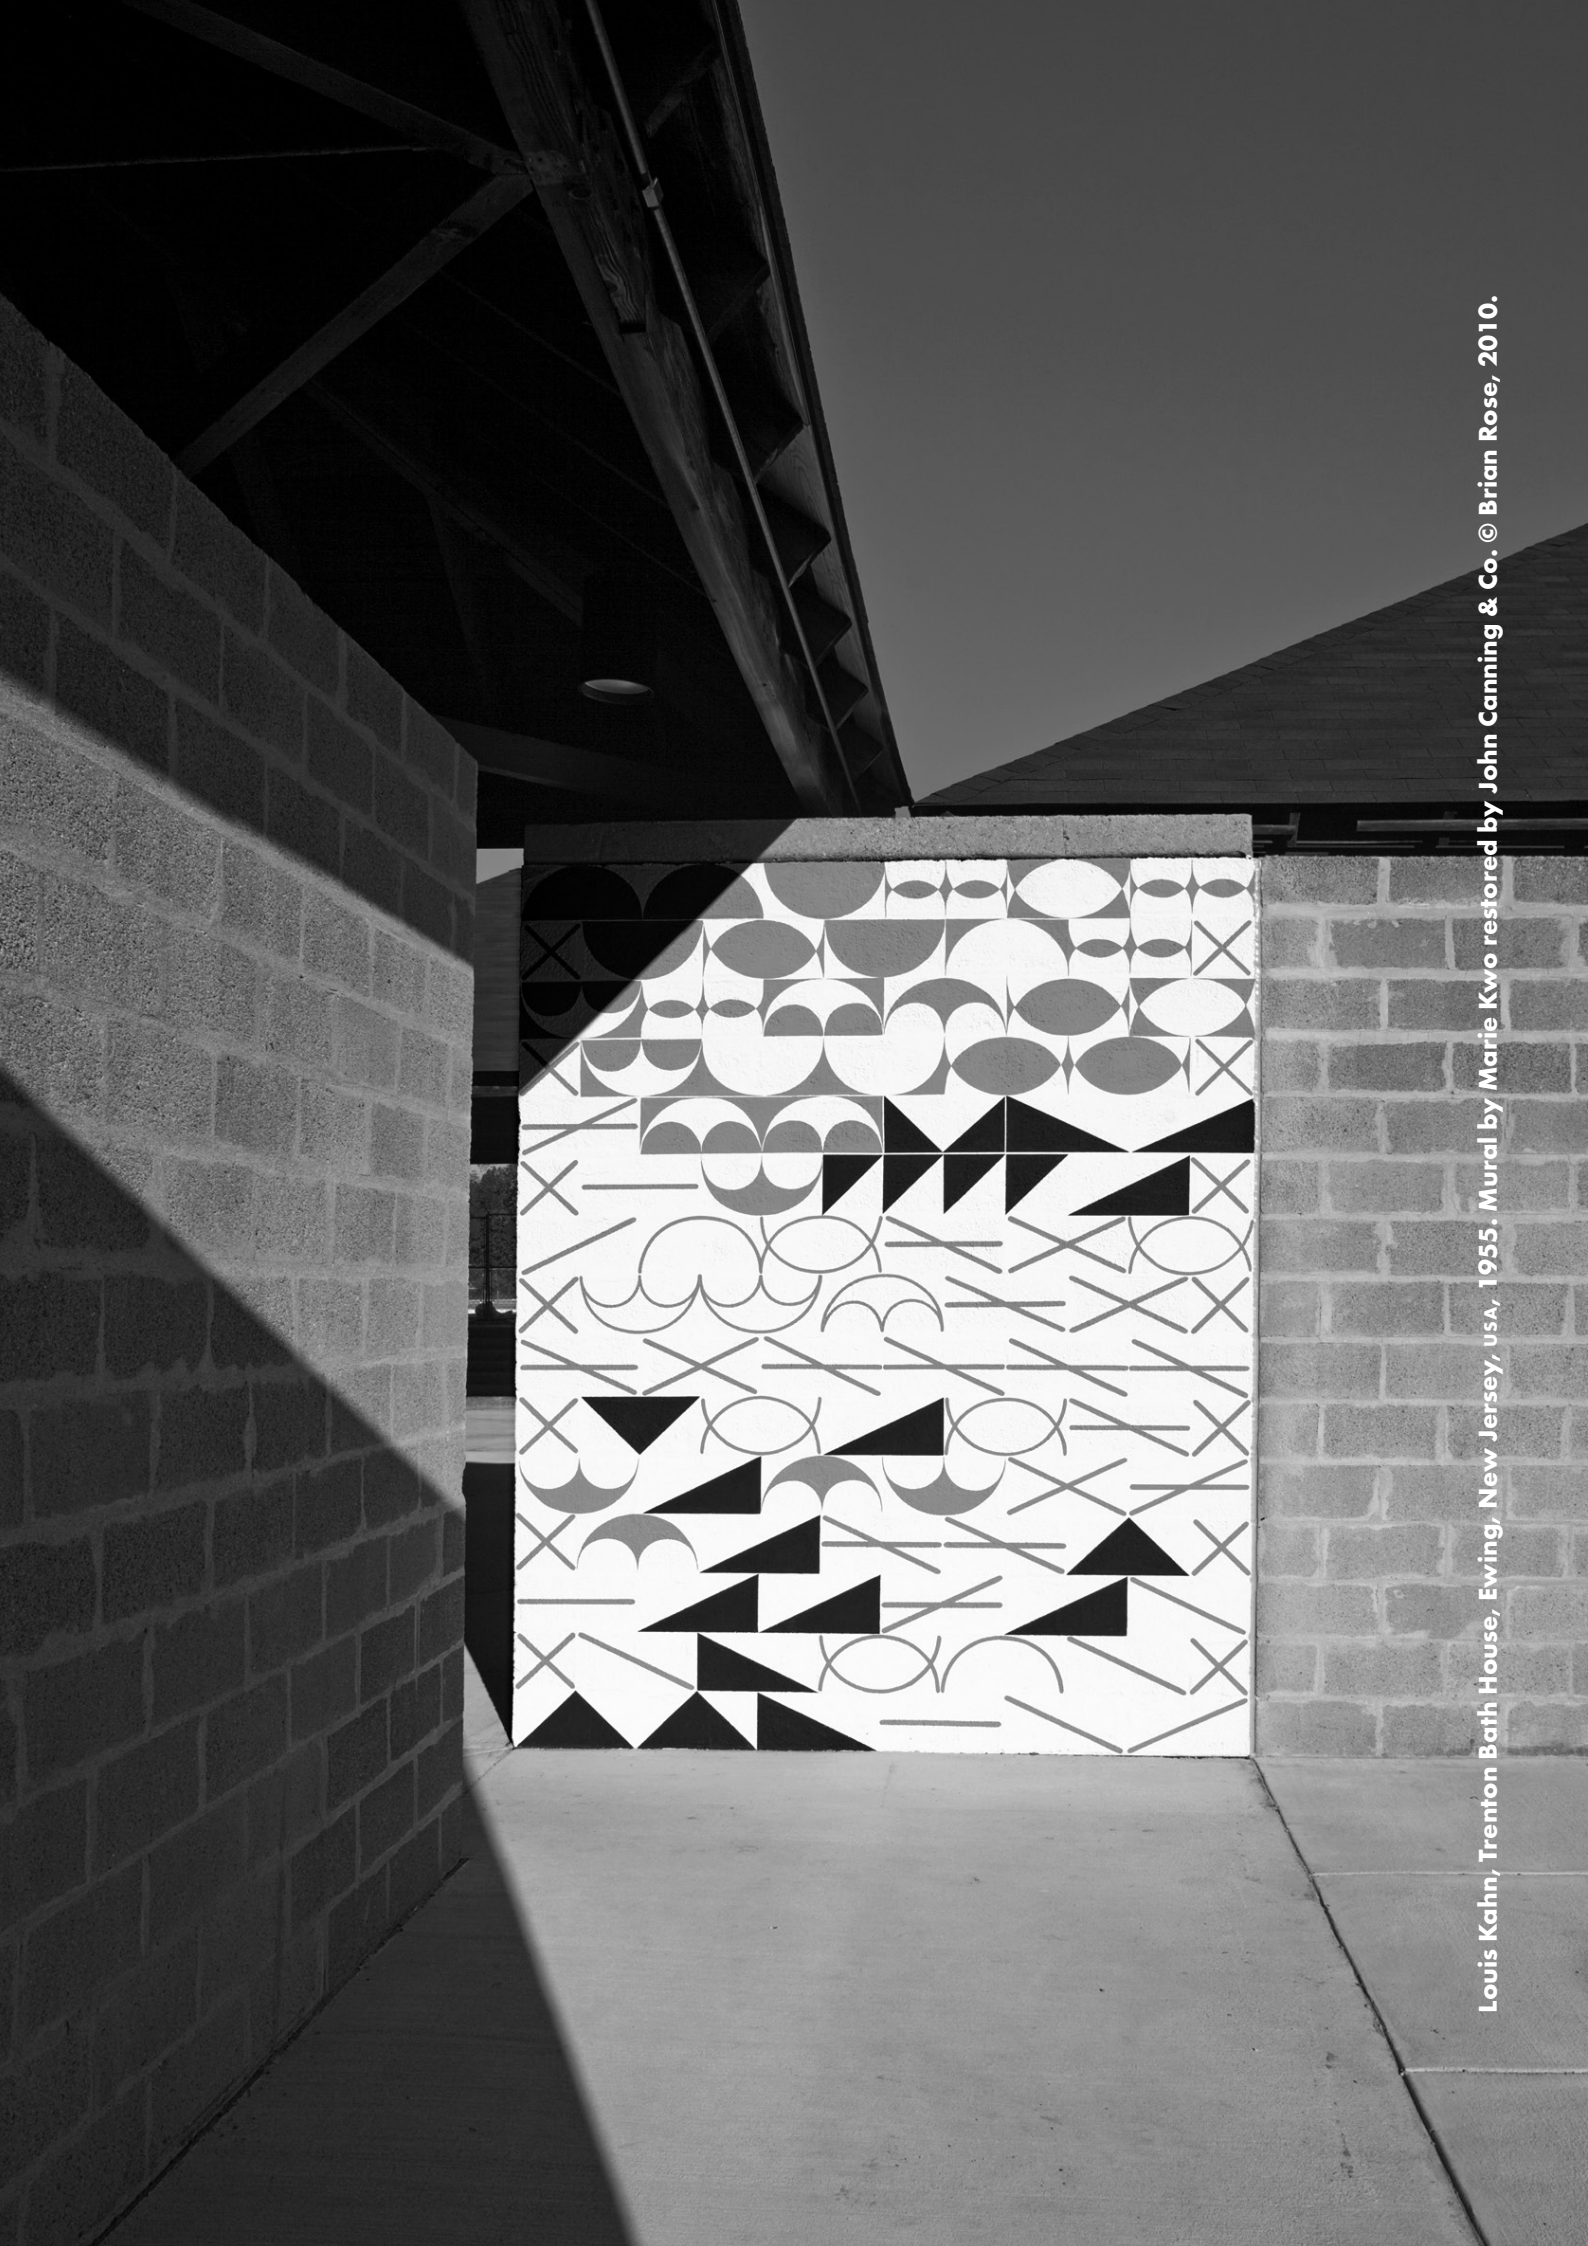
Louis Kahn, Trenton Bath House, Ewing, New Jersey, USA, 1955. Mural by Marie Kwo restored by John Canning & Co. © Brian Rose, 2010.

A mural marking the entrance to the Bath House was a part of the original construction, designed and painted by Kahn and members of his staff. The design highlighted the module of the concrete block in white, black, gray, and peach. For many years it had been painted over with gray paint. As part of this project, it was recreated through careful exposures, analysis, and study of original drawings and photographs².

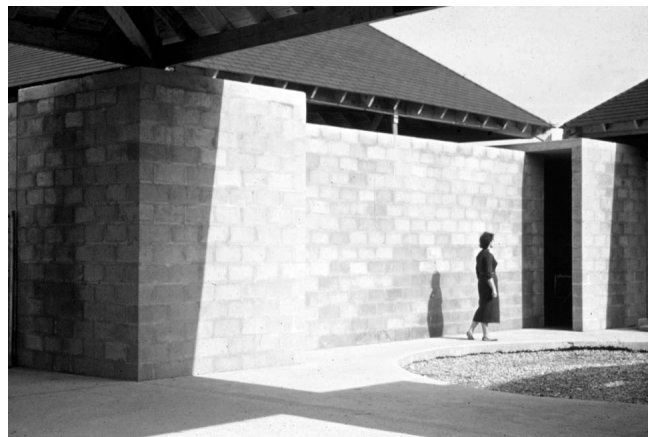
04 Louis Kahn, Trenton Bath House, Ewing, New Jersey, USA, 1955. View of Bath House during construction with removed demising walls. © Mills + Schnoering Architects, LLC, Michael J. Mills, FAIA, 2010.

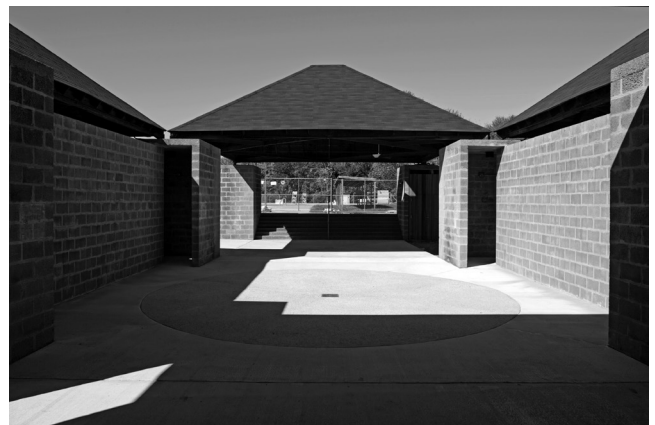
05 Louis Kahn, Trenton Bath House, Ewing, New Jersey, USA, 1955. Restored Bath House courtyard with paved circular element. © Brian Rose, 2010.

The open center court of the Bath House had an original circular feature, believed to have been intended to be a spray or wading pool. Photographic evidence shows it filled with river stone at the time of the opening, and as a lawn panel with paver edges within a year or so. By the 1990s, all the concrete had been replaced, obliterating the feature (figure 04). Functionally, a spray or wading pool was not acceptable, and the lawn panel had been worn to dirt due

to foot traffic when it existed, so that was not an option either. The design team instead used exposed aggregate concrete to create the circular element as part of the concrete paving, recalling the original temporary stone treatment while maintaining full access for the disabled (figure 05).

Barrier-free access was an important consideration in making the Bath House a functional public recreational complex. The site is extremely flat, which in general facilitates access. However, the procession through the center court up the stairs to the pool is key to the design (figure 05). A new concrete ramp leading from Bath House level to pool level now facilitates access both for visitors with disabilities and families with strollers or wagons.

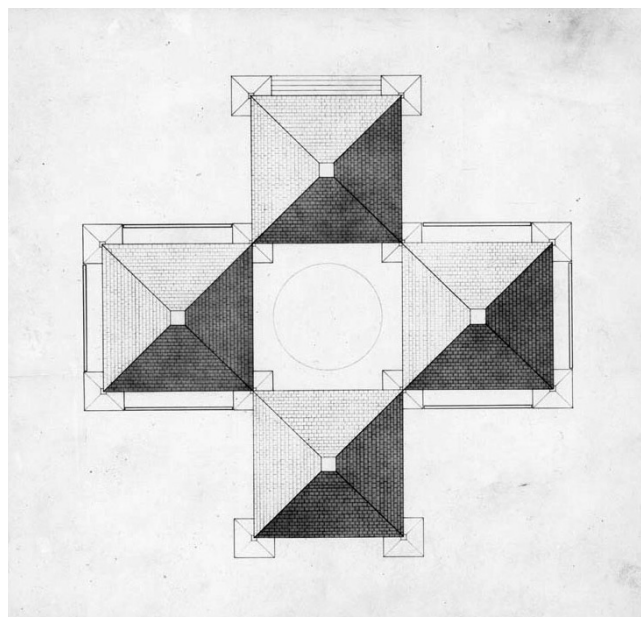
The Bath House and Pavilions reflect an important advancement in the way modern principles were infused with lessons from the past. The Bath House comprises five square, concrete block "rooms" arranged in a Greek cross plan (figure 06). Four of the rooms are covered by wood-framed roofs with black asphalt shingles; the fifth is an open courtyard. The roofs, which appear to float, are pyramidal in shape and rest lightly on large concrete block "columns" with concrete caps. These columns generate the narrow servant zones for the primary served zones, a device that Kahn developed further in the Richards Labs and other ma-

06 Louis Kahn, Trenton Bath House, Ewing, New Jersey, USA, 1955.
© Louis I. Kahn Collection, University of Pennsylvania and the Pennsylvania Historical and Museum Commission.

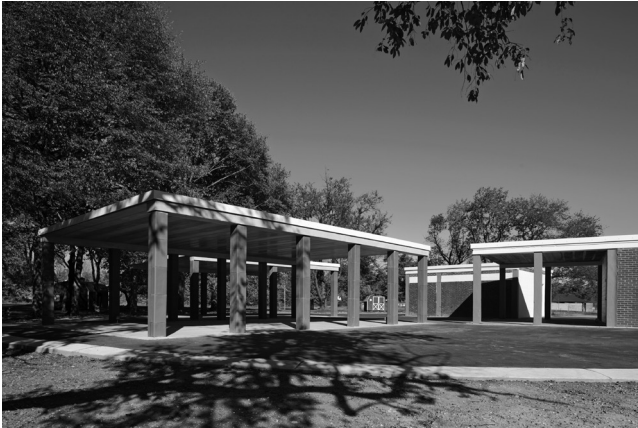
ior works. The four Day Camp Pavilions are centered on a small courtyard and each is set at a slight angle to the next, their arrangement recalling Kahn's sketches of the classical temples at Corinth (figure 07). The Bath House and Pavilions were listed on the New Jersey and National Registers of Historic Places in 1984, prior to reaching 50 years of age, reflecting their high level of significance.

07 Louis Kahn, Day Camp Pavilions, Ewing, New Jersey, USA, 1957. Day Camp Pavilions after restoration. © Brian Rose, 2010.

The Day Camp Pavilions are a very important part of the Community Center operations and were included in the restoration project. Two of the pavilions were restored and two rebuilt following a program of Historic American Building Survey documentation. The circle of gravel paving that contained the pavilions, long gone, was recreated by using a composite material that is a resilient, accessible, and maintainable surface resembling the original and contained within a new circular concrete curb.

The Day Camp Pavilions were designed with readily available local materials, including clay chimney tiles and locally manufactured concrete plank, and may have been partially constructed with JCC volunteer labor. The two largest pavilions were designed as open structures, one comprising four bays and the other five. The two smaller pavilions were partially enclosed and contained restrooms and storage. As early as the 1960s, the solid concrete fill began to cause the clay tile to exfoliate. Eventually, the clay tile was removed, and the remaining concrete columns were stuccoed and painted. Remnants of the clay tile remained at the partially enclosed structures, providing a color to match for the new material.

The roofs were formed of precast concrete plank spanning between beams above the uprights at the perimeter. At the two larger pavilions, if there had ever been any roof membrane, it was gone by the early 2000s. This allowed water to enter the plank, attacking the concrete and reinforcing steel. Because of the configuration and nature of the reinforcing, the plank could not be repaired without a substantial change to the appearance of the structure, and

it was subject to brittle failure. The team advised the JCC that the pavilions should be closed to the public because the roofs could fail without warning. Because of the extent of the failure of these original systems, reconstruction with new systems was recommended, and this approach was approved by the NJ Historic Sites Council and the Ewing Historic Preservation Committee.

For the columns, a system of terra cotta over steel columns without solid fill was selected. The *terra cotta* could be colored and molded to match the appearance of the original chimney tile. Selecting a system for the roof was more difficult. Current concrete plank is not made to match the 16" wide dimension of the original plank. The planks have rounded corners, so this system of joints was highly visible from the interior of the pavilion. Modern planks are generally made to a 24" width, which would create a 50% increase in the joint spacing. This was an unacceptable impact. The team turned to a proprietary floor system used for mid-rise commercial construction called Filigree. It consists of a precast base panel with concrete poured on top, interconnected by reinforcing. The module is 48" in width, so false joints could be created at 16" centers to match the appearance of the original plank while providing a more monolithic slab and eliminating two thirds of the opportunities for leakage between panels. A roof membrane was installed at both new pavilions with no visible change to the edge conditions from the ground. The new pavilions are very close in appearance to the originals.

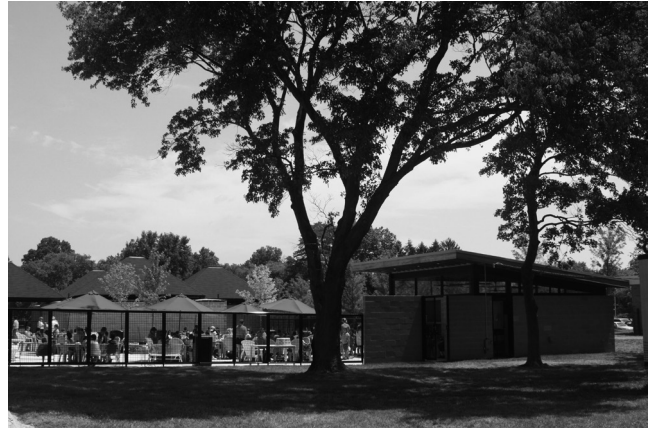
08 Louis Kahn, Trenton Bath House, Ewing, New Jersey, USA, 1955. Snack Bar and restored plaza. © Mills + Schnoering Architects, LLC, Andrew Burian, 2011.

In 2008, using State and County Greenacres funds, Mercer County purchased the entire property, and began planning its restoration and future use with assistance from the National Trust for Historic Preservation. The County ultimately conveyed the site with preservation easements to Ewing Township, but shepherded the buildings through a comprehensive planning and restoration program using funds from the New Jersey Historic and County Open Space Trust Funds. The transition was smooth and the facility remained open each summer. By 2010, the facility was fully renovated and functioning, with a new snack bar designed so as not to compete with the original structures (figure 8).

Other site improvements included removing foundation plantings installed by the JCC and replacing them with bosques of trees in keeping with Kahn's master plan (figure 11); and installing open-mesh fence at the perimeter (figure 08).

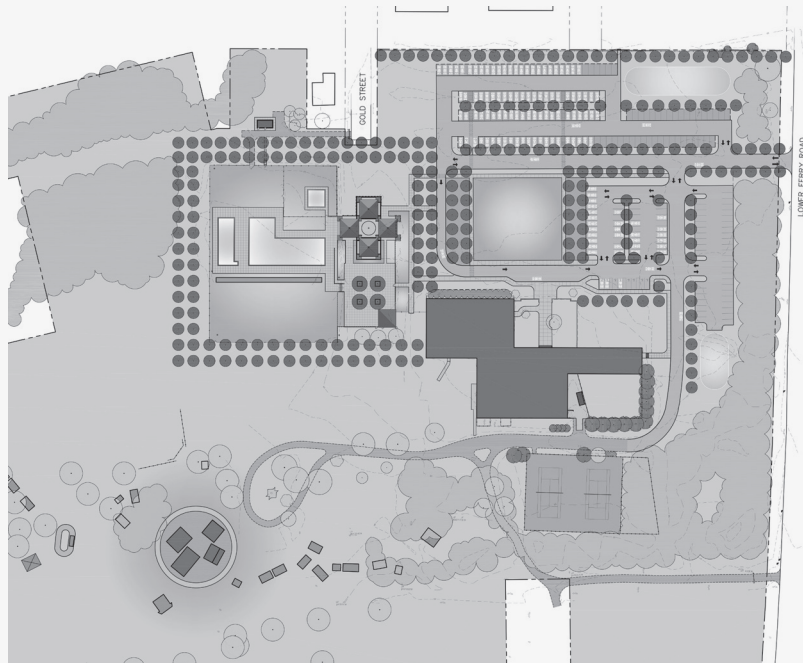
09 Mills + Schnoering Architects, LLC and Heritage Landscapes, Trenton Bath House Site, 2012. Louis Kahn-inspired landscape improvements. © Aislinn Weidele, 2016.

In 2011, the County began the effort to re-plan the site with Mills + Schnoering Architects (M+sa) assisted by landscape architects Heritage Landscapes and civil engineers The RBA Group. The landscape design and parking areas derive from a sustainable interpretation of Kahn's 1957 Master Plan, and feature a community green as originally intended with perimeter parking that is permeable and groves of trees that create outdoor rooms (figures 09–11).

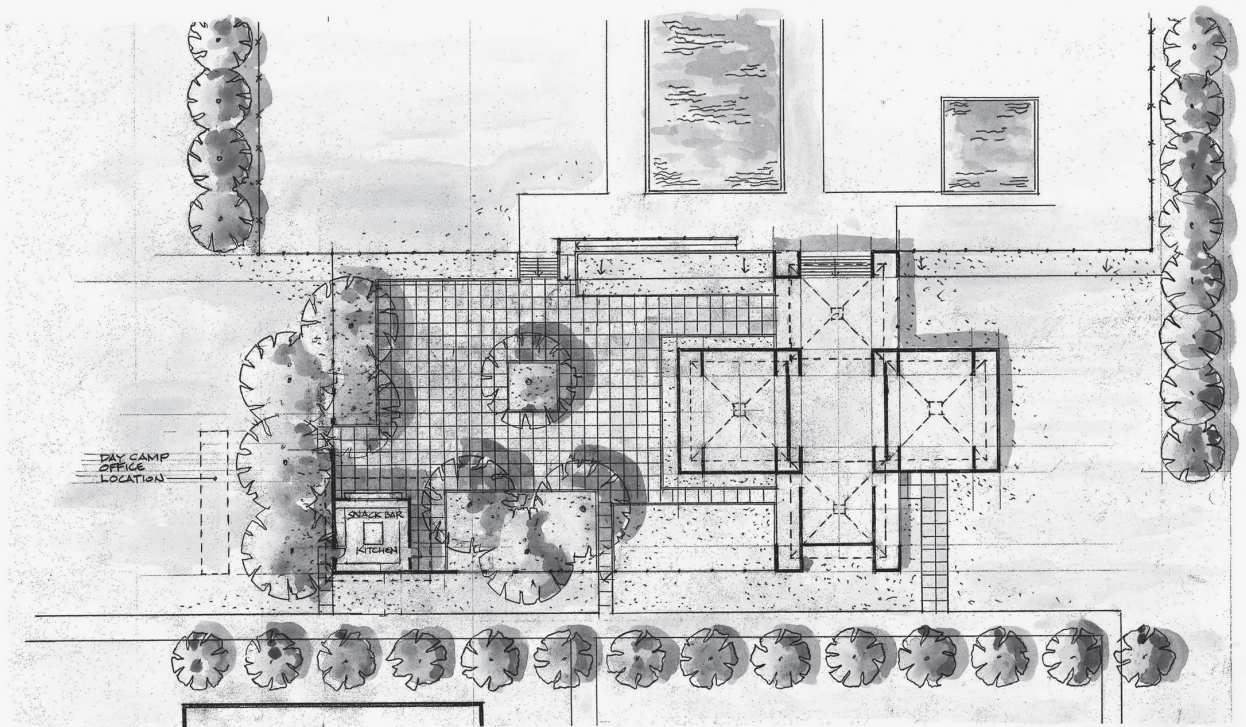
BI FLOOR PLAN / PARTIAL SITE PLAN
SCALE: 1" = 20'-0"

10 Louis Kahn, Trenton Bath House Ewing, New Jersey, USA, 1955. Site Plan, with the new Snack Bar location. © Mills + Schoeering Architects, LLC, 2011.

and had been addressed through temporary structures over the years. The new Snack Bar was built in one of several locations shown in Kahn's drawings, another square module to the west of the Bath House. The location mediates between the Bath House and the Day Camp Pavilions, a functional advantage for the site. The intent of the design was to honor Kahn's work but not mimic it. It incorporates a butterfly roof that hovers over the concrete masonry walls much like Kahn's pyramidal roofs do at the Bath House. The concrete block walls intentionally do not match the color and texture of the original, so that the Snack Bar will not be mistaken as part of the original fabric. As sited, the Snack Bar forms the corner of the fenced plaza and the larger pool enclosure.

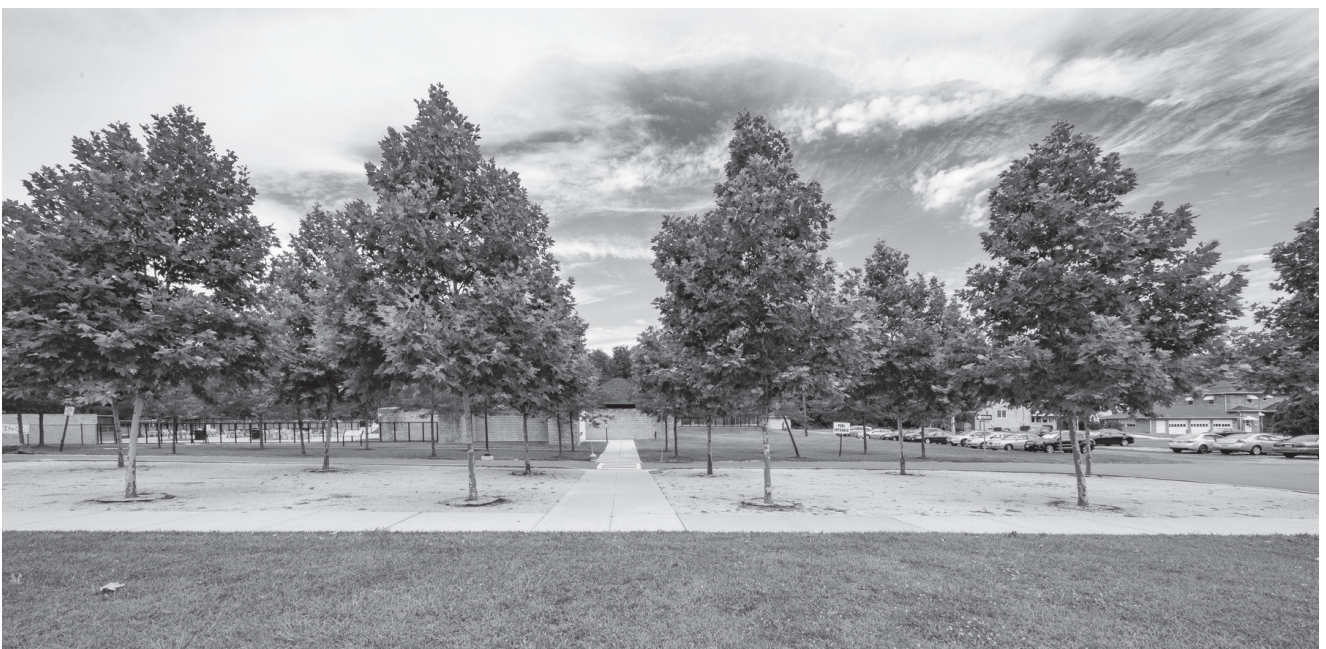
11 Louis Kahn, Trenton Bath House Ewing, New Jersey, USA, 1955. Mills + Schoeering Architects, LLC and Heritage Landscapes, 2012. Kahn-inspired landscape improvements. © Aislinn Weidele, 2016.
