Conserving the Teak Window Wall Assemblies at the Salk Institute for Biological Studies

BY SARA LARDINOIS AND KYLE NORMANDIN

In 2013 the Salk Institute for Biological Studies partnered with the Getty Conservation Institute (GCI) to commence development of a conservation program for the long-term care of the teak window walls. Phase 1 of the program included preliminary historic research and an assessment of significance, surveys and investigative inspection openings, wood and fungus identification, and analyses of past surface treatments. Guidelines were then developed based on three treatment approaches, ranging from *in situ* cleaning and treatment, to selective repairs, and finally in-kind replacement of teak wood. In Phase 2 of the work, the GCI and Wiss, Janney, Elstner Associates, Inc. (WJE) developed a trial mock-up program to assess the protocols of the three treatments. This article will review the overarching goal of the treatment approaches, integrating conservation and repair needs with select modifications to the window detailing to improve long-term performance, including surface treatments to protect the teak wood and retard fungal growth and weathering over time.

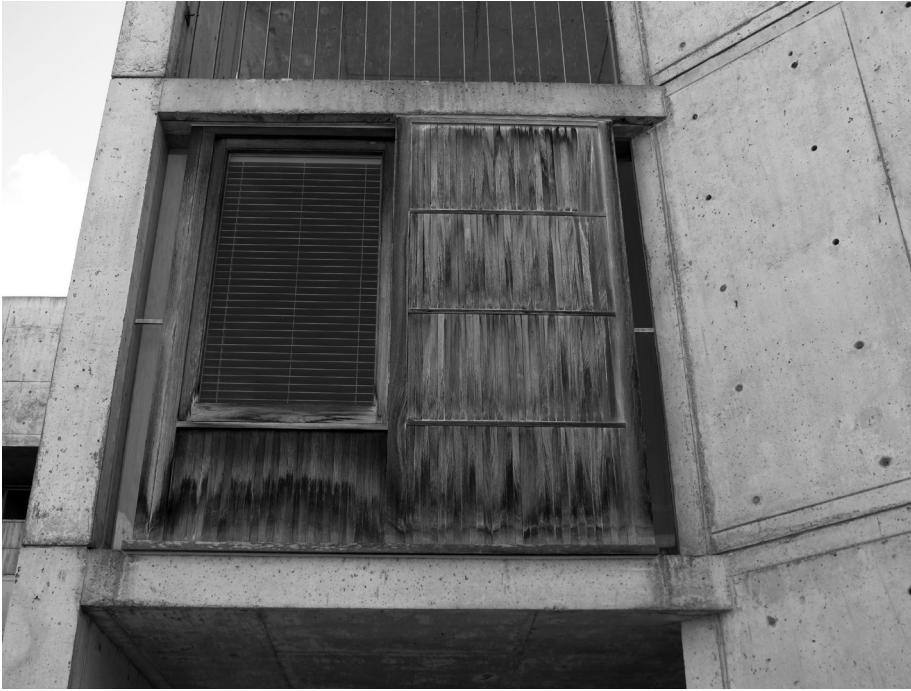
The teak window walls are prefabricated assemblies consisting of different combinations of horizontal sliding window sashes, louvers, and/or paneled shutters, with an internal pocket where required to accommodate these sliding components (figure 03). They were constructed using teak structural members and softwood stud framing, with asbestos-cement (transite) board which performs structurally similar to sheathing. The exterior face of the wall is clad in vertical tongue-and-groove teak siding, and the interior face is clad in oak paneling or gypsum board, installed over the transite board (figure 04). In some locations, the design includes oak shelving for the office occupants. Narrow glazed lights at either side of the assembly served as shim space when the assemblies were set in the wall, and allow for additional light to wash the concrete walls of the work spaces. Prefabrication was selected as both a means of reducing project costs and increasing quality, as the units were partially assembled in a local cabinetmaker's shop prior to being transported to the site and lifted into place by crane.

| <ol style="list-style-type: none"> 1. TEAK DRIP CAP 2. TEAK DRIP 3. TEAK TRIM BOARD 4. TEAK TONGUE-AND-GROOVE (T&G) VERTICAL SIDING 5. SECOND SIDING BOARD FROM LEFT IS T-SHAPED, WITH ADHESIVE AT EITHER SIDE, TYPICAL AT EACH ROW OF VERTICAL SIDING 6. SLOPED TEAK SILL 7. SEALANT 8. FURRING STRIP, NAILED TO TRANSITE PANEL (NOT VISIBLE - ASSUME WOOD OR PLYWOOD) 9. 2 1/2" x 3 1/4" PLYWOOD FURRING STRIP, NAILED TO STUDS 10. 1.5/8" THICK ASBESTOS-CEMENT (TRANSITE) PANEL 11. 1 1/2" x 8 5/8" WOOD STUD 12. 2" x 8 5/8" WOOD SILL | <ol style="list-style-type: none"> 13. 1/2" x 2 5/8" WOOD STUD 14. 2" x 2 5/8" WOOD SILL 15. ANCHOR BOLT, WITH 3/4" W x 3/8" H HEX HEAD, TYPICAL OF 4 AT SILL 16. WOOD HEAD 17. HEAD TRIM 18. WOOD PLUGS, WITH BOLT ATTACHMENT TO CONCRETE WALL / SLAB ABOVE, TYPICAL OF 4 AT HEAD 19. TEAK WINDOW SILL 20. TEAK JAMB 21. TEAK SLIDING LOUVER 22. TEAK SLIDING WINDOW SASH 23. WINDOW / LOUVER TRACKS 24. WOOD STOP | <ol style="list-style-type: none"> 25. 1 1/2" x 1 1/2" x 1/8" STEEL ANGLE, NAILED TO SIDE OF WOOD SILL PLATE AND CONCRETE CURB 26. 5/8" x 2 1/2" FURRING STRIPS, NAILED TO TRANSITE PANEL, FOR ATTACHMENT OF OAK PANELING 27. 1" THICK OAK PANELING, SCREWED TO FURRING STRIPS 28. GLASS SHEET 29. CONCRETE WALL 30. CONCRETE CURB 31. WOOD FLOORING |

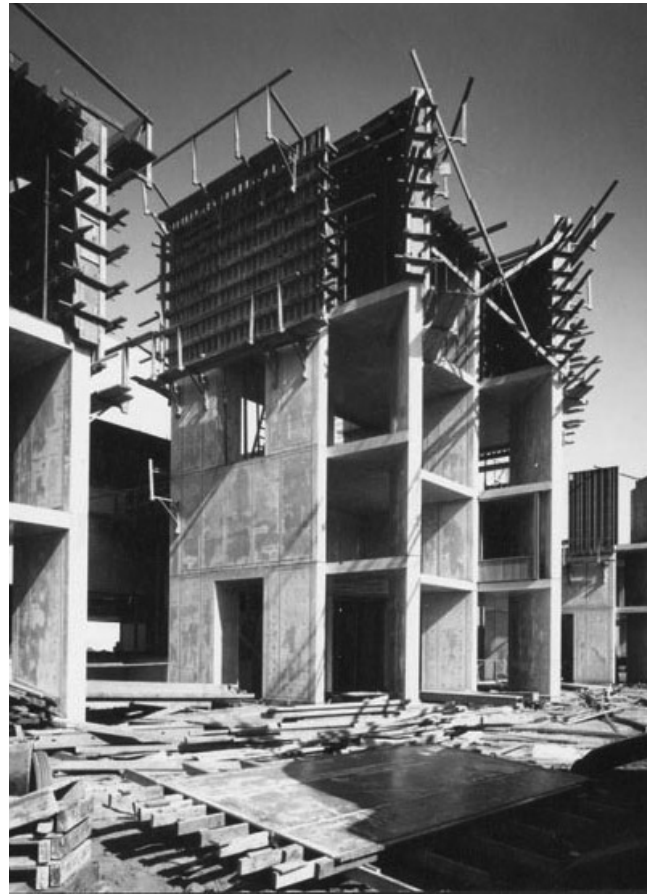
05 Louis Kahn, Salk Institute, La Jolla, California, USA, 1959-1965. Under construction. © Louis I. Kahn Collection, University of Pennsylvania and the Pennsylvania Historical and Museum Commission.

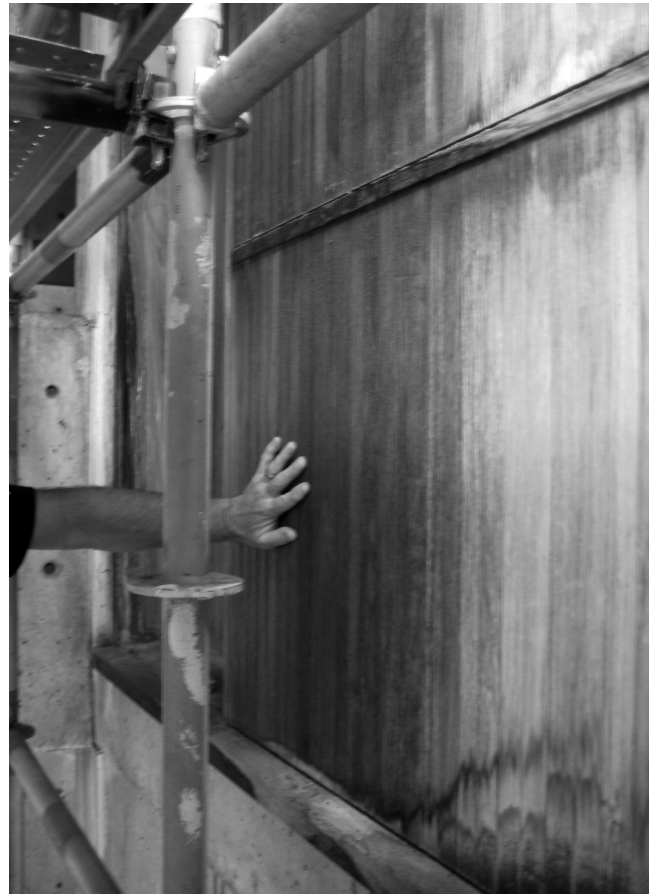
07 Louis Kahn, Salk Institute, La Jolla, California, USA, 1959-1965. Treatment discoloration and varied weathering patterns. © Wiss, Janney, Elstner Associates, Inc. 2015.

In addition, the window walls were exposed to weathering and ongoing moisture infiltration over time. Additional deterioration occurred due to termite infestation in both the internal framing and in some of the teak framing and cladding. Challenges related to the external teak woodwork also presented themselves once the building was in service. Only a few years after construction, beginning in 1967, the Institute started to wash the entire external woodwork of the teak wood window assemblies in an effort to consistently remove the surface accumulations of the black fungal biofilm; however, the fungal biofilm returned and routine washing of the teak wood continued routinely over 50 years. In the 1970s, surface treatments and coatings were tested and applied with the intent of protecting the wood; however, the treatments eventually gave the teak a deep red appearance that strongly discolored the wood and aesthetically contrasted with the adjacent concrete areas (figure 07).

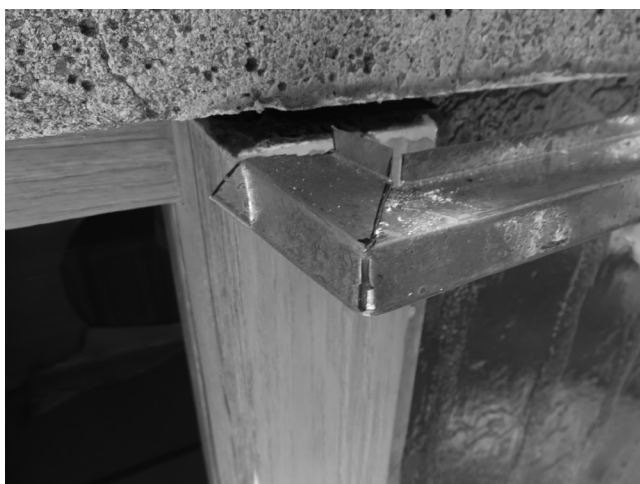
08 Louis Kahn, Salk Institute, La Jolla, California, USA, 1959-1965. New metal flashing at top of window. © Wiss, Janney, Elstner Associates, Inc. 2016.

In addressing these challenges, the project team grappled with how to balance technical and philosophical questions and arrive at viable solutions. One of the largest technical problems was how best to make the windows more weathertight, provide the flashings that had been omitted from the original design, and install other weatherproofing improvements, including an air and moisture barrier system in the internal wall cavity. Given that the flashings were part of the original design, integrating this detail in the conservation program was critical (figures 08 and 09). However, there remained a challenge of how to integrate a weather barrier system to improve the overall performance of the assembly without significantly altering the visual characteristics, construction detailing, and craftsmanship of the original design.

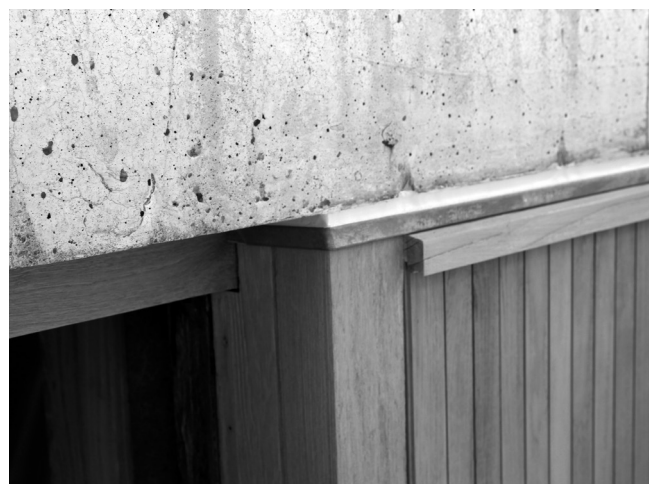
09 Louis Kahn, Salk Institute, La Jolla, California, USA, 1959-1965. Folded metal flashing installation at top of window. © Wiss, Janney, Elstner Associates, Inc. 2016.

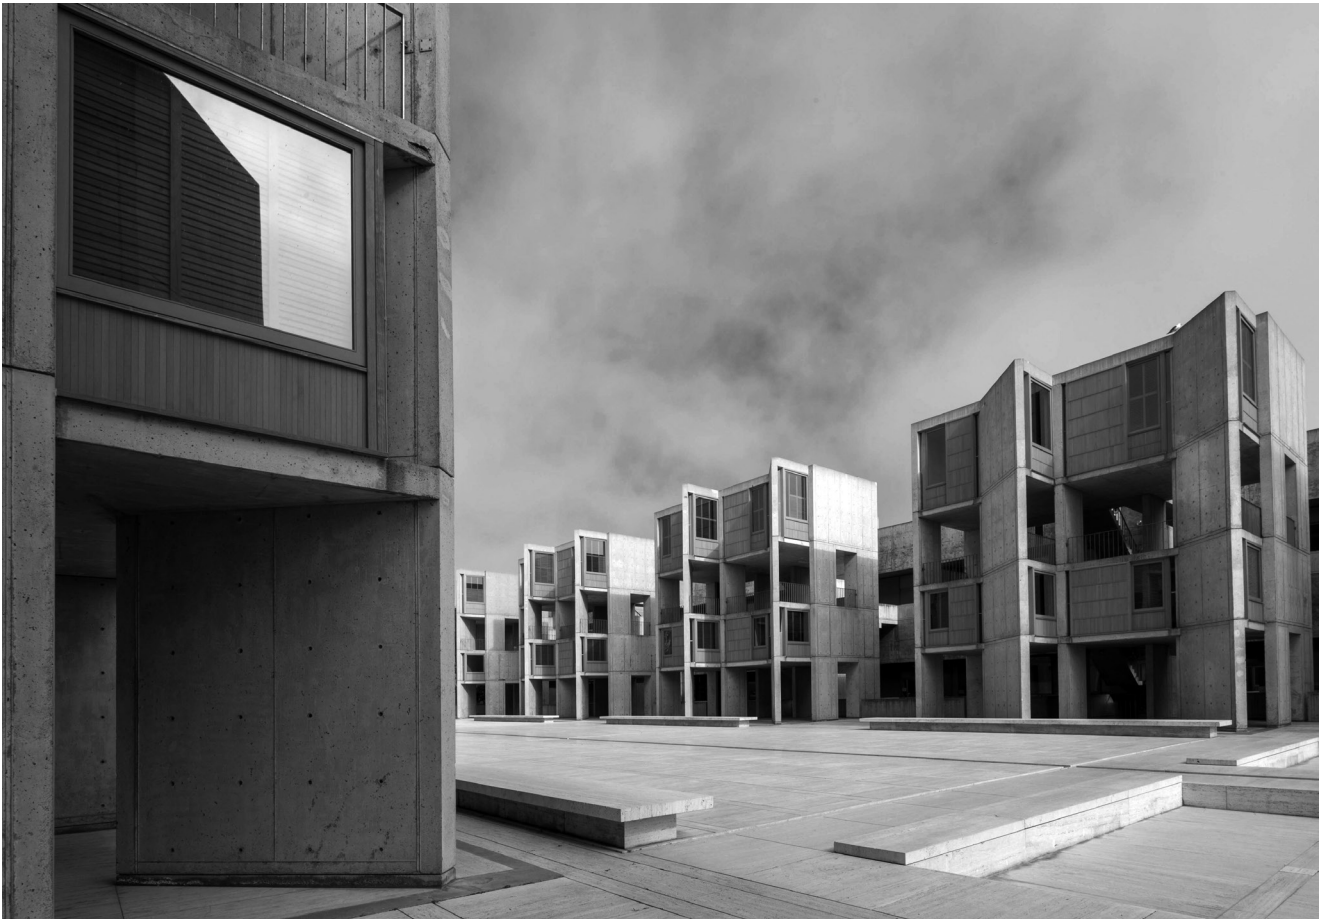
10 Louis Kahn, Salk Institute, La Jolla, California, USA, 1959-1965. Overall view, looking southeast across the plaza, following completion of project. © Elizabeth Daniels, 2017.

One of the major successes of the project is that over two-thirds of the original teak wood was conserved in place, preserving not only material authenticity but also a rare natural material resource – Southeast Asian teak (figure 10). The conservation repair approach represented a dramatic shift from a complete window replacement program that had initially been anticipated by the Institute for the window wall assemblies.
