## The Yale Center for British Art: a Building Conservation

BY GEORGE KNIGHT

### Conserving Louis I. Kahn: the Yale Center for British Art renewed

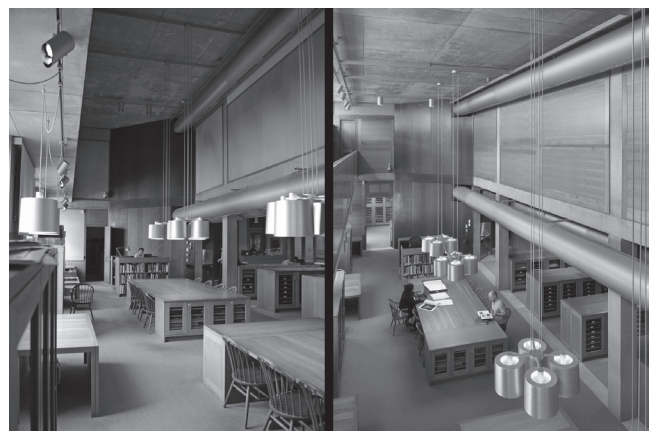
**08** Louis Kahn, Yale Center for British Art, New Haven, USA, 1966-1977. Prints & Drawings and Rare Books & Manuscripts Reading Room. Left: pre-conservation. Right: post-conservation. © Left: Knight Architecture LLC, Dylan Hayn, 2011. Right: Esto, Elizabeth Felicella, 2016.

An early phase of the building conservation project, focused on the renovation of the Center’s Study Room and Rare Books and Manuscripts Reading Room, double-height spaces surrounding the Library Court. In each space, existing linen panels lining the room’s upper levels were replaced with wood ones. The decision to do so was based on drawings discovered in Kahn’s archive which had called for such a finish treatment but which had never been executed – presumably due to cost-control measures at the time of construction. In this circumstance, the adoption of Kahn’s premise that wood not be stained required accepting a discernable difference between the new material and the existing.

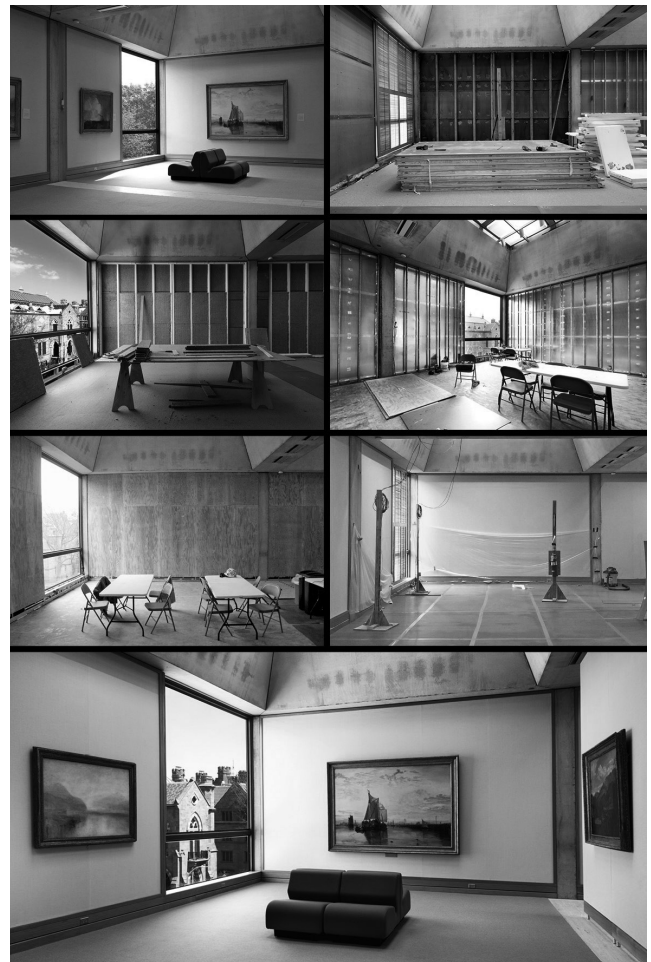
09 Louis Kahn, Yale Center for British Art, New Haven, USA, 1966-1977. Fourth floor "Turner Bay" displaying the exterior wall sequence that was typical throughout the project spaces. Top to bottom, left to right: 1) pre-conservation, 2) exterior panels, 3) insulation, 4) air barrier, 5) substrate, 6) finishes, 7) post-conservation. © 1) Yale Center for British Art, Richard Caspole, 2007, 2-4) 2015, 7) 2016, 5-6) Knight Architecture LLC, Daphne Kalomiris, 2015.

A building's exterior envelope is a critical component to the performance and resiliency of a given structure, particularly one enclosing irreplaceable works of art. While the Center's exterior envelope had successfully prevented rainwater from entering the building, its thermally-bridged wall construction and insulation assembly were not sufficiently designed to account for the condensation that, on the coldest New England evenings, would propagate due to the temperature and humidity requirements of an art collection environment. The building conservation project addressed the persistent and ultimately corrosive condensation by

stripping off all finish and substrate materials to the inboard face of the exterior metal cladding; de-scaling corroded steel framing and recoating it with a resilient primer; re-insulating the walls with non-gas-emitting rock-wool insulation packed tightly into the wall assembly; and installing a galvanized metal air-barrier and providing concealed stainless steel reservoirs set on the warm side of the wall into which the unavoidable condensation is diverted and from which it ultimately evaporates into the gallery environment.

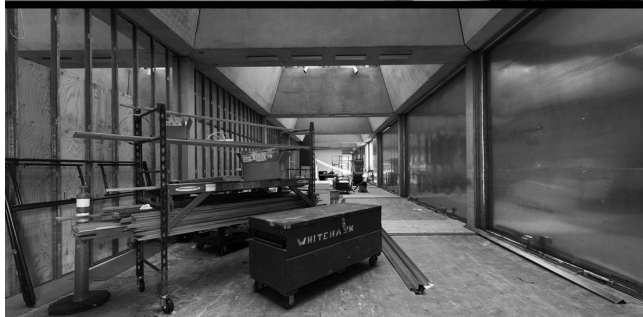
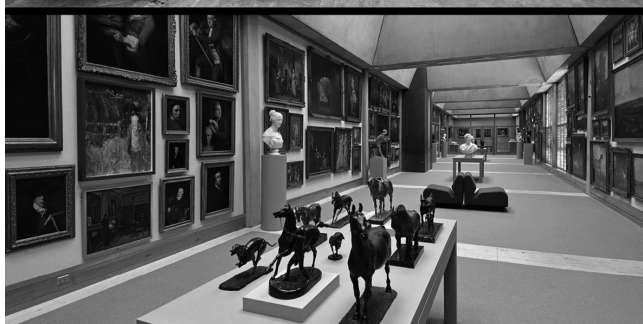
**10** Louis Kahn, Yale Center for British Art, New Haven, USA, 1966–1977. Long Gallery. Top: pre-conservation; center: construction; bottom: post-conservation. © Top: Yale Center for British Art, Richard Caspole, 2014. Center: 2015. Bottom: Yale University, Michael Marsland, 2016.

The Long Gallery is a linear exhibition space on the south side of the sky-lit fourth floor which was originally envisioned by Kahn and Jules Prown, the Center's founding director, as a teaching space within the galleries. However, with large pogo panels dividing the space, sparsely hung paintings, and ill-coordinated doorways, the aspiration for the longitudinal study gallery had never been fulfilled. The building conservation project restored this vision by removing the partitions, altering the configuration of the doorways to promote more logical circulation, and reinstating the dense, "salon-style" hanging of pictures. In addition, an office space at the end of the long gallery was transformed into the Collections Seminar Room, a newly wood-paneled space where works in various media can be presented in an intimate setting.

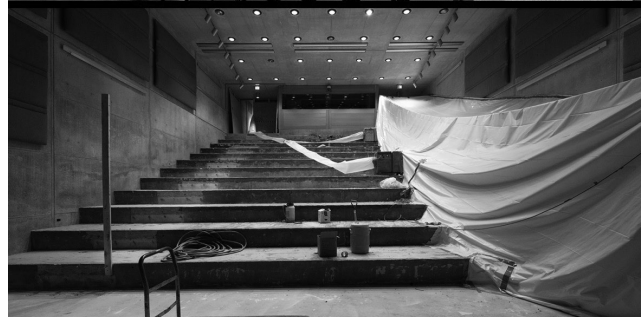
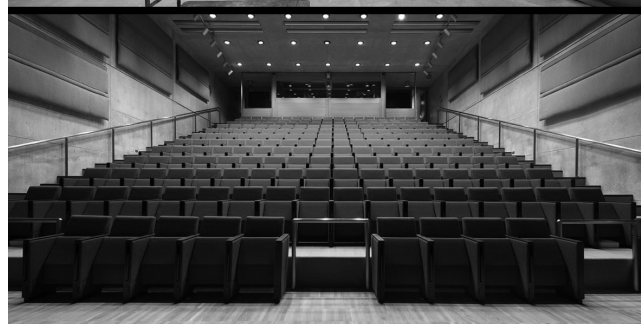
**11** Louis Kahn, Yale Center for British Art, New Haven, USA, 1966–1977. Lecture Hall. Top: pre-conservation. Center: construction. Bottom: post-conservation. © Top: Knight Architecture LLC Daphne Kalomiris, 2013. Center: Yale Center for British Art, Richard Caspole, 2015. Bottom: 2016.

Set within beautifully mottled cast-in-place concrete walls, the Center’s raked, two hundred seat Lecture Hall is one of the building’s most beloved spaces. While the hall was initially envisioned for the presentation of slides and lectures, its elegance has made it a favorite venue for diverse uses such as films, dramatic performances, music, and even dance. The space was comprehensively renovated including the replacement of all seats, carpeting and stage flooring – all of which had exceeded their reasonable lifetime; new step lights and power outlets were installed to conform with contemporary demands; the seating arrangement was slightly altered to allow for the inclusion of handrails; accessible seating was distributed throughout the space; original theatrical lighting, long since obsolete, was replaced with highly versatile LED fixtures; and the

antiquated equipment within the projection booth was completely replaced to expand capabilities for lighting control, amplification, recording, and broadcasting.

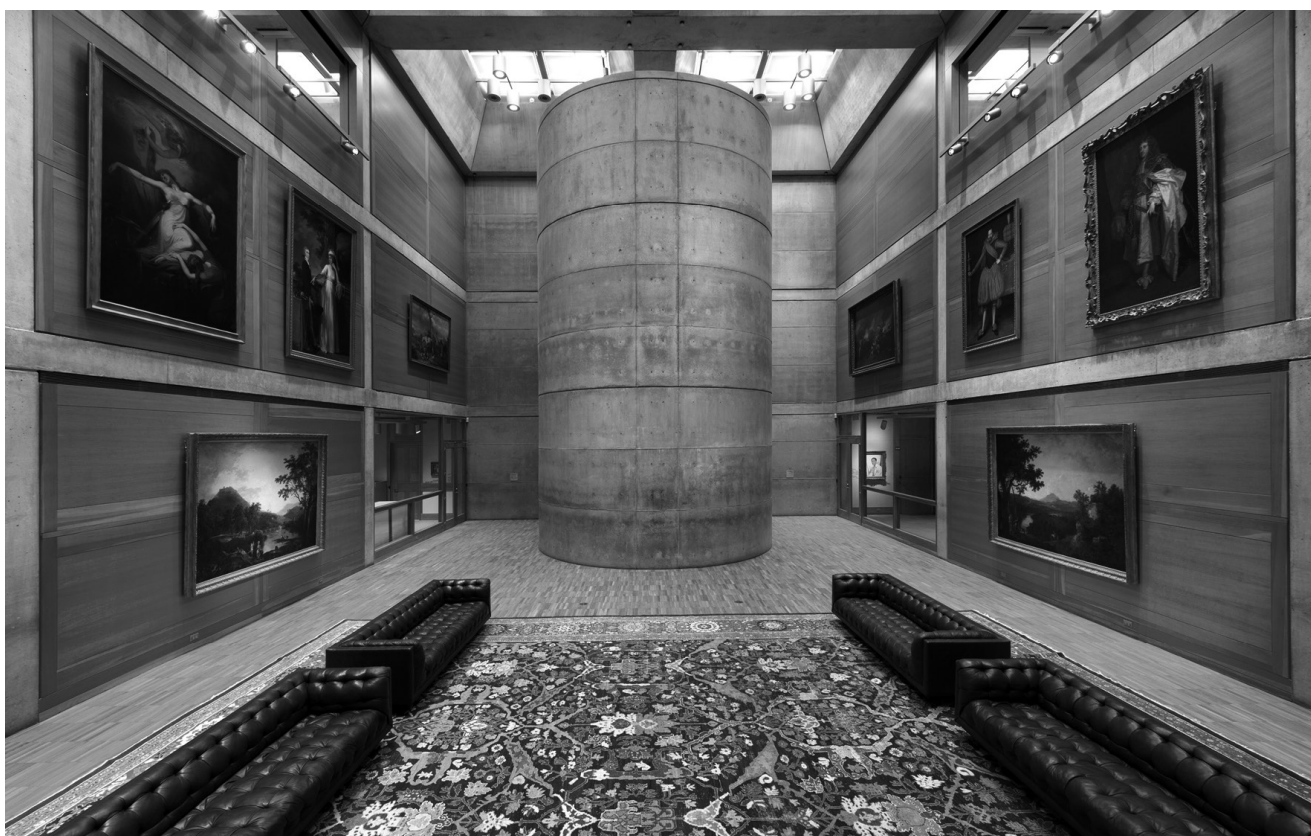
13 Louis Kahn, Yale Center for British Art, New Haven, USA, 1966-1977. Library Court following building conservation project. © Yale Center for British Art, Richard Caspole, 2016.
