# MATTI SUURONEN'S 'FUTURO' - PROTOTYPE 1968 AFTER 50 YEARS

ABSTRACT: The Futuro house was designed in 1968 by the Finnish architect Matti Suuronen. Its prototype, Futuro no. 000, currently in the collection of the Museum Boijmans van Beuningen in Rotterdam, underwent a major conservation treatment at the time of its acquisition a decade ago. The construction, the architectural details and the surface of fiberglass reinforced polyester (GRP) elements had suffered from transport and handling during the many assemblies on various sites, indoors and outdoors, over the previous decades. Before starting the restoration a research project was set-up to investigate the options for conservation. A clear vision about the best ways to exhibit the prototype was developed in order to avoid further deterioration. The decision to only exhibit the Futuro within the museum was essential for its conservation treatment. In contrast with the original function of the mass-produced Futuro houses as summer houses or ski-huts, it proves to be the best option to preserve the unique prototype for the future.

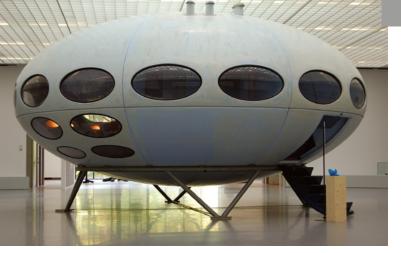
01 Futuro Prototype. Overview after conservation, 2011. © N. van Basten

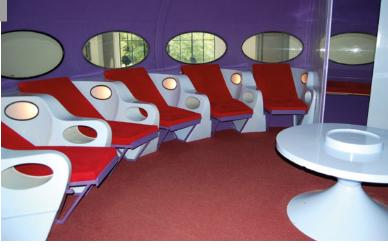
02 Futuro Prototype. Interior view in after conservation, 2011. © N. van Basten

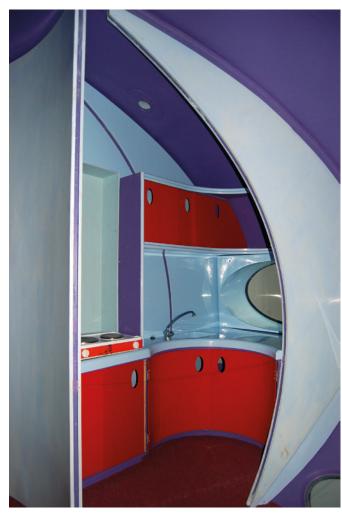
03 Futuro Prototype. View of the kitchen area after conservation, 2011. © N. van Basten

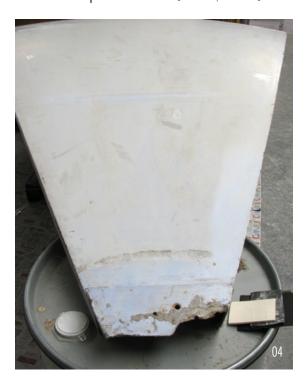
During the cleaning of the outer shell a remarkable shift in colors showed up [FIGURE 04, FIGURE 05]. The gelcoat colors are not monochrome blue anymore but seem to have faded partially due to sunlight exposure. Another possible reason for the patchy appearance could lie in the working method in the production. It is possible that the colors for the gelcoat had not been mixed well in the first place. In some areas large brushstrokes deriving from the application of the gelcoat mixture on the mold could be seen. The overall multicolored shades, which varied from blue to purplish beige and green grey, were not visible on the few remaining early photographs. How this process started is still the object of research [FIGURE 06, FIGURE 07].

- 04 Detail of one of the shell elements; halfway the surface cleaning treatment. © L. Beerkens
- 05 Detail of the same element during the cleaning process. © L. Beerkens
- O6 Detail of the damaged top end of one of the shell elements. © L. Beerkens
- 07 Detail of the same element in figure 06 after repair of the loss. © L. Beerkens

and old drill holes with the appropriate filler materials used in the polyester industry and mixed in matching colors [FIGURE 06, FIGURE 07]. This made it possible to execute a good and robust restoration within a reasonable time and budget. The door and stair element were cut open to add extra plywood and polyester reinforcement, and then closed-up again [FIGURE 10]. To preserve the prototype by refraining from future outdoor exhibition the treatment could be limited to cleaning, local repairs, small reconstructions and strengthening constructional components. The assembly in 2011 showed a good final result from the conservation treatment: the repetitive black lines of the oval windows and the smooth bluish polyester surface re-emphasize its character. The Futuro prototype has regained its strong features of futuristic design and lifestyle, and was welcomed back by its architect Matti Suuronen at the opening of the exhibition in the museum in May 2011.

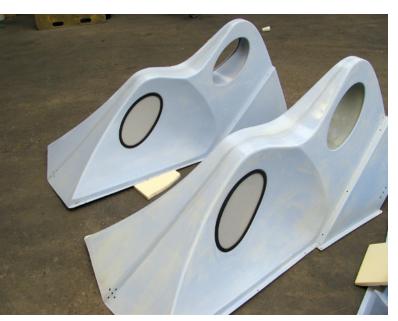
The blue polyester interior was in much better condition than the exterior although a similar but less pronounced shifting of the blue color could be detected there as well [FIGURE 08]. Some polyester interior elements were still fully blue, such as the bathroom where there has been very little exposure to direct sunlight [FIGURE 09]. Patches of dark retouched areas disturbed the purple walls and the ridges covering the bolted connections between the shell elements. The surface structure, typical of the GRP 'lay-up' method, was painted with a matt acrylic house paint. It was decided to completely repaint the inner walls and all purple elements rather than painstakingly try to remove the patches as there was no aesthetic or artistic value to this painted surface other than its color. 13 The cooperation with Poly Products B.V. provided the know-how for the repair and treatment of aged GRP objects. The conservation treatment was carried out by Poly Products employees in their factory with a lifting hoist, which enabled easier handling during assembly. The treatment consisted in a lot of cleaning and light polishing, filling larger lacunae

08 Two fiberglass reinforced polyester elements from the seats in the living room. © L. Beerkens

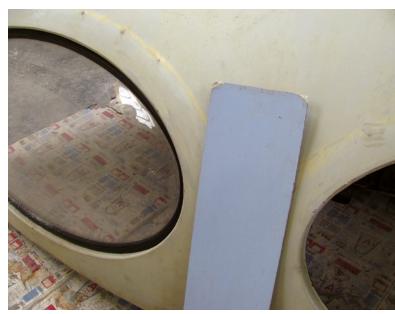
09 Detail with a small shelf from the interior, still bright blue, in front of the faded blue shell element.
© L. Beerkens

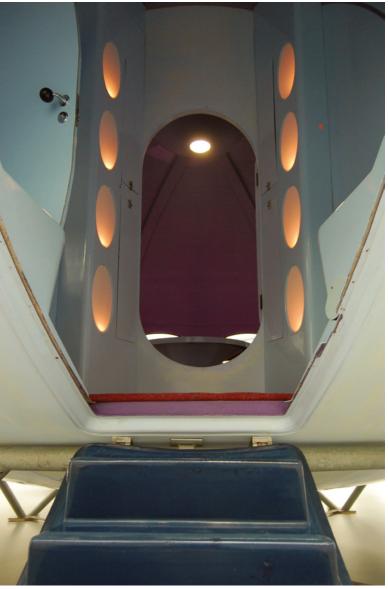
10 Futuro Prototype. View of the entrance after conservation, 2011. © N. van Basten
