HERITAGE IN DANGER

THE 'SHELTER' ALMOST SAVED BY HENDRICK DE KEYSER

The 'Shelter' was at risk of demolition: a fascinating story by the architect, Kor Aldershoff, and the restoration architect, Ann-Katrin Adolph.

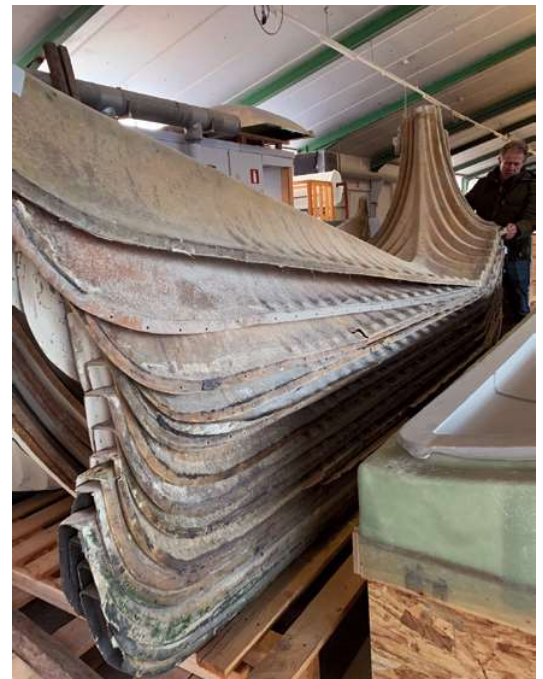
02 The 'Shelter' dismantled, under restoration. © Ann-Katrin Adolph

The restoration architect of the Association Hendrick de Keyser, Ann-Katrin Adolph, explains in an interview that they wanted to retain and restore the original materials in line with the aims of the Association. A specific difficulty in planning the works was related to the fact that the prototype was unfinished, and new problems and dilemmas

in conservation arose due to the unfamiliar material, GRP. The exposed outer surface of the elements could no longer be remediated, and a new layer of GRP had to be added. In some cases, substitutions were necessary.

Also, within the original shells were large voids/pockets which had to be filled. Left unattended, the ingress of moisture to these voids would eventually lead to the detachment of the glass-fiber and polyester. This was a complex but necessary intervention to ensure the conservation of the 'Shelter' prototype.
