RECOVERING THE HISTORICAL CONSTRUCTION AND MATERIALS OF ERIK GUNNAR ASPLUND'S STOCKHOLM PUBLIC LIBRARY

Patrick Fleming, Petronella Mill, Marcelo Rovira Torres, Anders Bergström

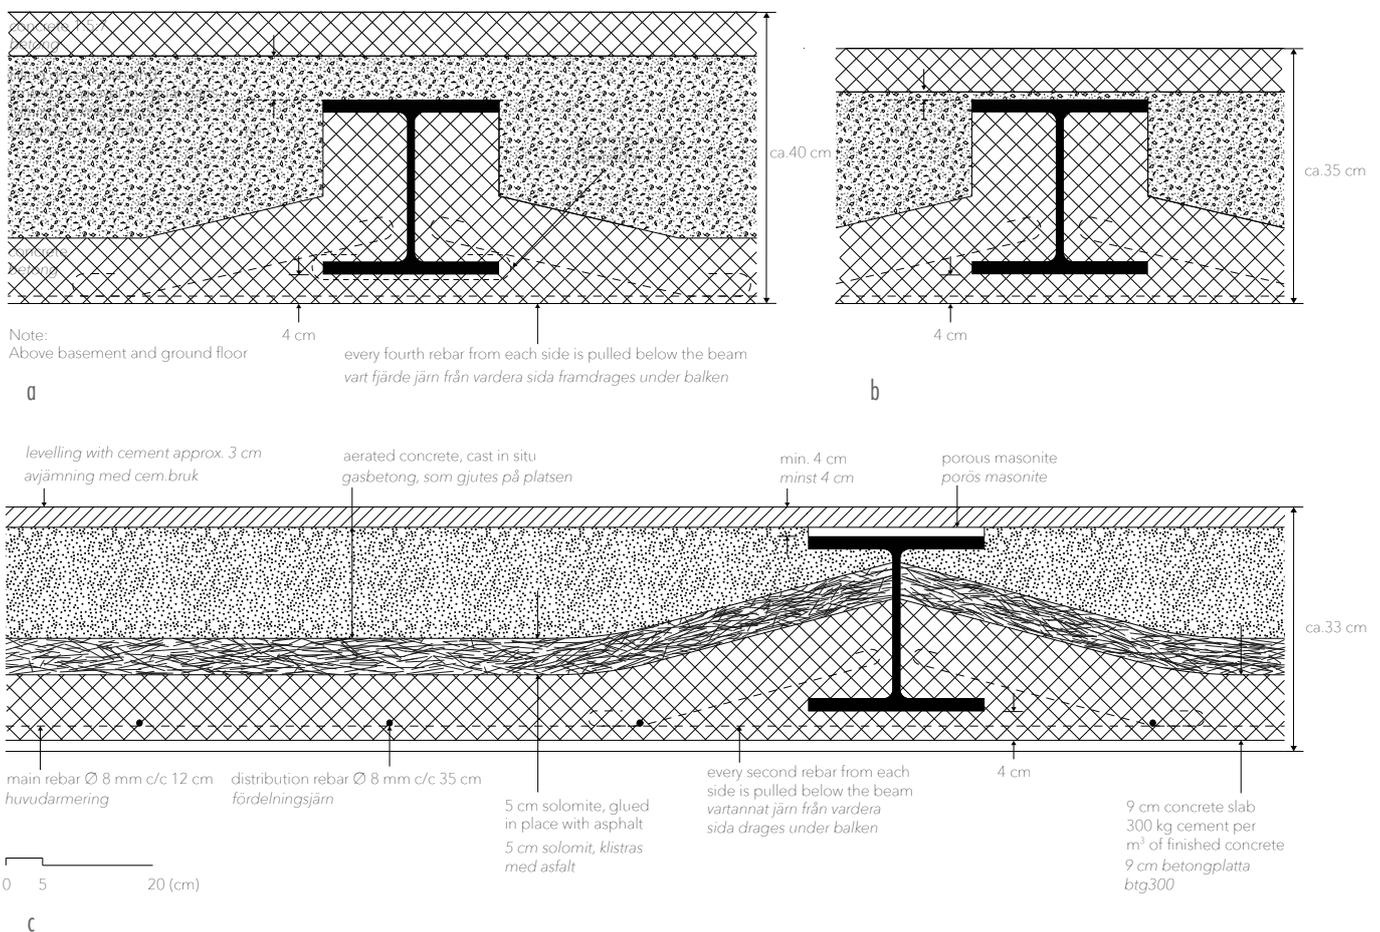
03 Floor sections of the library's original 1928 construction: (a, above left) reading room and (b, above right) upper office level, both drawn from the library's 1924 construction plans and Building Specifications text; (c, below) floor section for the western reading room, drawn from the library's 1931 construction plans. © Petronella Mill.

on subsequent text, [FIGURE 03] illustrates additional layers of the library's specified floor slab construction, including a filling of coke ash and limestone gravel, in equal parts, followed by a 6 cm subfloor poured with a relatively low-grade mixture of 1:5:7 concrete.² While these text-based descriptions of the library's construction can offer some important insights beyond basic construction plans, they still omit key information such as floor beam dimensions and positions, and more specific details concerning reinforcement that could have been decided spontaneously on the construction site.

the floor slabs between steel beams. Additionally, these plans illustrate a schematic section of a typical floor beam, with the beam's web poured and encased in concrete [FIGURE 03 a-b]. This section also notes a minimum concrete cover of 4 cm underneath beam flanges, with folded wire mesh around the lower flanges, closely matching the descriptions offered in the *Building Specifications* book (*Arbetsbeskrivning*, 1924, p. 19). These plans, however, provide additional construction details regarding concrete thicknesses, and reinforcement diameters and spacing; they include a table specifying 9 cm thick reinforced concrete slabs between most floor beams [FIGURE 04], where every fourth reinforcement bar in a floor slab should be pulled underneath the adjacent steel beam. Although these plans belong to the historical tendering process, and do not necessarily correspond to the actual revised construction plans that were used to build the library, they still give rare and valuable insight into a preliminary version of the library's planned construction details.

immediately revealed. As suggested in the previous 1931 construction plans and derived from non-destructive GPR measurements, the floor displayed steel beams with a multi-layered construction, including layers of reinforced concrete, Solomite, and aerated concrete [FIGURE 07]. Starting with the floor's exposed steel beam, the top flange had an overall width of 240 mm and a thickness of 18 mm. As the beam's lower flange was embedded in the floor's lower-most layer of reinforced concrete, the overall height of the beam profile could not be determined. Nonetheless, the beam's measured flange width and thickness correspond precisely to the historical standard 'Dip24' profile noted in the 1931 construction plans [FIGURE 03 d] (Swedish Institute of Steel Construction, 2020).

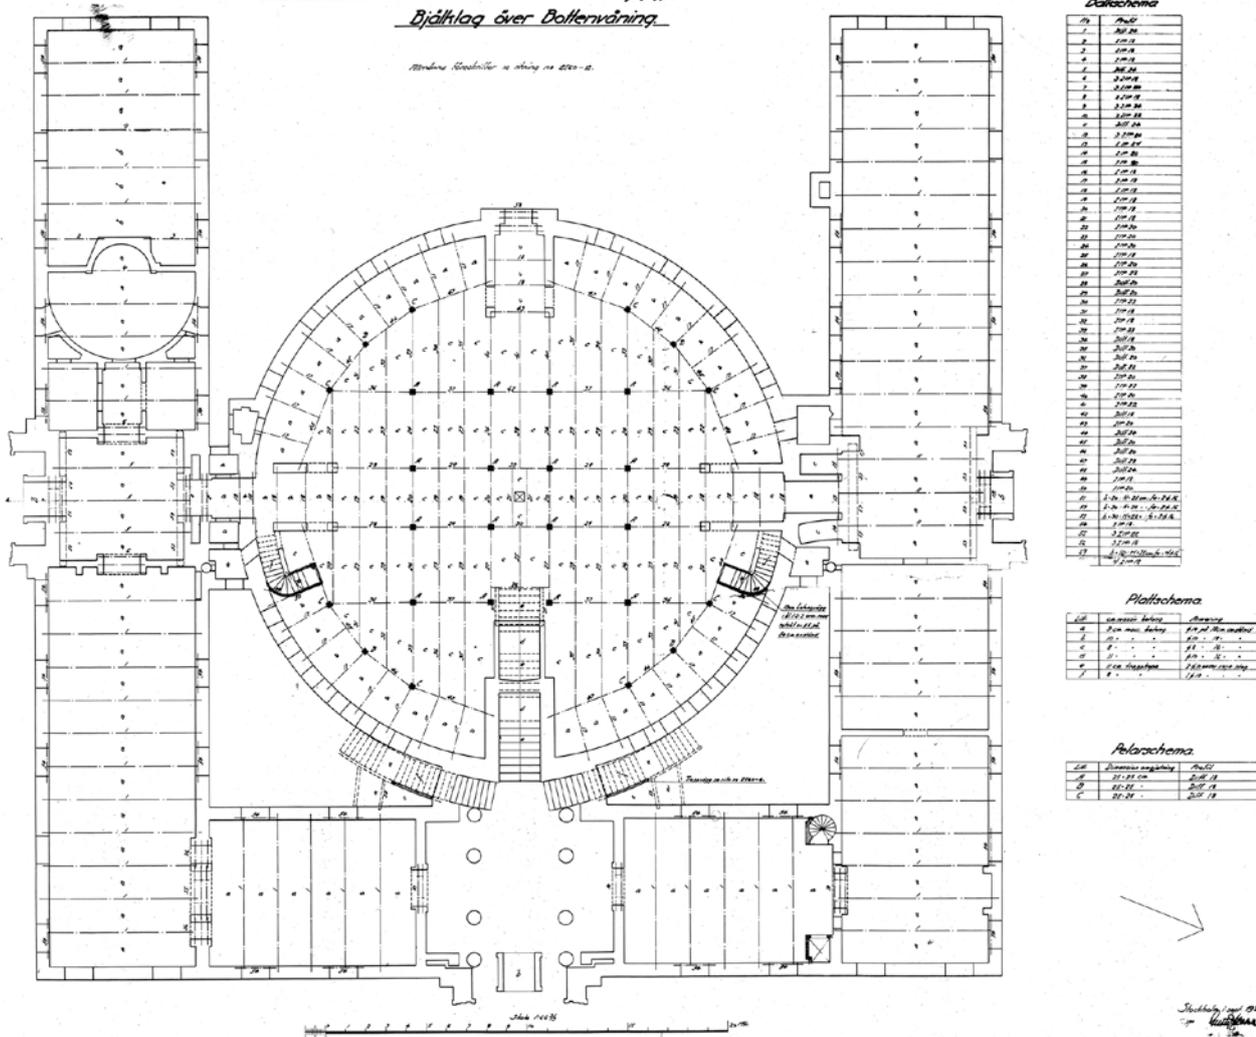
04 Digital copy of a construction plan of the Stockholm Public Library, signed by Gustaf Jilcke and dated September 1924. The plan shows floor construction details for the library's main entrance level, including floor beam locations and tables of specified beam profiles, concrete slab thicknesses, and reinforcement details. © Stockholm City Archives and courtesy of Sweco Sverige AB.

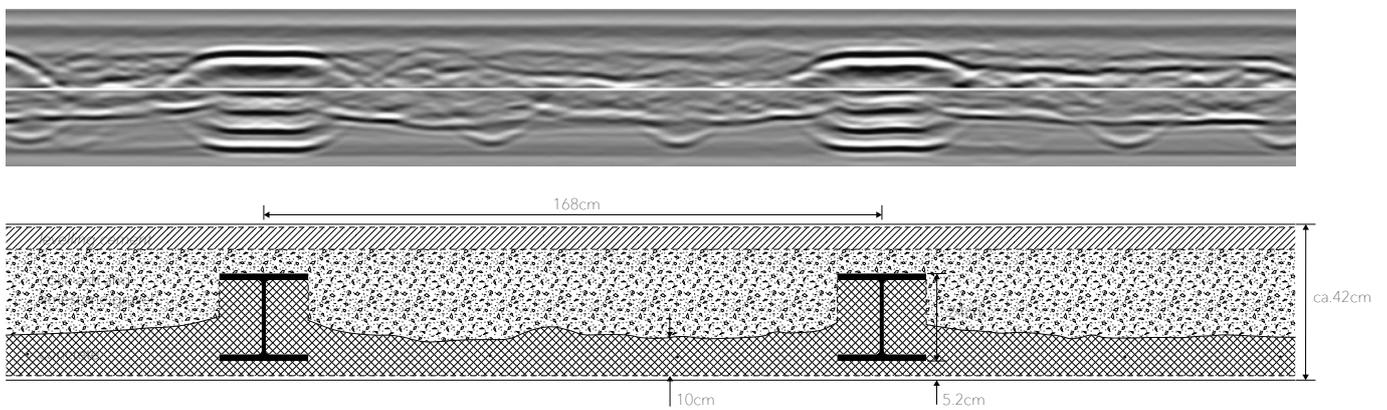
05 Representative GPR measurement examples (above) of the 1928 southern reading room floor and children's library ceiling on the library's main entrance level, and the corresponding floor section (below) interpreted directly from the GPR measurements. The total floor section depth of 42cm was measured directly from the authors' 3D point cloud model of the entire library. © Patrick Fleming.

GPR scanning was coordinated at the Stockholm Public Library in November 2021 and June 2022 with Northscan AB.⁵ The floors of all the library's reading rooms were scanned first to determine the location of steel beams. In each reading room, two parallel lines of scans were performed along the entire length of the room. [FIGURE 05] shows an illustrative measurement example where the beam locations and spacing can be estimated directly from the measured GPR data. To better understand the library's original 1925–1928 floor construction, the ceiling directly underneath the southern reading room was additionally scanned. These scans from below could be used to estimate the thickness of the lower layer of reinforced concrete in the reading room's floor slab, thereby complementing the previous scans on the floor above. From the representative measurement shown in [FIGURE 05], the lower concrete slab thickness is estimated to be about 10 cm from the GPR measurements, when a typical value of 5 is taken for the relative dielectric permittivity constant of concrete (Bigman, 2018, p. 28). Furthermore, the measurements yield a distance of about 5.2 cm from the underside of the lower beam flanges to the underside of the finished ceiling. Assuming a thickness of roughly 1 cm of render for the finished ceiling, the resultant concrete cover thickness estimate of about 4.2 cm from GPR measurements agrees fairly well with the 4 cm cover thickness noted in the library's 1924 construction plans and *Building Specifications (Arbetsbeskrivning, 1924, p. 19)*. Similar agreement can be seen between GPR measurements and the 1924 construction plans for the typical center-to-center beam spacing of approximately 165 cm in the southern reading room's floor. These results indicate that the overall structural concepts and construction principles seen in early construction plans were not significantly altered or updated before or during the library's construction process. These initial measurements further demonstrate the

overall usefulness of the GPR technique for determining the basic locations of steel elements and estimating concrete thicknesses. While the slightly sloping upper concrete surface directly next to the beams can be discerned from the GPR data [FIGURE 05], the measurements do not offer a sufficient resolution or a level of detail to determine if the webs of the floor beams have been encased in concrete. Here, we find both the usefulness of such GPR measurements and their limitations in terms of accuracy and detail.

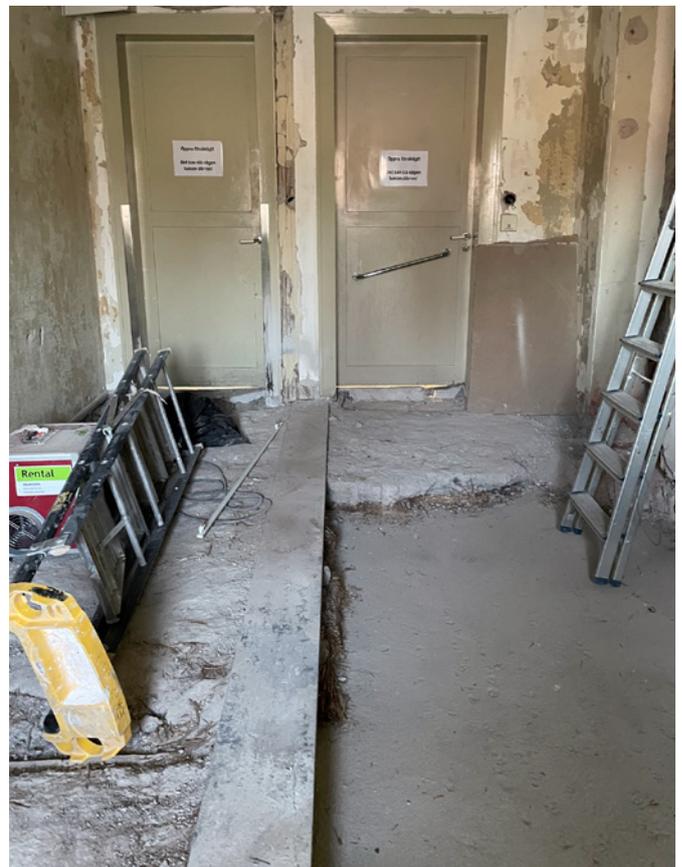
07 The local intervention and exposed layers of Solomite and aerated concrete materials in the library's uppermost floor in the 1932 western wing. © Marcelo Rovira Torres, 2022.

concrete [FIGURE 07]. The layer of Solomite measured approximately 50-60 mm thick, and being made of compressed straw, had a rather dry and brittle quality. The intervention process further revealed how the Solomite layer was originally manufactured with wire mesh to bundle and restrain the cross-section of compressed straw. It was precisely this steel mesh that was detected and noted as an unexpected result in the previous GPR measurements [FIGURE 06]. A more thorough review of the original French patents related to Solomite and its production further confirmed how such steel mesh was originally specified in the product's first 1922 patent by its inventor, Serge Tchayeff (Tchayeff, 1922). While Solomite has been discussed in previous literature more so as a thermal insulation material, it is important to note that Tchayeff also received a subsequent French patent in 1925 for using Solomite to construct 'sound-proof' floors (*Construction de planchers insonores*) (Raychine, Boumier, & Tchayeff, 1925). As this ceiling above the western reading room is an internal structure, with a storey of offices directly above, the use of Solomite here was certainly for acoustical reasons rather than thermal issues. The actual acoustic insulation performance of this historical construction remains an open issue to address in future work and a forthcoming publication.

Directly above the Solomite, the layer of aerated concrete measured approximately 9–10 cm thick. This thickness is notably less than the expected 14 cm of aerated concrete indicated in the 1931 construction plans [FIGURE 03 c]. With less aerated concrete poured on site, the actual floor construction displayed a much thicker layer of levelling cement directly above the aerated concrete. Compared to the ideally smooth surfaces of the aerated concrete drawn in the section of the construction plans [FIGURE 03 c], the actual historic material on-site featured a rather rough, uneven upper surface [FIGURE 07]. Upon closer inspection, the cross-section of this aerated concrete layer also had a porous, almost volcanic stone-like quality, and appeared to be slightly denser at the bottom than at the top of the section. Shrinkage and variations in the surface and materiality of historical aerated concrete were expected when considering the cast-in-situ process and extended curing time of the material. As noted in Axel Eriksson's 1923 American patent for producing aerated concrete, warm water could be used to speed up the chemical reactions during on-site curing of the aerated concrete, and workers on the library site in 1931–32 most likely followed this process (Eriksson, 1931). With Eriksson's subsequent patented development of autoclaved aerated concrete only a few years later in Stockholm, which has been well documented in both German and English literature (Hellers & Schmidt, 2011; Rychner, 1952; Schramm, 2008), far more uniform and smooth prefabricated panels

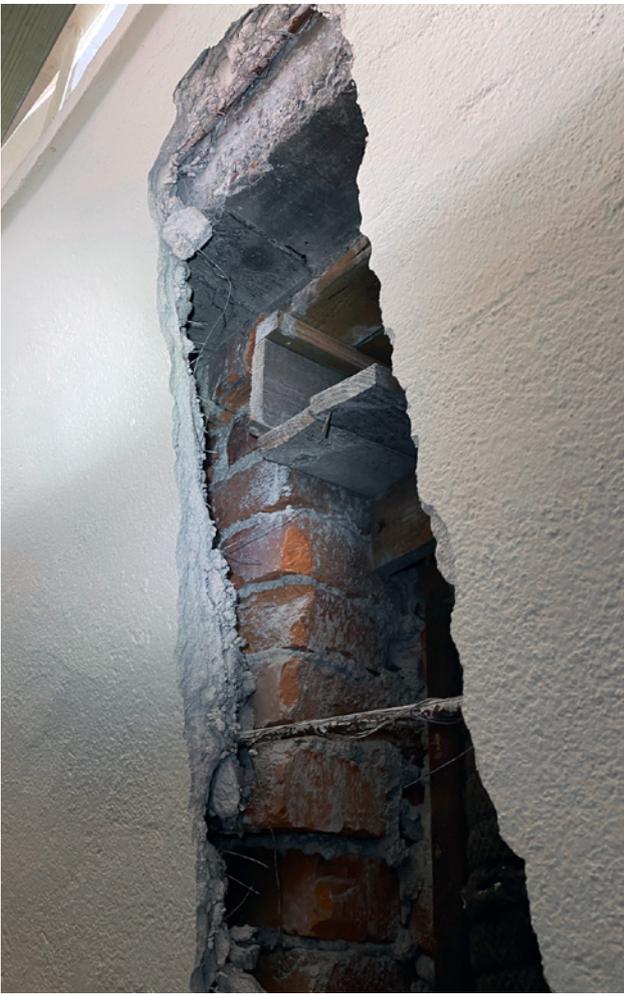
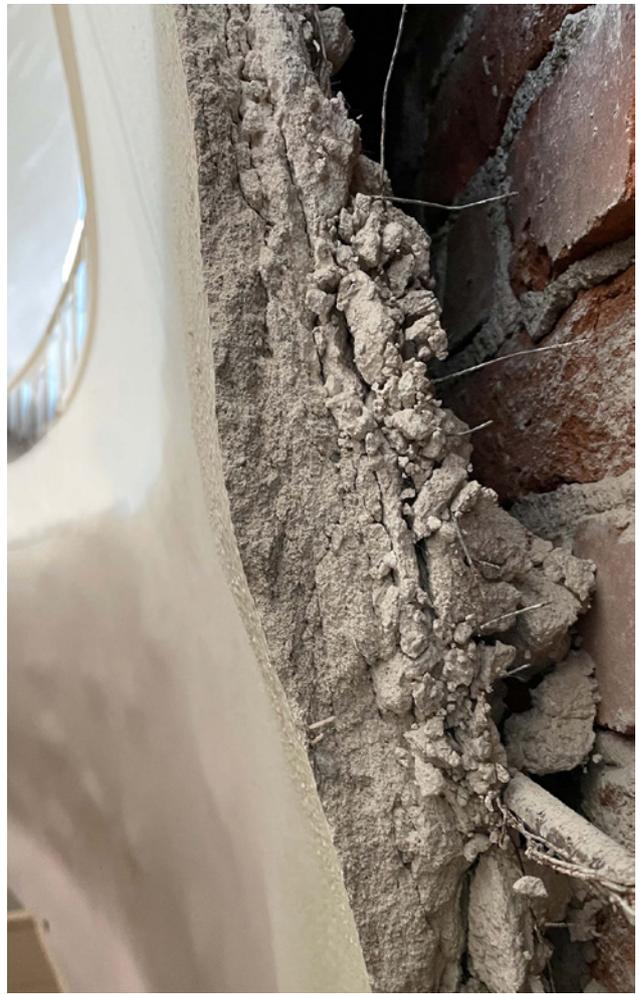
08 The rotunda wall intervention provided access to existing pipes for renovation purposes, while also revealing the wall construction and multiple layers of the wall's unique rendered texturing for research purposes. © Marcelo Rovira Torres, 2022.

The intervention process revealed how the rotunda wall's finish texture was rendered with multiple layers of lime-mortar with significant variations in thicknesses [FIGURE 08]. The rendered layers were applied directly on to the masonry of the curved rotunda wall, without any

additional protruding substrate. The first layer, acting as a parge coat, consists of a coarser render supported by a thin metal mesh with a grid of 20x20 mm. Because the parge coat was primarily used to even out the irregularities of the main brick wall, its thickness varies from several centimetres to being practically omitted in some places. The second layer is of a finer grain than the parge coat and again varies in thickness [FIGURE 08], from a few millimetres to approximately 30 mm. Before finishing with a basic layer of paint or lime wash, this second layer was effectively built up or thickened in localized areas to give a subtle depth to the wall's finish and texturing. Hence, by varying the thickness of the individual layers of the rotunda wall's rendering, the irregular and crafted texture of the rotunda wall was achieved.
