Restoration of Crown Hall

This essay documents the research of restoration and modifications to Mies van der Rohe's masterwork, Crown Hall, the heart of the Chicago campus of the Illinois Institute of Technology. Restoration was necessitated by 5 decades of use during which the building had fallen into major disrepair. During the restoration, practical and philosophical issues arose from the building's landmark designation by regional and national authorities. The essay describes the forensic research that preceded design, investigation and selection of alternate materials modifications to the building envelope. This includes a detailed description of modifications balancing original materials and systems with current codes.

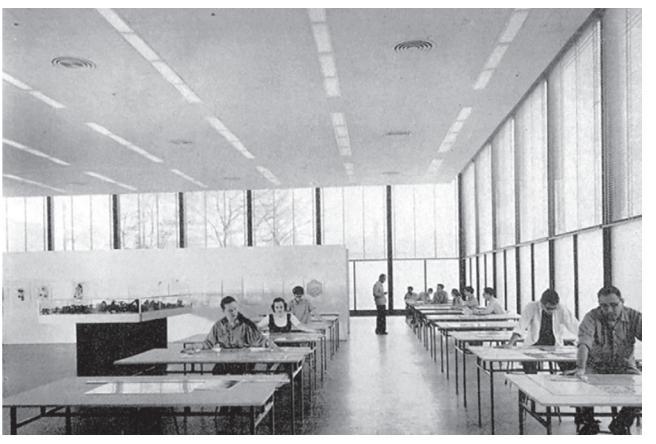
The review process focused on the steel and glass stop details of the façade where all of the building's elements steel, glass and paint - come together at a critical point. An exemplar of Mies van der Rohe's meticulous approach to construction, this detail required modification to capture and hold the replacement glass. Adherence to the highest level of historic preservation initially seemed to be at odds with the current code and safety requirements. The detail needed to change; but how to most appropriately choose the modification that would have no adverse impact on the historic building? Replacement of the glass presented a similar challenge. Glass and modified aluminum stops installed in 1975 were to be removed because they were not in keeping with the highest standards of historic restoration. The new glass needed to meet the current code requirement. More importantly, it needed to restore the building's

03 Mies van der Rohe, Crown Hall, Chicago, USA, 1950-1956. Detail drawing of original (left) and restored (right) glazing stop condition. © Krueck + Sexton, 2005.

The original $5/8 \ge 1^{1/2}$ inches (16 mm ≥ 38 mm) profile of the steel stops was maintained using all new materials at the lower level lights. This afforded a high degree of shop fabrication and finishing quality control while eliminating the need for costly specialized efforts to repair material or areas of material that had deteriorated through the years.

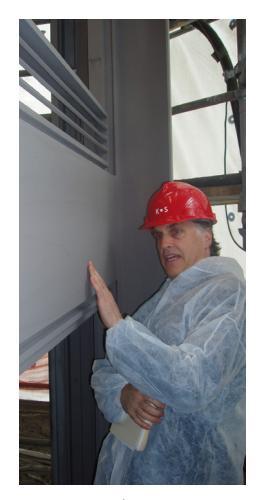
Mies van der Rohe, Crown Hall, Chicago, USA, 1950–1956. Restoration works.
© Krueck + Sexton Architects, 2005.

The restoration of the exterior steel consisted of removing and replacing steel that had corroded beyond repair, sandblasting the remaining steel frame and a three-coat paint system. The building's entry doors were removed and sent to the original manufacturer, Ellison Bronze Inc., for refurbishment then reinstalled with modern hardware and integrated security devices. Italian travertine for the entry porches was selected to match the texture, color and grain of the original stone.
