DETERIORATION, HARM AND CONSERVATION OF BUILDING PLASTICS HERITAGE

Robert Loader

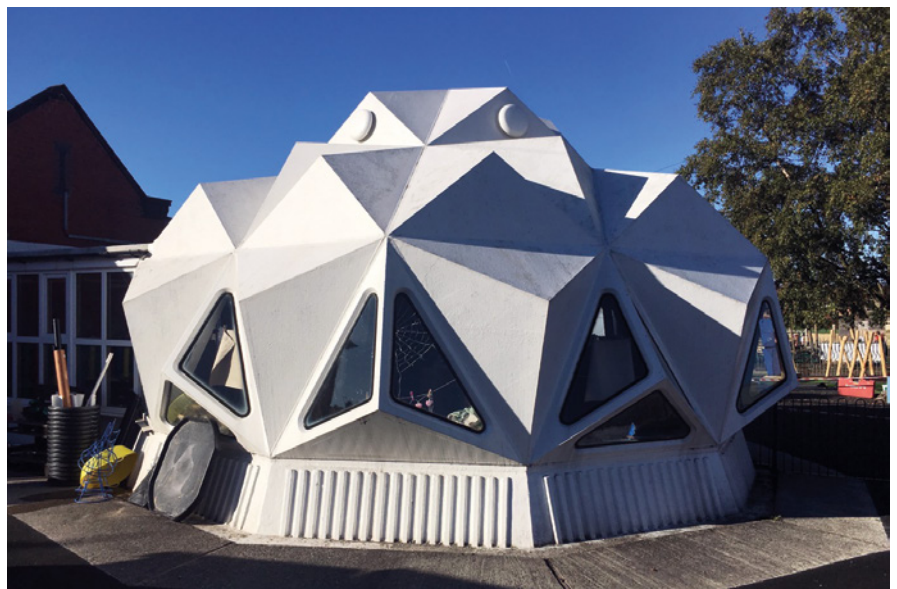
05 The classroom at Kennington Road Primary School, October 2018. © R. Loader

The classroom at Kennington School in Preston is a sophisticated assembly in a modified icosahedron shape using tetrahedral folded-plate structural panels [FIGURE 05]. The building was designed by Lancashire County Council Architects Department (Architects: Ben Stephenson and Mike Bracewell under Roger Booth, County Architect, and Structural Engineer Roy Partington). It was completed in 1974 as a prototype for a full-sized primary school that was never built due to the rapid increase in oil and hydrocarbon prices in 1973. The classroom was listed Grade II in 2017. It is unusual to use GRP in this way, and the engineer, Roy Partington was an important figure in the design team in promoting folded plate construction. Z. S. Makowski with L. Holloway of the University of Surrey were later appointed as consultants to assist with detailed analysis of the structural design, and Holloway and Partington subsequently published their work.⁹ The attention to economical structural design is exemplified in the very thin GRP walls: the main body of the panels is only 3 mm thick, increasing to 6 mm at edges and corners [FIGURE 06].

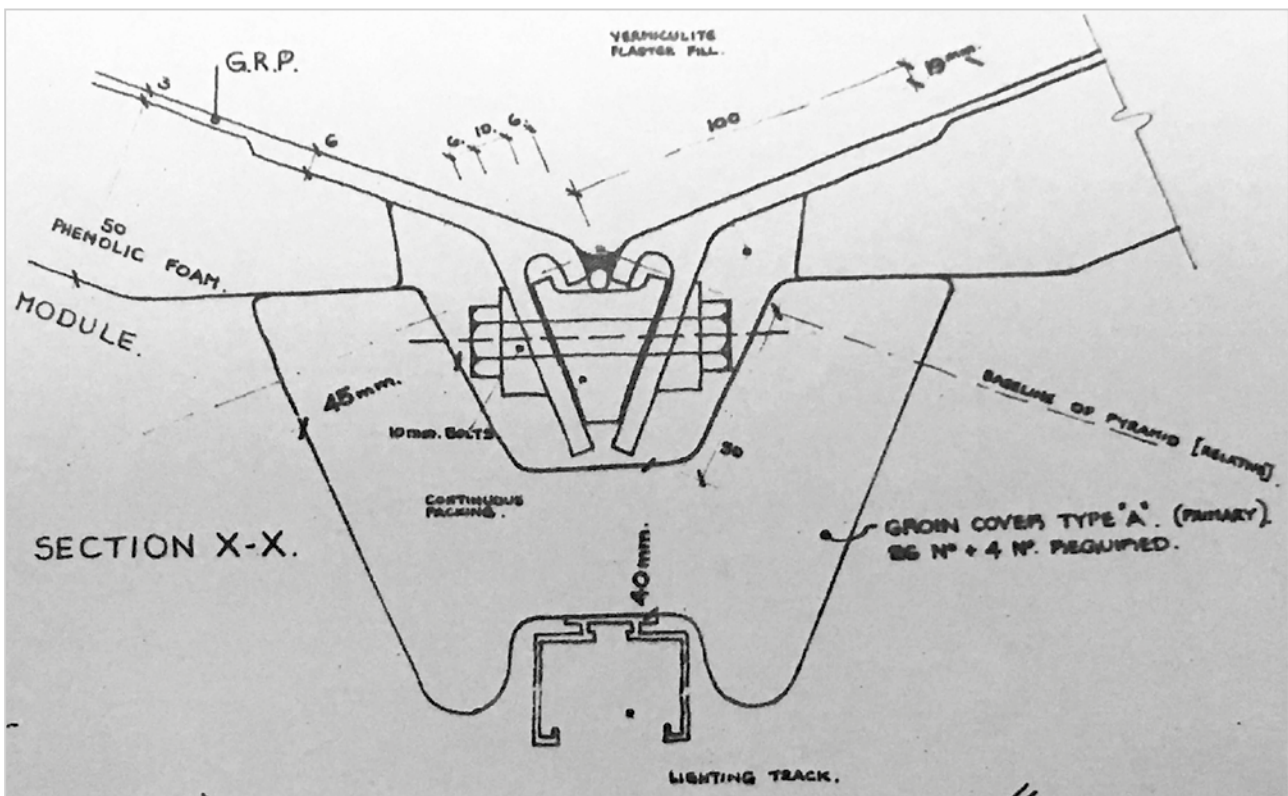
06 Panel to panel construction detail showing fixings through teak spacers and a phenolic grain cover to provide continuity of insulation and fire protection. Part of drawing titled, Prototype GRP Structure for Experimentation, file SMFu/1/4. © Lancashire County Council Archive

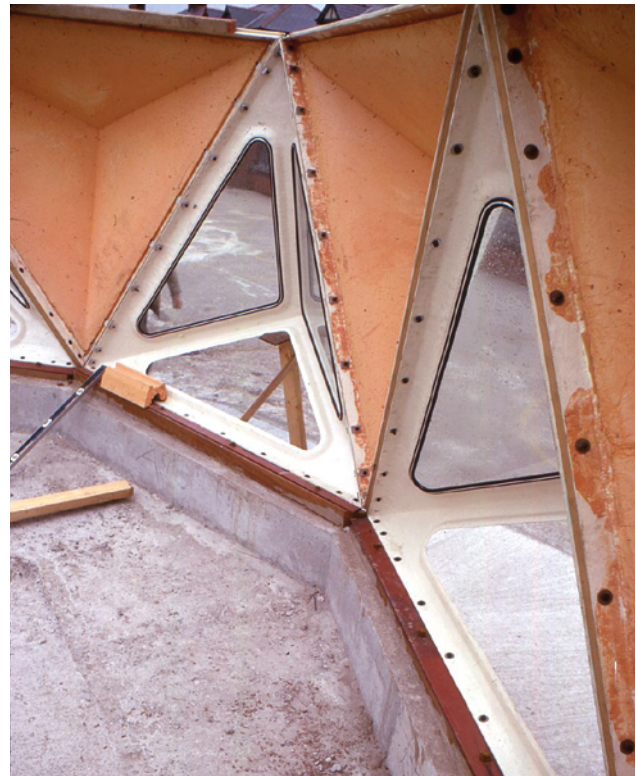
Phenolic foam was added to the Kennington School panels for thermal insulation and also to act as fire protection to the interior face of the single skin panels. After the outer face had been fabricated by hand lay-up, a timber form was located 50 mm away to create a two-sided mould for phenolic insulation to be injected between both skins.¹² An initial fire test found that the foam cracked and quickly caused the panel to fail.¹³ To solve this problem, a 'veil' of chopped strand glass-fibre matting was attached to the inner former which bonded to the inner face of the phenolic foam. When set, the inner panel was lifted off and the foam exposed. This reinforced face performed very well in subsequent fire tests and is still in place as an exposed (now painted) finish [FIGURE 07].

07 Photo during construction showing the pink exposed phenolic insulation (subsequently painted). The panel to panel joints are yet to be clad with pre-formed phenolic groins. © M. Bracewell
