Taro Amano, Musashi-Ranzan Country Club clubhouse, Koutou, Tokyo, Japan, 1961. © Shiraishi Kensetsu K.K., 1962.

Progress Report on the Musashi-Ranzan Country Club Clubhouse Conservation and Repair Work

BY MITSURU HIRAI

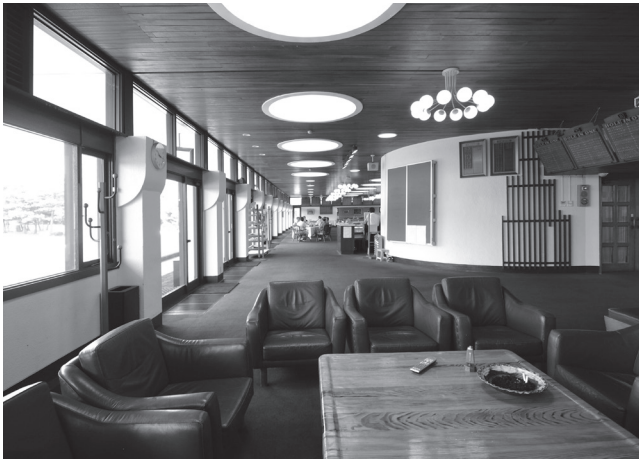
03 Taro Amano, Musashi-Ranzan Country Club clubhouse, Koutou, Tokyo, Japan, 1961. Lounge. © Drawing notes, 2011.

In the first stage, the store on the second floor was relocated to the area in front of reception on the first floor, and by turning the space where the store had been into a chat corner, a larger variety of spaces for players to spend time in was created. Together with this, the orientation of the reception counter on the first floor was changed, space was made for the store, and the place for settling payments for the store was changed to the reception desk. At the same time, part of the ceiling which had been blocked after the clubhouse was built was removed, and the original section was restored, along with the top lights.

lounge after the clubhouse was first built were removed, and chairs and tables which suited the enlarged space were designed. Further, the entrance of the conversation lounge was removed, the original state of the room was reproduced, and it was converted into a memorial room displaying the club's history. Further, at this time, two experiments were conducted. Firstly, the dark coating that was applied to timber parts after the clubhouse was constructed was removed, and the original clear coating was restored. Next, since current golf shoes mainly have soft spikes, the floor of the memorial room was changed from carpet back to flooring blocks, and members' reactions were observed. These experiments were performed well technically and reaction from members was favorable, so it was decided to make similar changes throughout the clubhouse in the third stage of work. At this time, the memorial plates which had covered the surface of walls all through the second floor were all removed, and a design which organized them into smaller spaces in the chat corner and the memorial room was created.

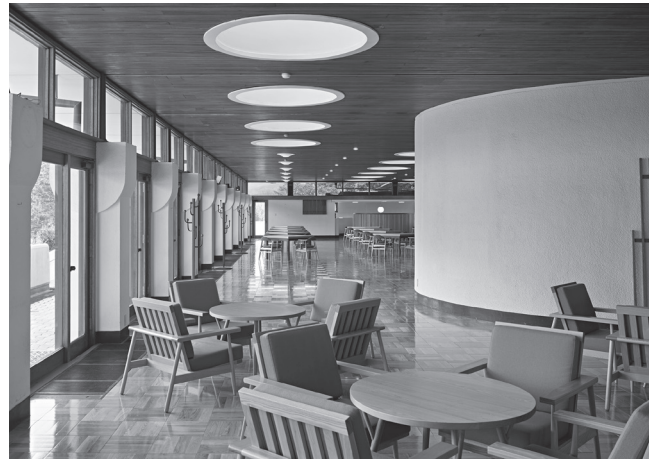
04 Taro Amano, Musashi-Ranzan Country Club clubhouse, Koutou, Tokyo, Japan, 1961. Conservation and repair project by Drawing notes. Dining room. © Koichi Torimura, 2014.

In the third stage, work was carried out on a large scale. Details of the work carried out include flooring, coating of timber parts, and reproduction of the original ceiling. Further, seismic reinforcement work was carried out. Firstly, the flooring all through the second floor was removed, together with the mortar foundation. As a method for raising the floor, while making sure there were routes for wiring, flooring blocks were reproduced as in the original construction, at the level of the original floor. Doing this enabled cracks in the concrete slab to be injected with epoxy, and in addition, removing the mortar reduced the weight of the floor. Further, coating was removed from timber parts, including those around window frames, and a clear finish was restored. Lighting fixtures such as chandeliers which were added at times after the building was first constructed were removed from the ceiling, and the original lighting fixture design was reproduced. At this time, there was a problem in that the original lighting fixtures had a low level of illumination. However, this was solved by inserting small LED downlights into the holes left after the chandeliers had been removed. As a result, the interior of the second floor brightened overall, and received a favorable reaction. The original tables that remained were reused. Also, the dining chairs which were not original were removed, and new ones were designed.

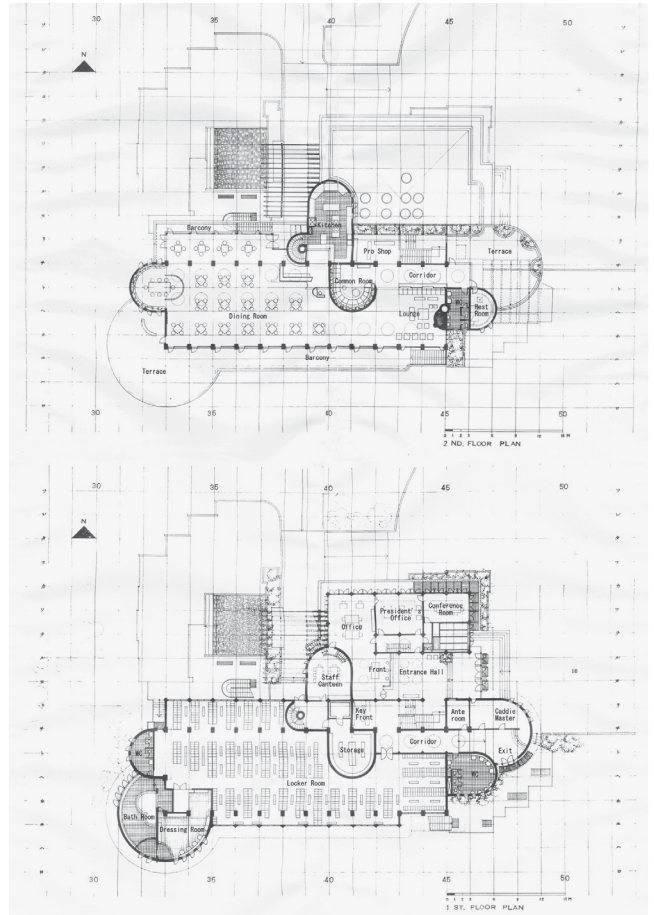
06 Taro Amano, Musashi-Ranzan Country Club clubhouse, Koutou, Tokyo, Japan, 1961. First and second plan showing the current state of building in 2011. © Drawing notes, 2011.

The documents show that extension and reconstruction work has been carried out five times, in 1978, 1981, 1985, 1993, and 2005. In 1978, the meeting room and men's bathroom were added to the northwest side using concrete construction. In 1981, the toilets on the first and second floors were repaired, and at that time the lounge on the second floor was turned into the ladies' toilets. Further,

at that time, the corridor in front of the ladies' toilets on the second floor was extended by one span. In 1985, the outdoor cart storage area on the east side was added. In 1993, the kitchen was added north of the center, using steel construction. In 2005, the interiors of the reception area, the toilets, the lounge, and the dining room were repaired. I was unable to identify when the outdoor grand staircase south of the center, the caddie master room on the southern side of the first floor, and the entrance canopy were added.

Following are the main details of the comparison of the clubhouse when it was first built with the state of the clubhouse as it was before the repairs that are being carried out. Concerning the basement level, there have been large changes in the way the rooms are used. Due to the increase in female players in recent years, the area of the ladies' locker room and the ladies' bathroom has been increased, and the area for employees has decreased. Following the addition of the men's bathroom on the first floor, the former men's bathroom was converted into the men's locker room. Further, due to the addition of a doorway leading from the men's locker room to the golf course, a new line of flow to the exterior was created. On the second floor, a grand staircase was added to the center of the balcony on the southern side, creating a main line of flow giving access from the exterior of the first floor directly to the dining room on the second floor. The meeting room and kitchen were added to the northern side, and along with that, the old kitchen was converted into a memorial room. Compared to the first floor, there were fewer additions and changes to the way rooms were used. In particular, the added sections greatly marred the external appearance of the original.
