The Marseille *Unité d'Habitation* after Le Corbusier: Or the Chronicle of a Permanent Construction Site

BY YVAN DELEMONTÉY

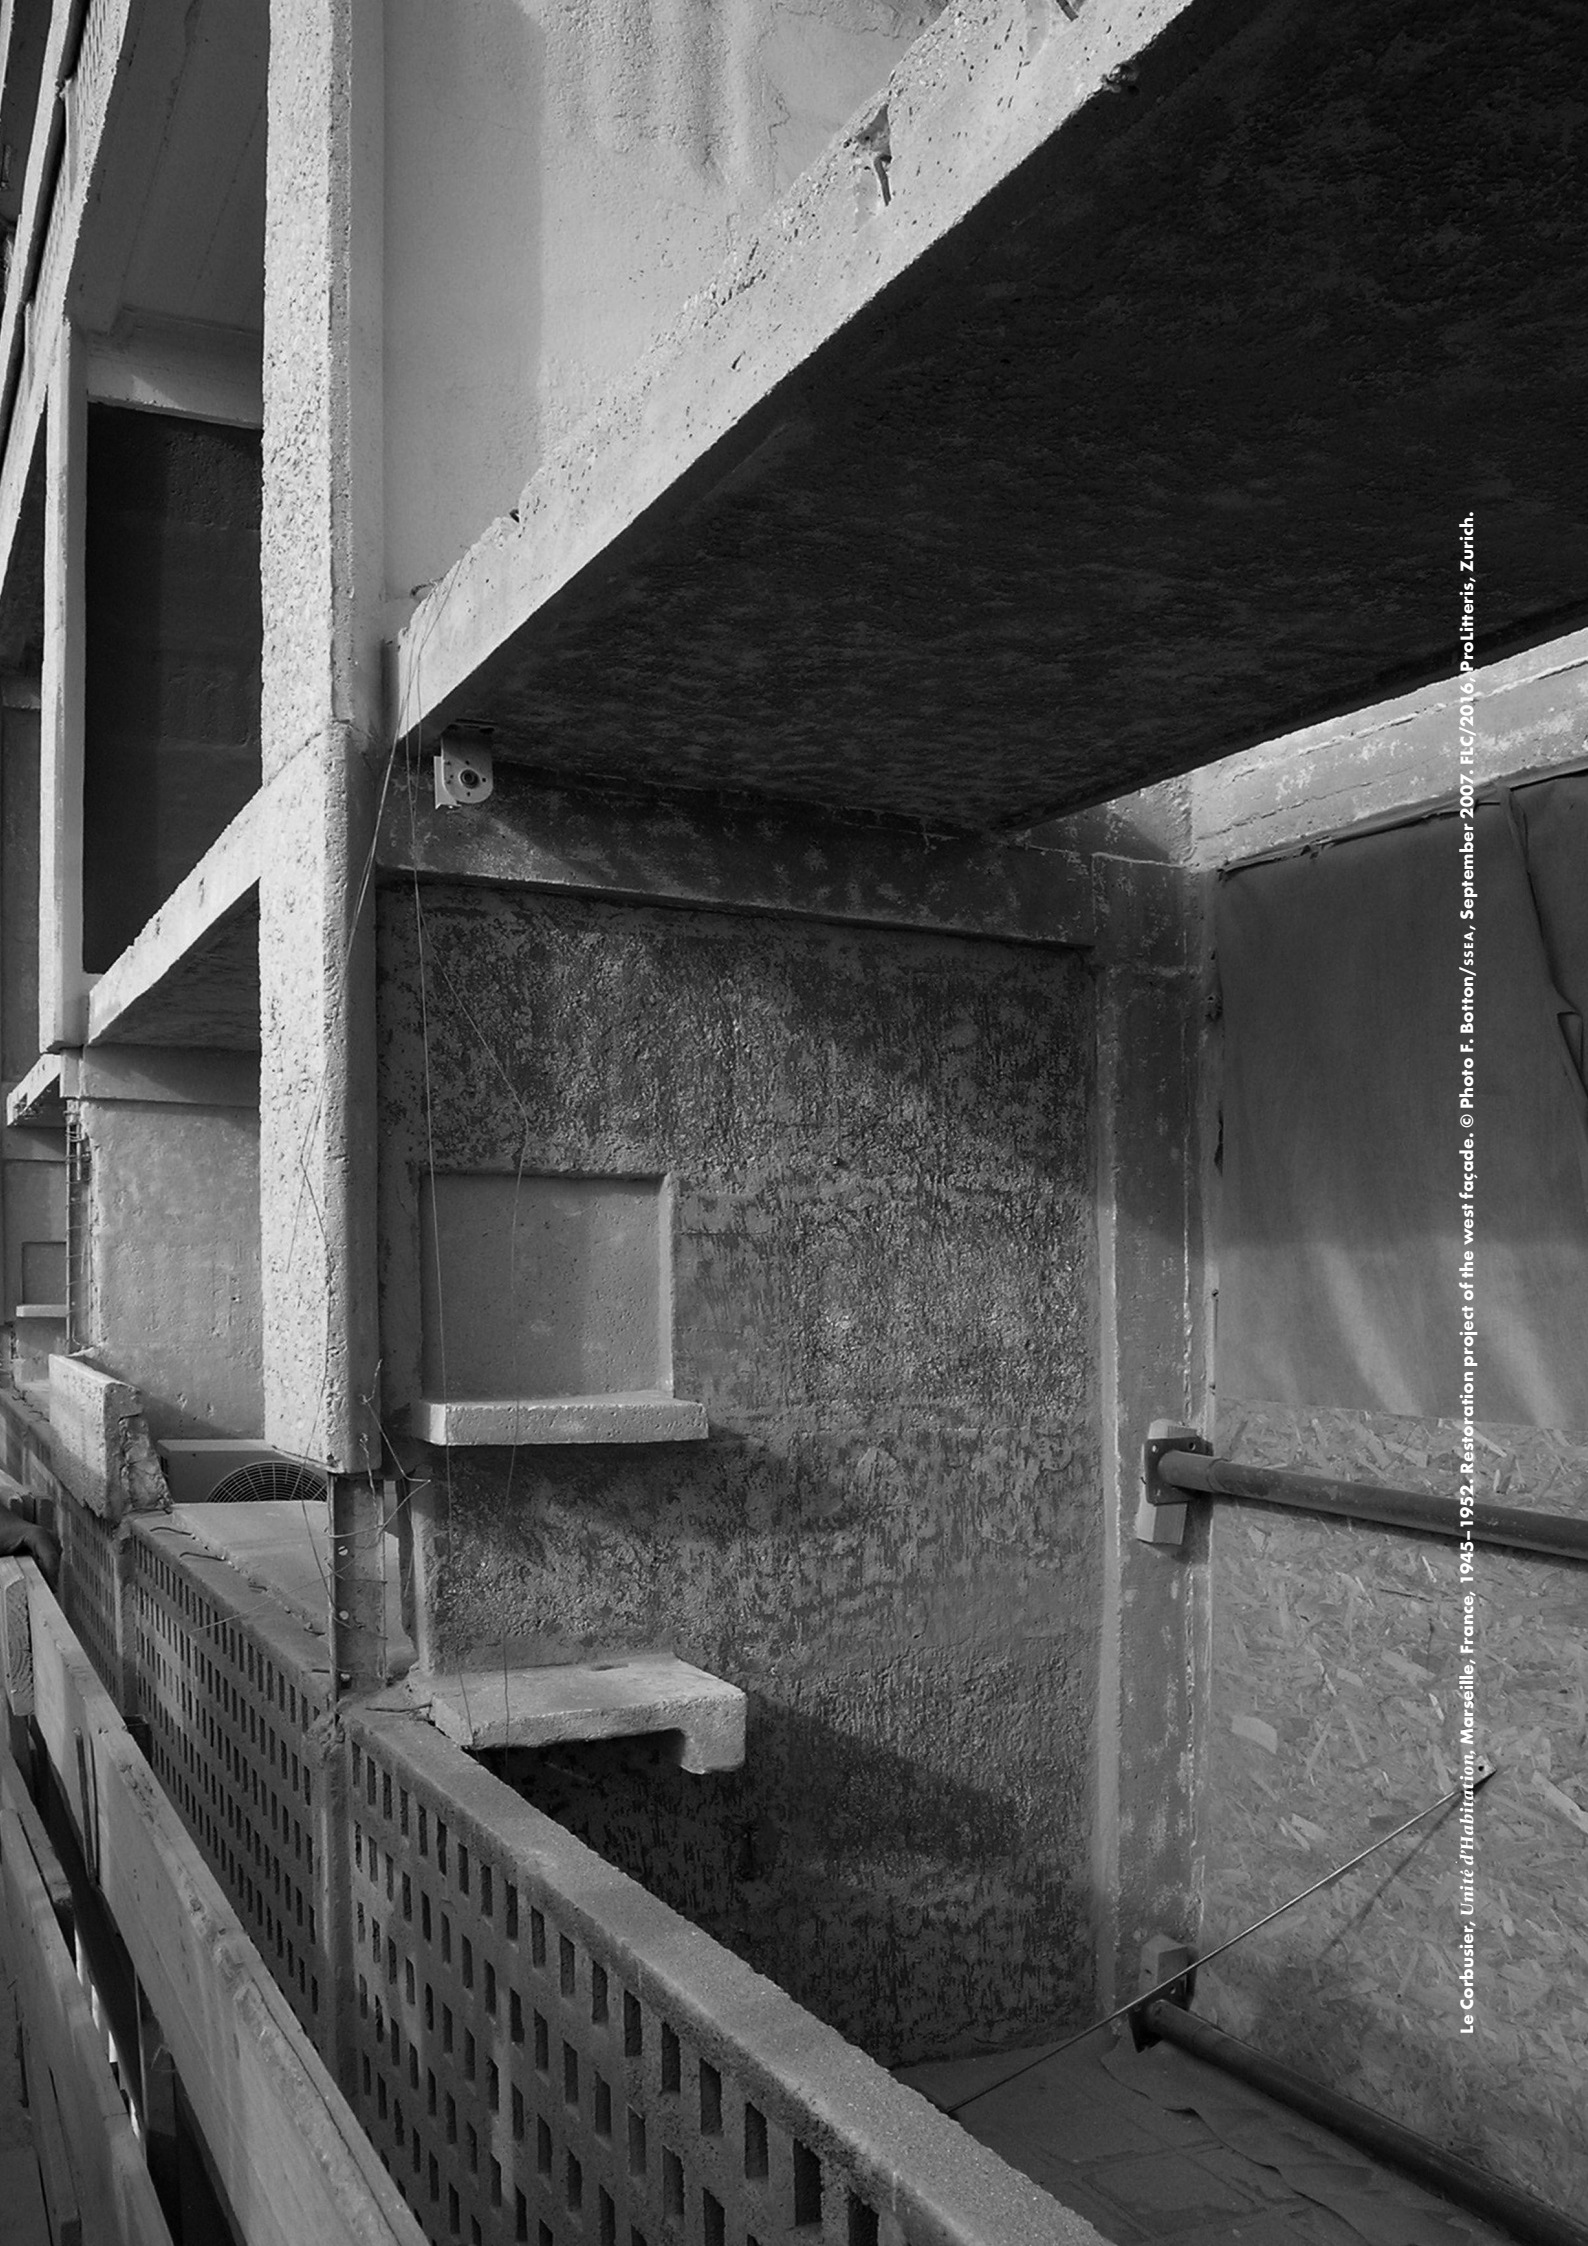
Le Corbusier, *Unité d'Habitation*, Marseille, France, 1945–1952. Restoration project of the west façade. © Photo F. Botton/ssea, September 2007. FLC/2016, ProLitteris, Zurich.

Launched in 2001, the restoration of the west façade was an opportunity to test the validity of this approach. A trial section (2001-2006), including the pilotis, was first chosen to develop the technical solutions essential to carrying out the work on a larger scale. Diagnosis and an accurate survey of the damage (fissuring, crumbling of the concrete caused by corrosion of the rebars, spalling, etc.) then revealed the fragility of the concrete, which suffered from “numerous pathologies with a low degree of severity”⁹. In addition to conventional methods, involving replacement of the areas affected, more advanced repair techniques were adopted, such as dechlorination and electrochemical realkalisation of the *pilotis*, or preventive impregnation with corrosion inhibitors applied to many of the prefabricated elements (vertical *brise-soleils*, railings, façade cladding panels, etc.). Unlike the *Maison Radieuse* at Rezé, where almost all the façade elements were changed in the late 1990s, here only the worst affected parts were removed and replaced with identical panels. An on-site prefabrication workshop was installed for this purpose beneath the *pilotis* at the foot of the building. In addition to physically restoring the façade, the work included the renovation of its original polychrome finish, altered over time, which rapidly emerged as a “defining issue in the relevance of the project”¹⁰. Thanks to careful study in the archives and stratigraphic surveys, the initial distribution and range of colouring appear to have been restored.

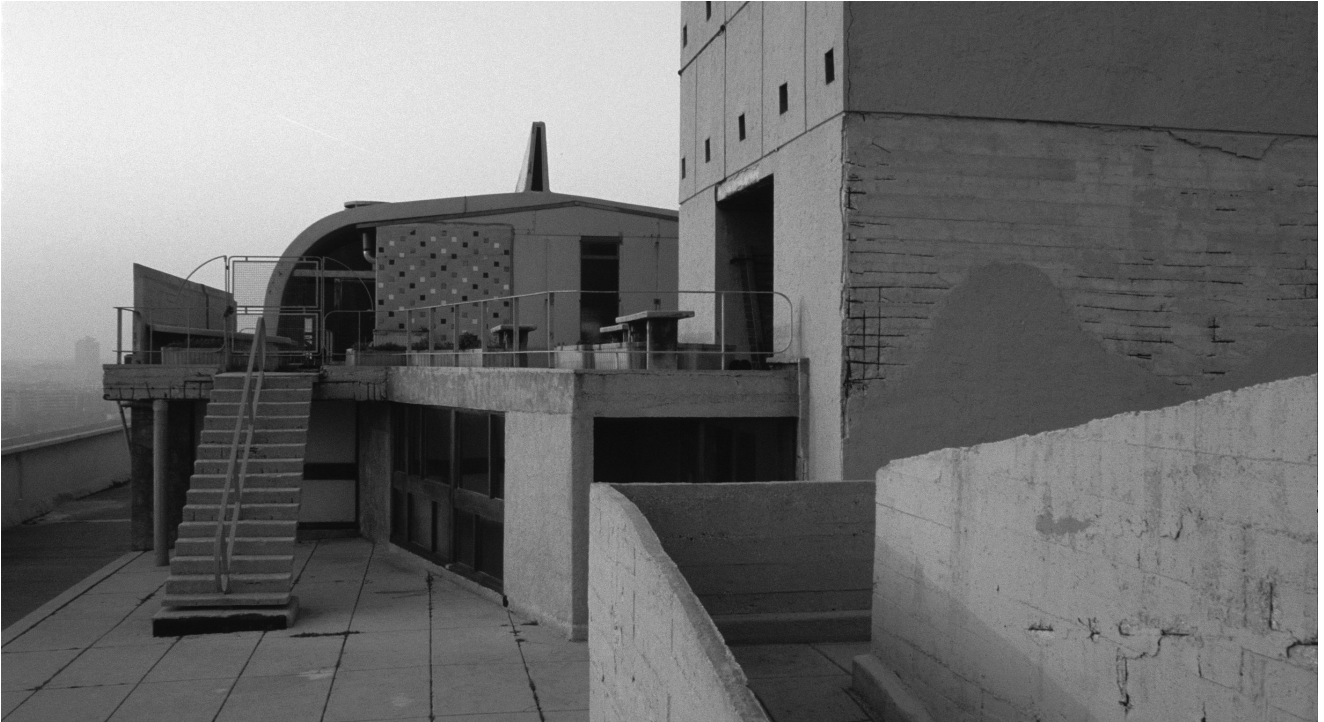
01 Le Corbusier, *Unité d'Habitation*, Marseille, France, 1945-1952. State of the rooftop terrace in the 1980s. © Archives of architecture of the *Université de Genève*, Bruno Reichlin fund (slide library). FLC/2016, Prolitteris, Zurich.

When work on the west façade was completed, an ambitious program to restore the roof terrace and its structures was launched in 2008. The preliminary study by the chief architect referred to “repeated infiltration that cannot be dealt with piecemeal”¹¹. Passing severe judgement on his predecessor’s method of intervention, and instancing the chronic deterioration of the terrace, the architect invoked the recent example of the renovation of the roofing of the *Unité d’Habitation* at Firminy to support the need for the building to be completely re-waterproofed and the cladding of the ceiling slabs restored to their original state. Work continued in 2010–2011 with the necessary restoration of some emblematic elements that were part of the roof, such as the planters, benches, ramps, theater and other *formes libres* [“free-formed objects”] designed by Le Corbusier. The two major concrete ventilation stacks, badly decayed, were made the subject of a thorough technical study that led to the structural reinforcement of their walls, repair of the damaged parts, and a general realkalisation of the concrete. The parasitic kiosk (a locker room) built in 1967 on the solarium terrace was demolished. The roof of the gym, a major component of the composition of the roof terrace, was completely rebuilt in order to prevent the infiltrations which had spread damage continuously ever since it was first built.

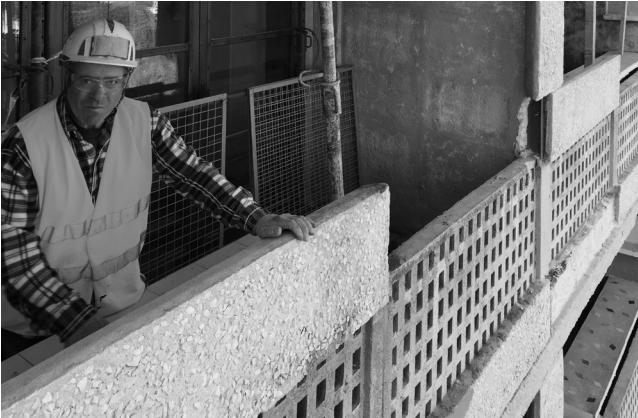
02 Le Corbusier, *Unité d'Habitation*, Marseille, France, 1945-1952. Work on restoration of the east façade. Replacing the prefabricated cladding of the loggias rebuilt identically. © Photo F. Bolton/ssea, November 2015. FLC/2016, Prolitteris, Zurich.

Currently it is the turn of the façade to be restored. Begun in spring 2015, the work is following essentially the same procedure as the restoration of the other façade, the degree of decay observed being equivalent on each side of the building. Some improvements have also been introduced, such as optimising the phasing of work to minimise the inconvenience to the occupants or inserting stainless steel

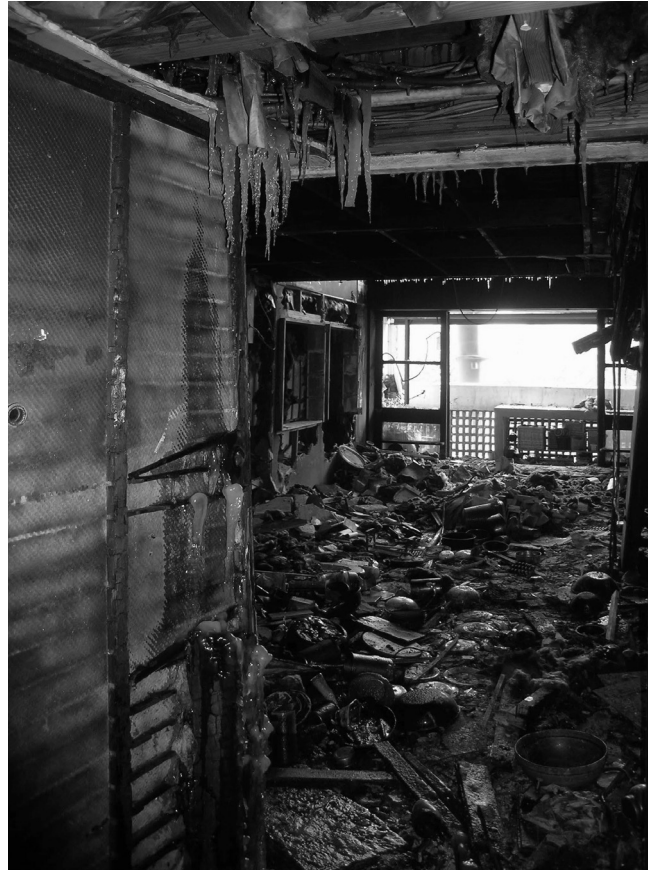
03 Le Corbusier, *Unité d'Habitation*, Marseille, France, 1945-1952. One of the apartments most damaged by the fire. © Photo F. Bolton/ssea, February 2012. FLC/2016, Prolitteris, Zurich.

On 9 February 2012, a violent fire destroyed several apartments and hotel rooms in the *Unité d’Habitation*. The statement of damage revealed “the weakness of the internal structures in the wooden walls and the utility ducting that spread the fire”¹². Represented in the press as a “fire trap”, Le Corbusier’s building then raised the issue of the fire regulations even more sharply and rekindled debate about the waivers it had benefited from because of its unusual nature and its heritage status. Delayed by the need to remove asbestos and decontaminate the blighted areas, the diagnosis of the chief architect drew a comprehensive picture of the damage affecting the structure and utilities of the building, all due to the fire and smoke as well as the effects of the intervention of the emergency services and systems (flooding caused by the fire hoses, landing doors demolished with axes to evacuate the inhabitants).

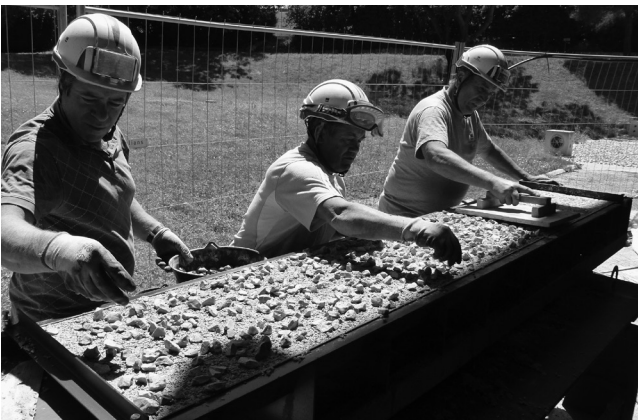
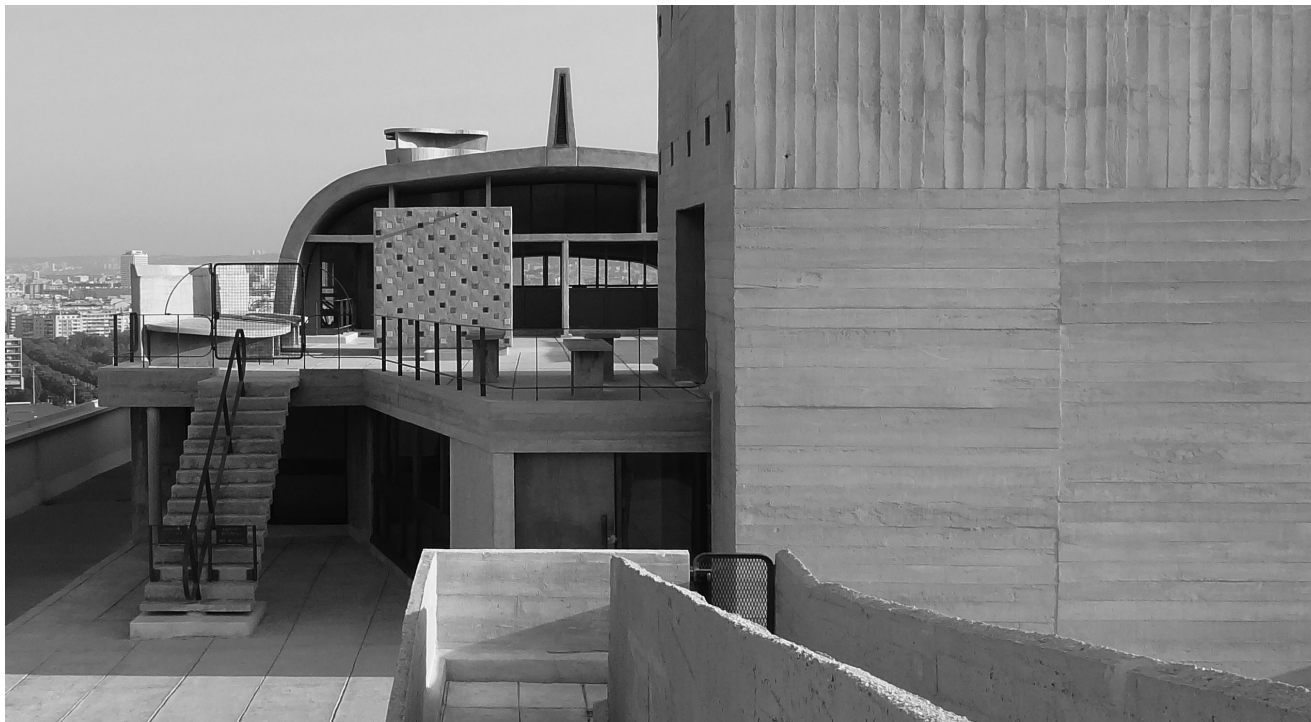
04 Le Corbusier, *Unité d'Habitation*, Marseille, France, 1945-1952. Work on restoration of the east façade. Prefabrication on site of the reinforced concrete cladding of the loggias. © Photo F. Bolton/ssea, November 2015. FLC/2016, Prolitteris, Zurich.

fibres to facilitate the installation of the concrete elements that need to be reconstituted.

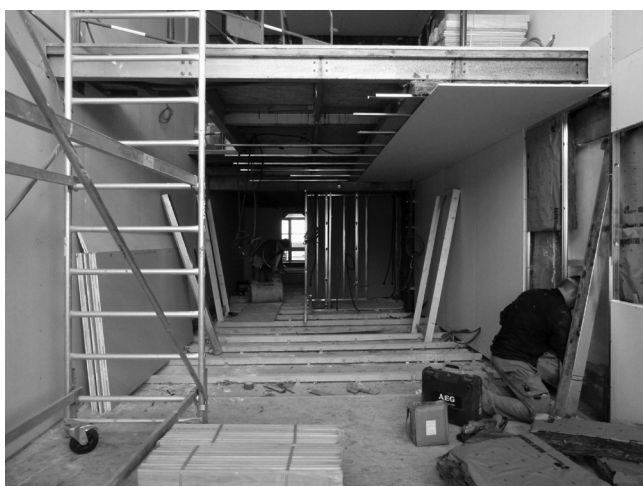
06 Le Corbusier, *Unité d'Habitation*, Marseille, France, 1945-1952. Reconstruction of fire-damaged apartments. Installation of the firewall partitions of precast gypsum panels. © Photo F. Botton/ssea, March 2014. FLC/2016, Prolitteris, Zurich.

Developed with the idea of preserving the decayed original elements, whenever this was possible, the reclamation project deals with both the impacted public areas (façades and internal “streets”) and the units completely destroyed [*hypersinistrés*], namely 8 duplex apartments, 2 studio apartments and 2 hotel rooms¹³. With regard to the reconstruction of nine of the apartments, it should be borne in mind that they are not listed, but the work was based on an agreement with the owners to restore the original architectural layouts of the interiors while incorporating the necessary technical improvements, especially fire protection. This entailed negotiating compensatory measures case by case with the security services, for example to enable the new landing doors to comply with the fire regulations while maintaining the original design characterised by the lack of surrounds, or the intermediate floors in wood and metal for the residential units to be remade new without altering their *Modulor* dimensions. The whole of the integral furniture was reproduced exactly, as were the *Prouvé* model stairs, the kitchen units designed by Charlotte Perriand (including the parts in diecast aluminium), or again the remarkable glass panes that open onto the loggias. In 2007 the many challenges to be faced and difficulties to be overcome already foreshadowed the “transcript” of a standard cell of the *Unité d’Habitation*, later presented in the modern and contemporary gallery of the *Cité de l’Architecture et du Patrimoine* in Paris.¹⁴ Begun in September 2013, the reconstruction work was completed in the autumn of the following year, the choice of the polychrome finish having been finally left to the residents in the absence of reliable information on the subject.

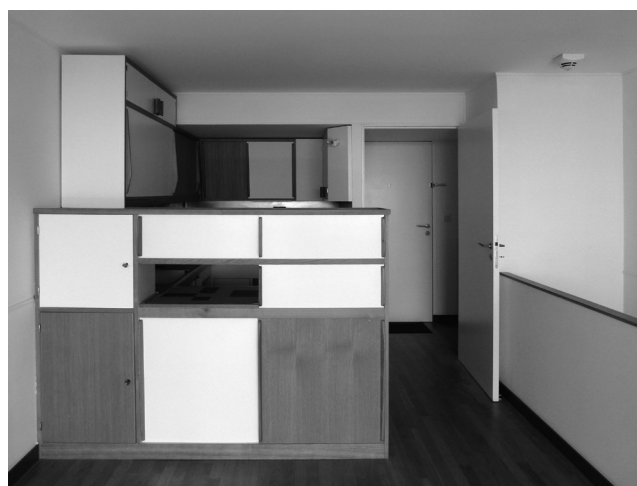
07 Le Corbusier, *Unité d'Habitation*, Marseille, France, 1945-1952. Reconstruction of fire-damaged apartments. A kitchen and its furniture fully rebuilt identically. © Photo F. Botton/ssea, September 2014. FLC/2016, Prolitteris, Zurich.
