Should Le Corbusier's E.1027 murals be considered as "historical monuments"?

BY AGNÈS CAILLIAU

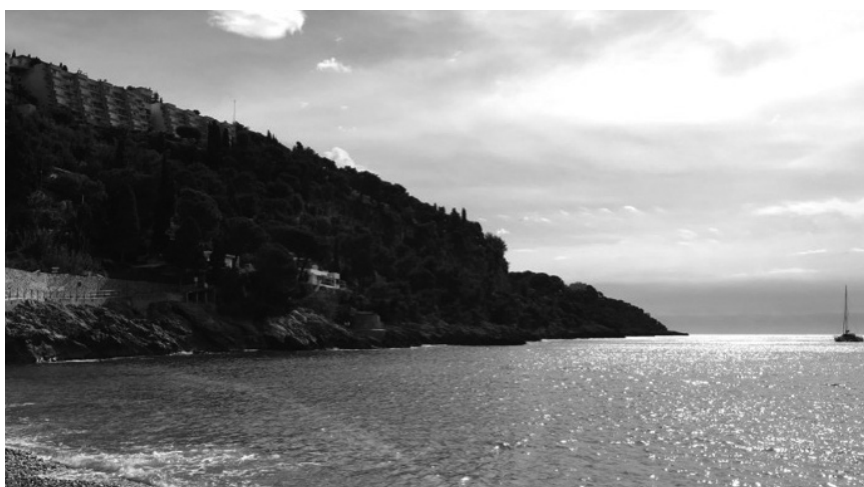
01 General view of *Maison en bord de mer* E.1027 in Roquebrune-Cap-Martin (toponymic name: brown rocks), France. © Agnès Cailliau, 2019.

Twenty-five years later (27 march 2000), the French Ministry for Culture and Communication issued a new decree that superseded the older one giving it the name of "*La Villa E.1027 d'Eileen Gray*" as an historical monument in its entirety, including the garden and lands. Thus granting it the maximum protected status available, and naming its designer, which is rare enough to be worthy of note (Figure 01). The name of the creator of E.1027, the designer Eileen Gray, was

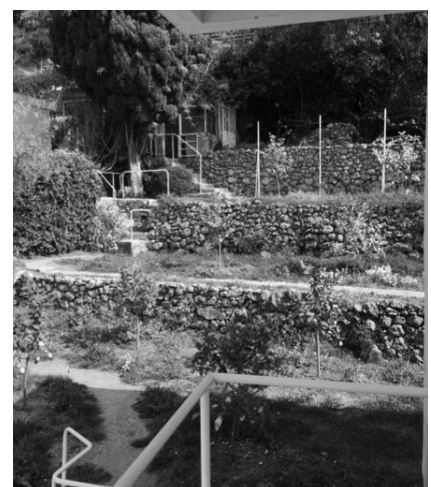
02 Path leading to the *Maison en bord de mer* E.1027, Roquebrune-Cap-Martin, France. © Agnès Cailliau, 2019.

The entrance, a pedestrian-only access, leads us to “*La Maison en bord de mer*” grounds, via concrete steps. As an introduction, waves, little pebbles and fish swimming have been drawn in the fresh mortar, with simplicity and poetry, Eileen Gray’s deep qualities. See the hand rail made of tubes. Minimalism is obviously already present, anticipating the whole property’s atmosphere. The “tiny house” is built on narrow terraces held up by dry stone walls (Figure 02).

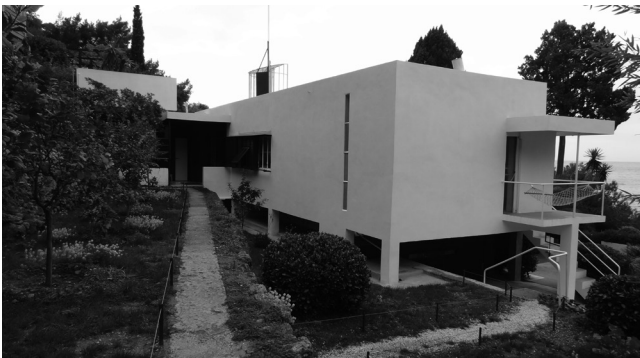
03 E.1027, view of the main entrance. © Viviana Andrada Baumann, 2016.

The main entrance of E.1027, at the end of a concrete path that runs parallel to a terrace, was also used as a dining area, as it is next to the kitchen and sheltered from the wind and the sun.

In a very detailed analysis of this painting, Tim Benton sees an allusion to Yvonne, Le Corbusier’s wife, who loved knitting. The existence of this painting in the main entrance is disturbing.

The painting in the entrance clearly dominates the area that leads to the interior, the dazzling and contrasting colors – green, red, blue, yellow, brown and light blue, – in the shadows of the entrance can be interpreted as wanting to revitalize the wall. However, it is difficult to construe this painting as anything other than dominating the villa⁹.

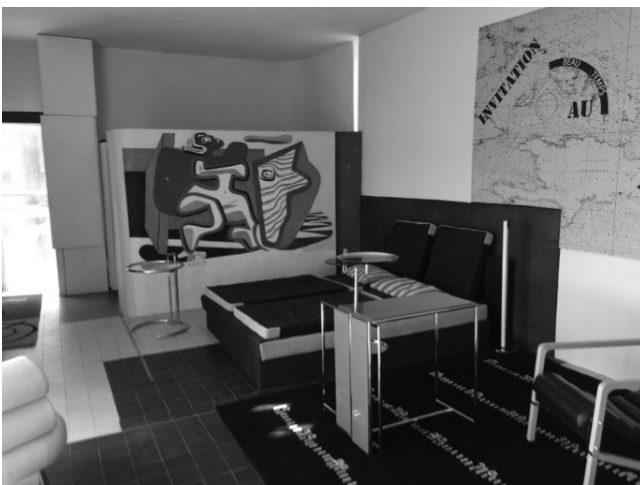
04 Le Corbusier, “*La grande pièce*”, or living-room in E.1027, *Maison en Bord de mer*, Roquebrune-Cap-Martin, France, mural referred to as “*Peinture murale de la toilette complète*” by P.A. Gatier & M.O. Hubert, or “*La première peinture dans la salle de séjour*”, according to Tim Benton. © Agnès Cailliau, 2017.

It is a version of a 1938 mural that brings to mind previous paintings known as “The Figure with the Yellow Door” and “Figure in front of the White Door”, according to Tim, who describes it as the

This painting is, therefore, related to the house where Le Corbusier and his wife spent their holidays, in Cap Ferret, in the Arcachon Bay. The impact of this painting is even more “violent” because Le Corbusier placed it at the end of the long diagonal line of the living room, so that it is immediately visible and imposing on the field of vision of anyone entering the house.

The mural renders Eileen Gray’s concept of the E.1027 living-room impossible.

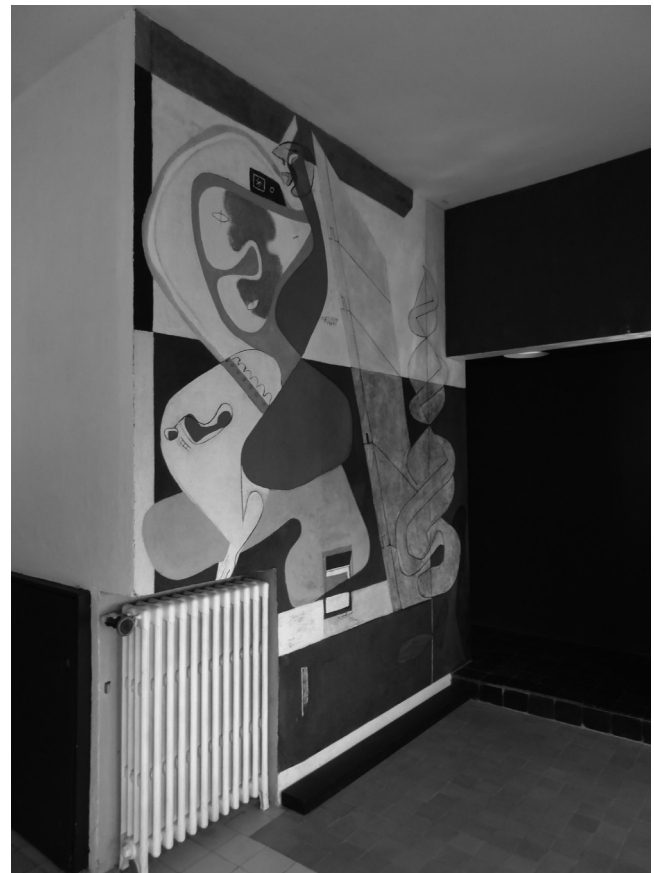
05 E.1027, view of the dining area, 1939, a variation on “*Spirales géométriques*” 1932. © Viviana Andrada Baumann, 2016.

In August 1939, one year after the first mural, Le Corbusier painted another mural in the interior dining area — “*coin salle à manger*” — that covers the entire wall (Figure 05).

The presence of the radiator in the corner of the painting does not seem to bother the painter, even though for many, the underlying effect is to highlight its presence. This mural shows how Le Corbusier did not adapt to the architectural partition wall. Instead he monopolized it. This mural invades all of the deliberately narrow space for meals, and goes against the obviously minimalist and fluid traits which characterize the prevailing atmosphere of the house. The Eileen Gray and Jean Badovici portfolio in 1929 gives the first state of the room.

the painting in the dining area, which is located in front of a large window, in direct sunlight. It is prone to rising damp with salt efflorescences, that easily migrate due to the wide range of temperatures and multiply the many parameters of serious risk to the works.
